Effectiveness and maintenance of technical avalanche protection measures in Switzerland

Stefan Margreth^{1*}

¹ WSL Institute for Snow and Avalanche Research SLF, Flüelastrasse 11, CH-7260 Davos Dorf, SWITZERLAND
*Corresponding author, e-mail: margreth (at) slf.ch

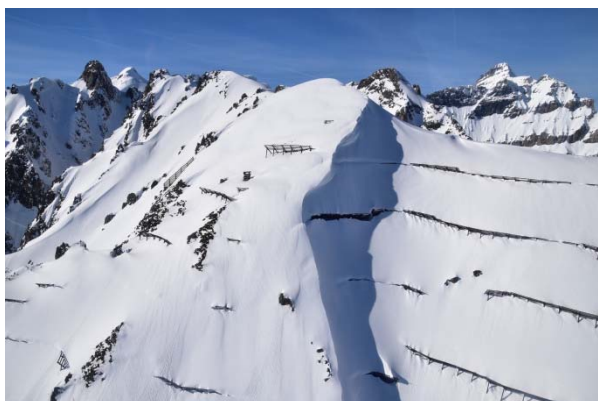
In January 2018 the snow distribution was rather irregular due to wind. As a result, several areas with supporting structures were locally overfilled with snow (Figure 1). Since an increase in snow depths was to be expected in the further course of the winter, emergency measures were drawn up in case new snowfall events overflow the structures extensively and reduce the effectiveness of the controlled areas. Surprisingly, relatively large avalanches triggered in around 10 sites with supporting structures during the avalanche cycle of 22/23 January 2018 (Figure 2). The fracture depths of these avalanches were rather small, mostly in the range of 0.5 m. Since the supporting structures were usually not completely filled with snow, the avalanche snow was slowed down and partly stopped by the lines of structures. The steeper the terrain and the more the structures were prefilled with snow, the less avalanching snow could be retained. With regard to the fracture propagation, the lines of structures showed practically no effect in some cases.

Figure 1 Supporting structures in the Valais, in the centre the structure height is 6 m. On 24 January 2018 the snow height was locally > 8 m (Photo J.J. Lugon).

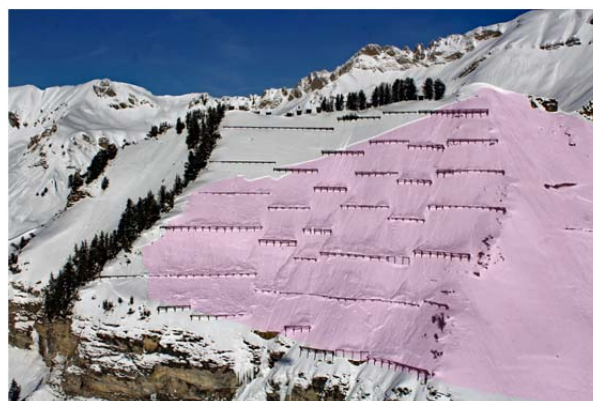
Figure 2 Supporting structures in the Bernese Oberland, on 22 January 2018 a large slab avalanche released within the controlled area (Photo U. Ryter).

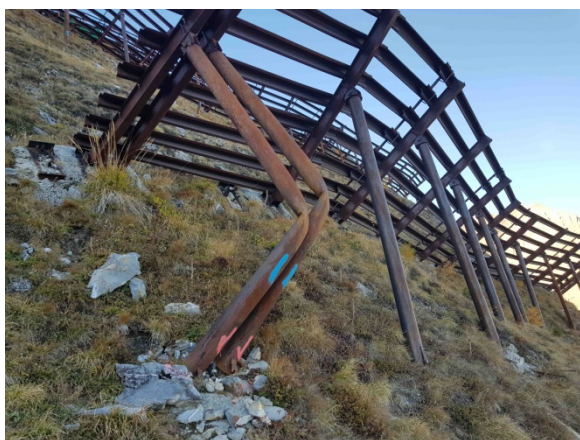
yet significantly affect the function of the structure. In the winter of 2018, the total amount of damage to supporting structures amounted to around CHF 1.5 million. In comparison to the total number of supporting structures, this figure is in the per mil range. The most frequent damage was to the valley-side buckled steel supports of snow bridges. Around 200 supports from older structures buckled out, because in addition to the normal force, a transverse force occurred (Figure 3; Margreth, 2007). The snow layer below can cling to the supports. In some snow-covered structures, girders and cross-beams broke or were bent. Such damages typically occur if a structure is overfilled with more than 1.0 m of snow. In some locations, where the distance between the lowest crossbeam and the ground was large ($> 0.3\text{--}0.5$ m), the uphill anchor bars were deformed or broken (Figure 4). This damage typically occurred in connection with strong snow gliding.

Figure 3 Buckled supports of end of line structures in the Valais. No lateral snow pressure was considered in the design (Photo Nivalp SA, 2018).

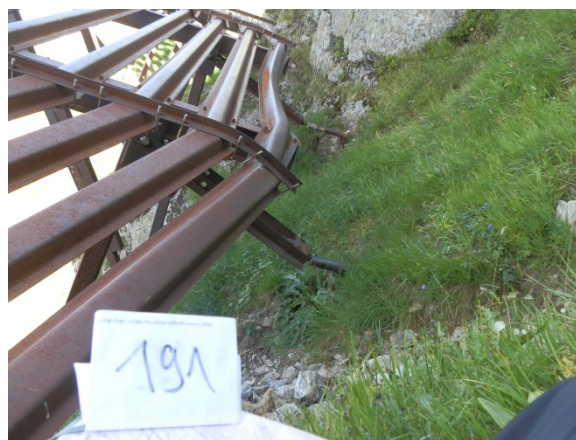
Figure 4 Deformed crossbeams and anchors because of a too large gap between lowest crossbeam and ground, canton Uri (Photo R. Planzer, 2018).

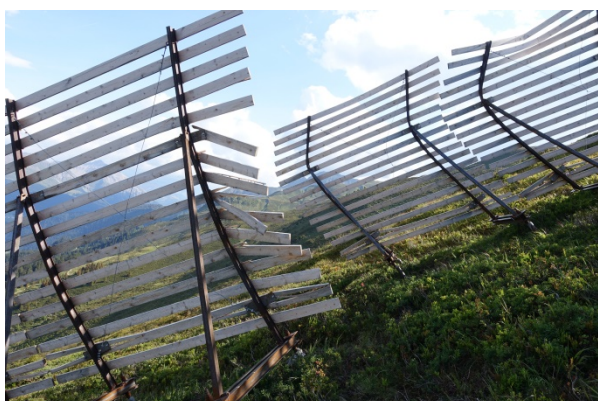
The combination of snow drift fences and wind baffles was efficient in conditions with snowfall and strong winds. Detailed observations are available from the snow drift fence at Tanngrindel in the Bernese Oberland. The 4 m high and about 90 m long fence reduces snow accumulations in an avalanche release area. The fence is located at a distance of 30 m from the edge of the terrain. On 27 January 2018, a laser scan-based snow depth map was prepared. Behind the fence about 40 m^3 snow per m was deposited. The maximum deposition height was slightly over 4 m. A total of about 5000 m^3 of snow was retained by the fence. Significant damage occurred at a 275 m long snow drift fence at Valtschamela in the canton Grisons, which was constructed in a 25° to 30° slope. Since the ground gap of the 4 m high fence was only about 40 cm, the fence was covered with snow relatively early in the winter. As a result snow pressure acted on the fence. Several steel girders and anchors were bent in the direction of the valley (Figure 5). The snow drift fence must be completely rebuilt. In inclined terrain, snow pressure as well as wind loads must be taken into account for the design of snow drift fences.

Figure 5 Snow drift fence damaged by lateral snow pressure acting in the line of slope, Valtschamela, canton Grisons (Photo S. Margreth, 2018).

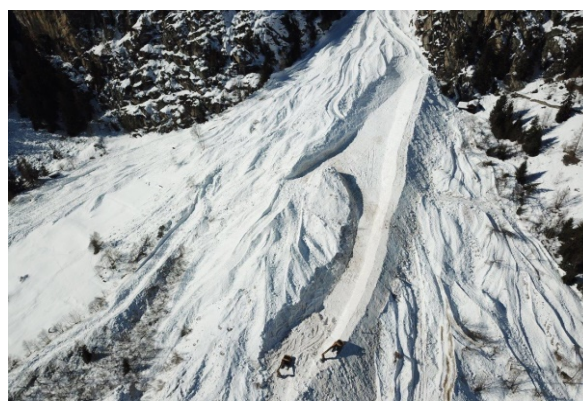
Figure 6 Deflecting dam made of snow, canton Valais (Photo W. Gitz, 2018)

At least 50 snow sheds were hit by avalanches in January 2018. One problem with snow sheds is their length, which is often planned to be as short as possible for financial reasons. At least ten snow shed portals were overflowed laterally. The structure of a snow shed protecting a railway line was damaged due to lateral snow pressure. A number of avalanches occurred in avalanche tracks protected with dams. However, only few avalanches reached the dams. In the Lötschental (Canton Valais), a site with supporting structures was largely destroyed by an avalanche in winter 1999. In order to protect the village and the supporting structures from avalanches, a 380 m long and 10 m high wedge-shaped deflection dam was constructed on a terrain terrace above. In January 2018, an artificially triggered avalanche reached a similar size as in 1999. The snow masses were completely deflected by the dam. At the upper end of the dam, the snow masses practically reached the top of the dam. In the Matter valley, 3 to 7 m high dams of snow were built in the lower part of four avalanche tracks in order to prevent the railway from being buried by subsequent avalanches, which could have a longer runout than usual in the smoothed out avalanche tracks (Figure 6).
