Veðurstofa Íslands Report

Corrosion of steel and wire constructions under Icelandic meteorological conditions with special reference to steel snow bridges and avalanche nets

Report of observations of supporting structures in Auðbjargarstaðabrekka, Ólafsvík and Siglufjörður and a compilation of relevant information about corrosion protection of steel structures in Iceland

**VÍ-G98004-ÚR04
Reykjavík
January 1998**

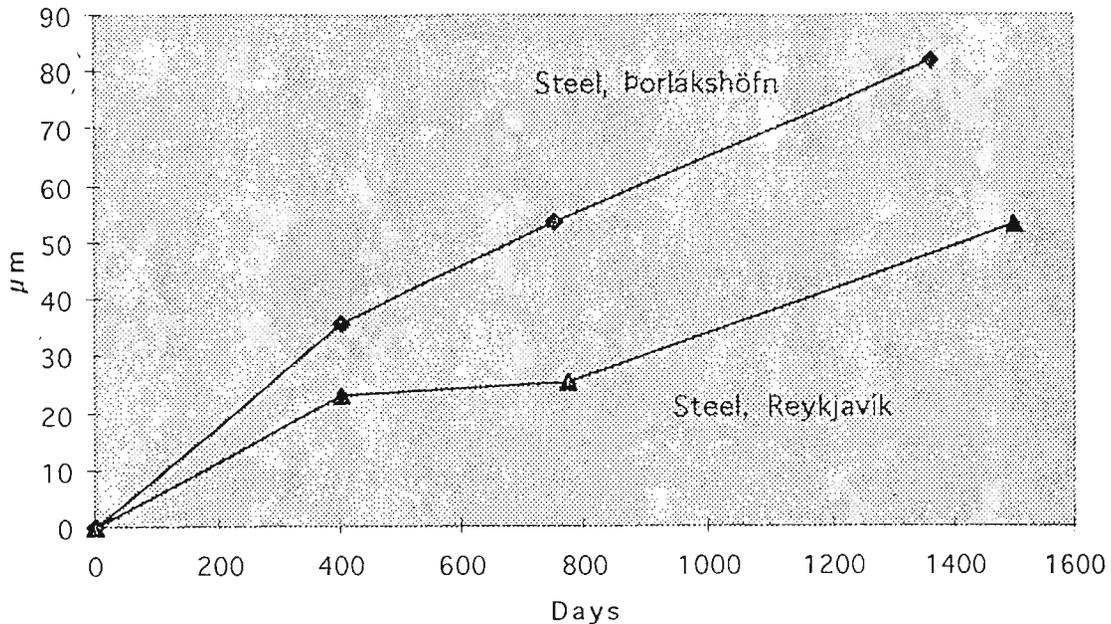
As expected, the corrosion rate decreases with time. This is due to the formation of a corrosion layer on the surface which prevents corrosion agents from reaching the metal surface. A further decrease in the corrosion rate of steel may be expected after longer time has elapsed (*cf.* the ISO/DIS 9224 standard), but the experiments in Reykjavík and Þorlákshöfn were not continued long enough for this to be observed. A further decrease is, however, not expected for zinc according to the same standard.

Figure 1. Steel corrosion in Reykjavík and Þorlákshöfn, 1984-1988.

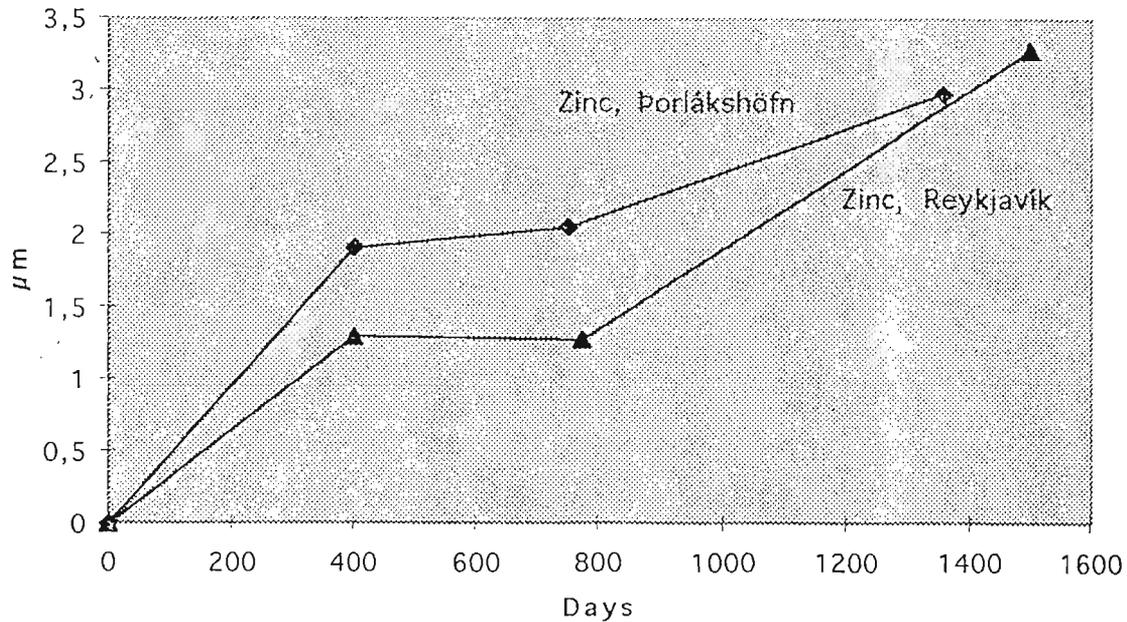
Figure 2. Zinc corrosion in Reykjavík and Þorlákshöfn, 1984-1988.

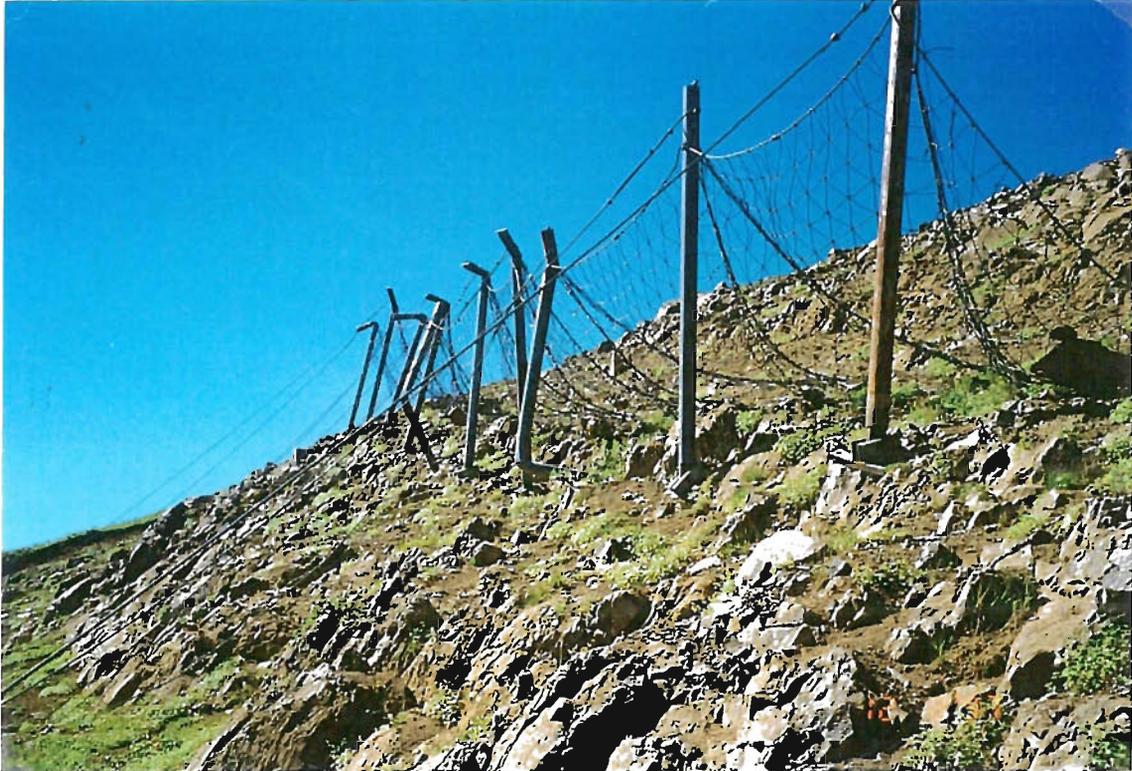
Heavy loads in winters when the nets were buried, and impact by avalanches from above, have caused repeated damages of the nets (*cf.* photograph 1). A total of 7 out of the 10 posts have failed near the top, at the location of the downslope wire loop or the perimeter wires, and the middle or lower parts of 2 posts are bent due to high compressional loadings. One groundplate has, furthermore, been broken due to high pressures. There are no visible damages of the uphill or downhill wire rope anchors, except that the upper part of one of the uphill wire anchors has been forced into loose material near the top of the bore hole. Some of the posts were originally not installed with the correct orientation with respect to the slope. In spite of this, none of the groundplates below the posts have been visibly moved due to the heavy loads, with the exception of the groundplate that has broken.

The corrosion condition of nets in Auðbjargarstaðabrekka after 13 years is not bad although some corrosion is visible in the net mesh and u-bolt clips. The supporting construction is, however, badly damaged and needs substantial repairs if nets are to be maintained on the slope in the future.

Photograph 1. Snow nets from EI in Auðbjargarstaðabrekka, northern Iceland.

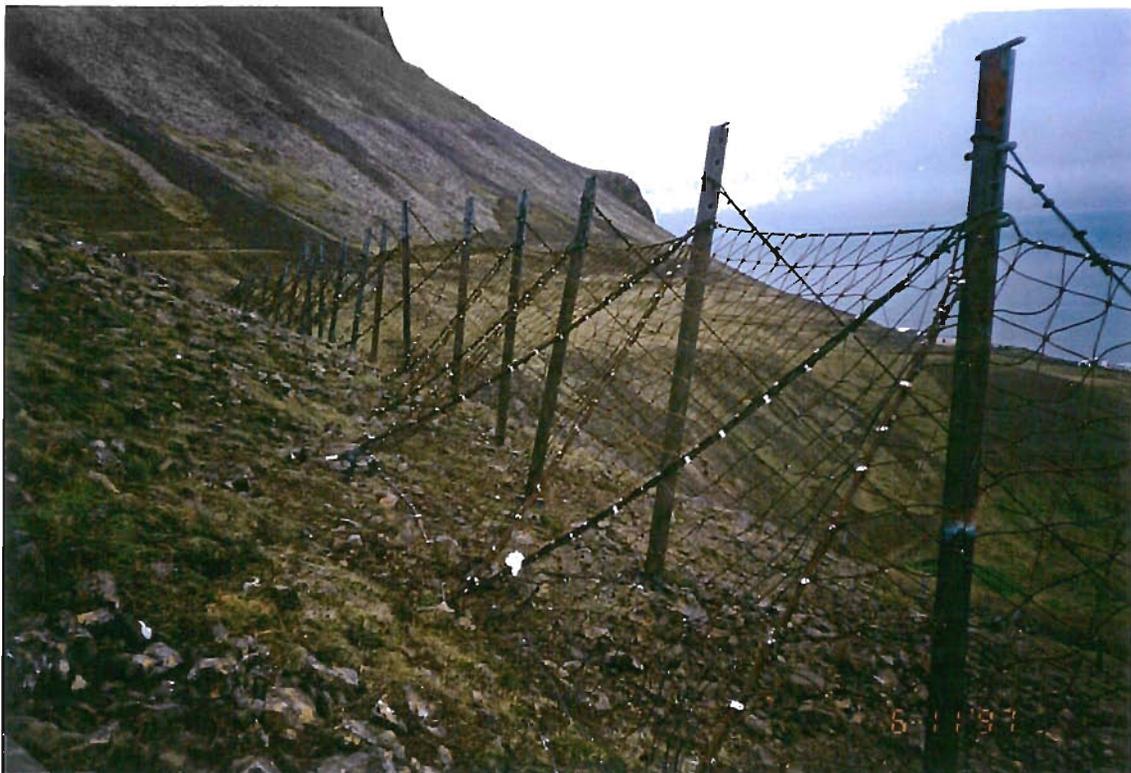
Photograph 2. Snow nets from EI in Ólafsvík, western Iceland.

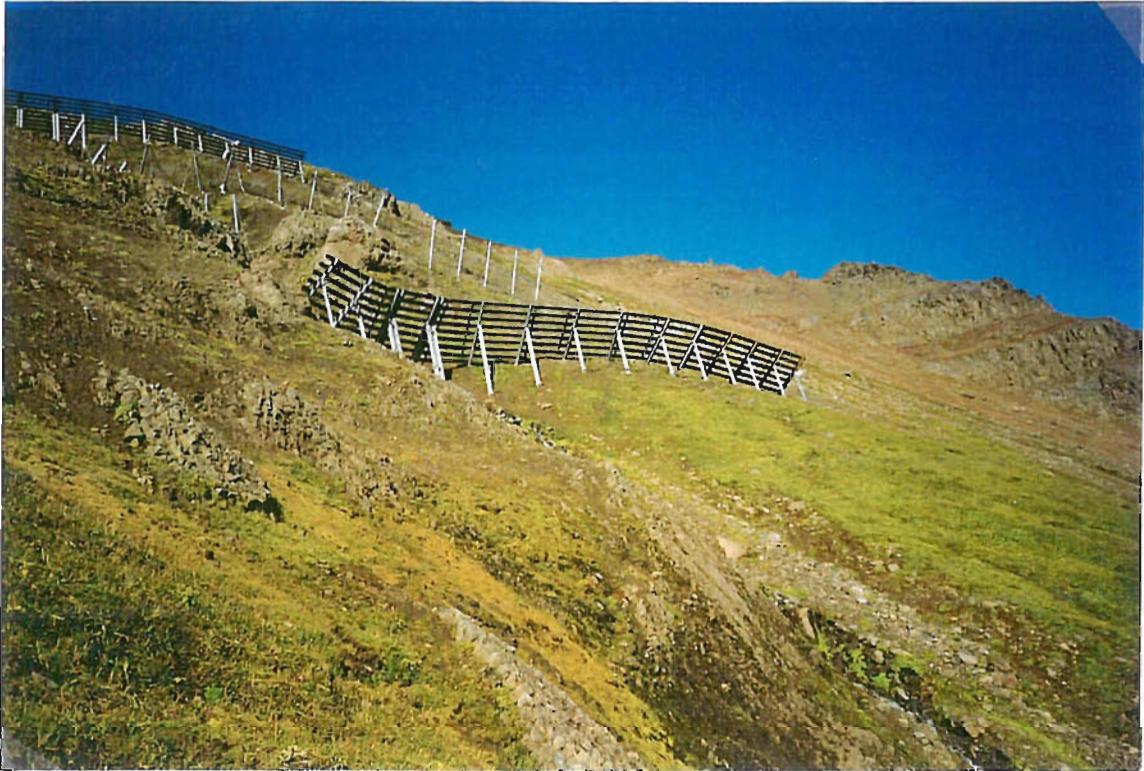
The supporting structures in Siglufjörður were installed in October 1996 by the Icelandic Meteorological Office and the Icelandic Avalanche Fund for experimental purposes (photograph 3). They are stronger than the nets in Auðbjargarstaðabrekka and Ólafsvík because they are designed for higher values of the snow density which are believed to be appropriate for Icelandic conditions.

Photograph 3. Supporting structures from J. Martin, Geobrugg and EI in Hafnarfjall in Siglufjörður, northern Iceland.

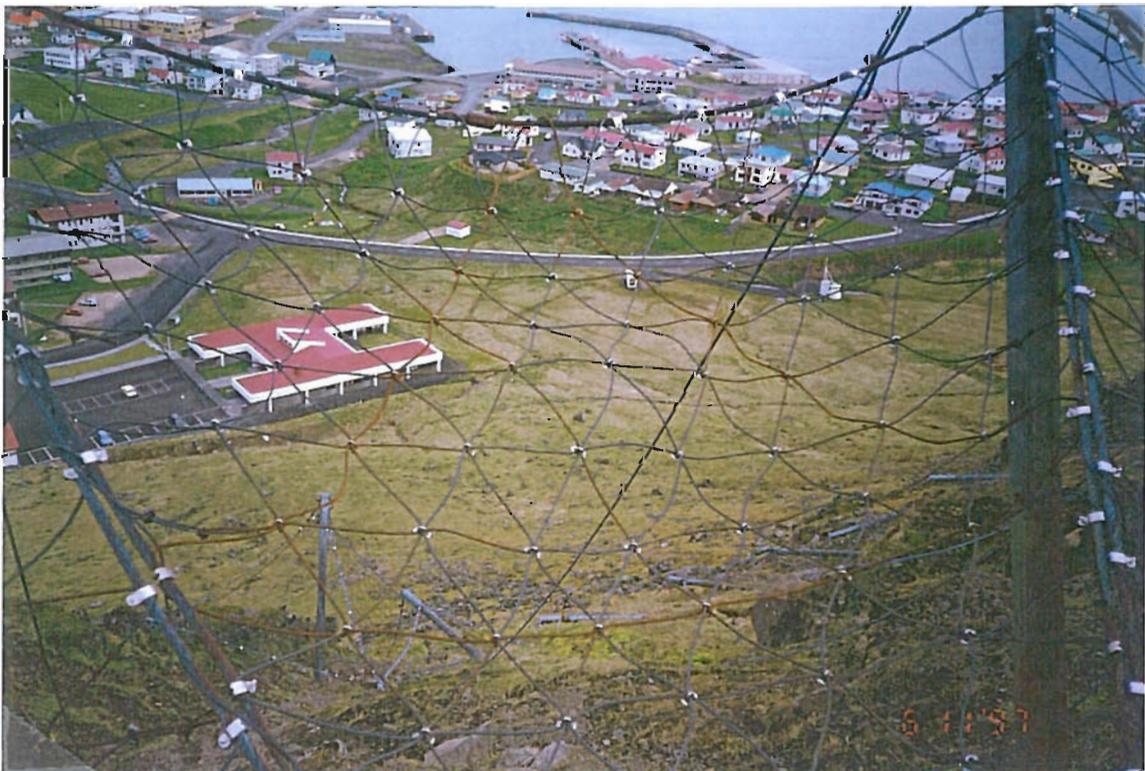
A large proportion of the wires in the mesh of the nets in Ólafsvík is heavily rusted (photograph 4), in some cases to the extent that the wires are stiff from the accumulated rust and break easily when they are bent back and forth a few times. Some mesh wires were so corroded that they could be pulled apart by hand. These wire ropes are of the same type as the mesh wires in Auðbjargarstaðabrekka, *i.e.* they have a diameter of 5.25 mm with 0.35 mm wires. Samples of the wire ropes were tested for breaking strength by the Icelandic Building Research Institute. A sample with little visible corrosion had a breaking strength of 14.5 kN, a second sample which had substantial visible corrosion and had become rather stiff had a breaking strength of 10.9 kN and a heavily corroded wire rope with some broken threads had a breaking strength of only 9.3 kN. According to information

The corrosion condition of nets in Ólafsvík after 12 years is very bad and both mesh wires and some of the perimeter wires are in urgent need of replacement. Parts of the supporting construction is also badly damaged. The repair work in the fall of 1997 has improved the condition of the nets, but there is clearly a need for further repair work in the near future.

Photograph 4. A rusty part of the EI nets in Ólafsvík.

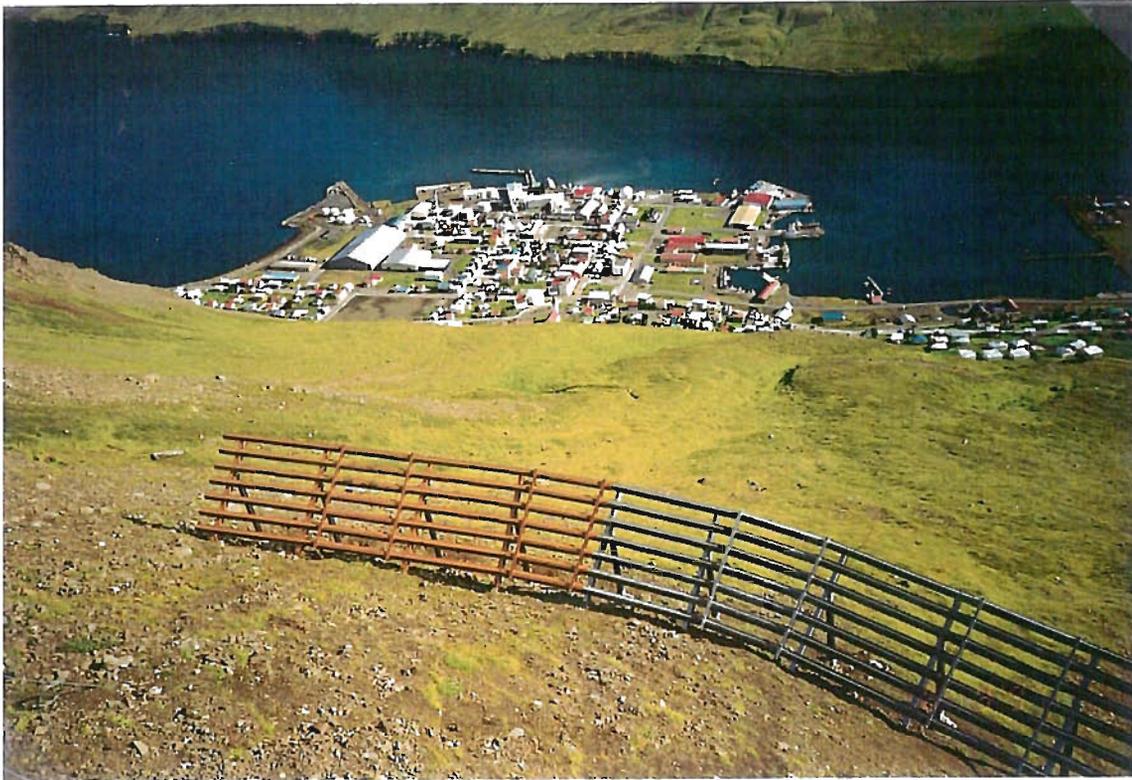
Most of the stiff constructions from J. Martin are hot dip galvanised according to the standard SS-3583, class B, but two units in the lowest line are made of black steel for comparison (photograph 5). Nuts and bolts are zinc plated but not hot dip galvanised and many of them are visibly corroded after the first winter (photograph 6). The main difference with regard to corrosion protection between the steel bridges in Siglufjörður and steel structures designed according to current practice in Iceland is that the anchors and parts of the foundations are not hot dip galvanised and that nuts, bolts and other smaller steel parts are only zinc plated. Changing this to conform with the Icelandic work practice would result in a minor cost increase compared to the structures which were installed in Siglufjörður. The main structure of steel bridges are usually not hot dip galvanised in Alpine countries. Requiring hot dip galvanisation for such structures in Iceland, as was done in Siglufjörður, leads to a cost increase on the order of 10% compared to traditional Alpine structures.

Photograph 5. A part of the stiff steel structures from J. Martin in Siglufjörður showing both black and galvanized bridges.

It is recommended that all steel parts of solid steel structures, including the subsurface parts of anchors and micropiles, are hot dip galvanised according to the standard SS-3583, class B, which is described above, with an average zinc thickness of 115 μm for parts thicker than 6 mm.

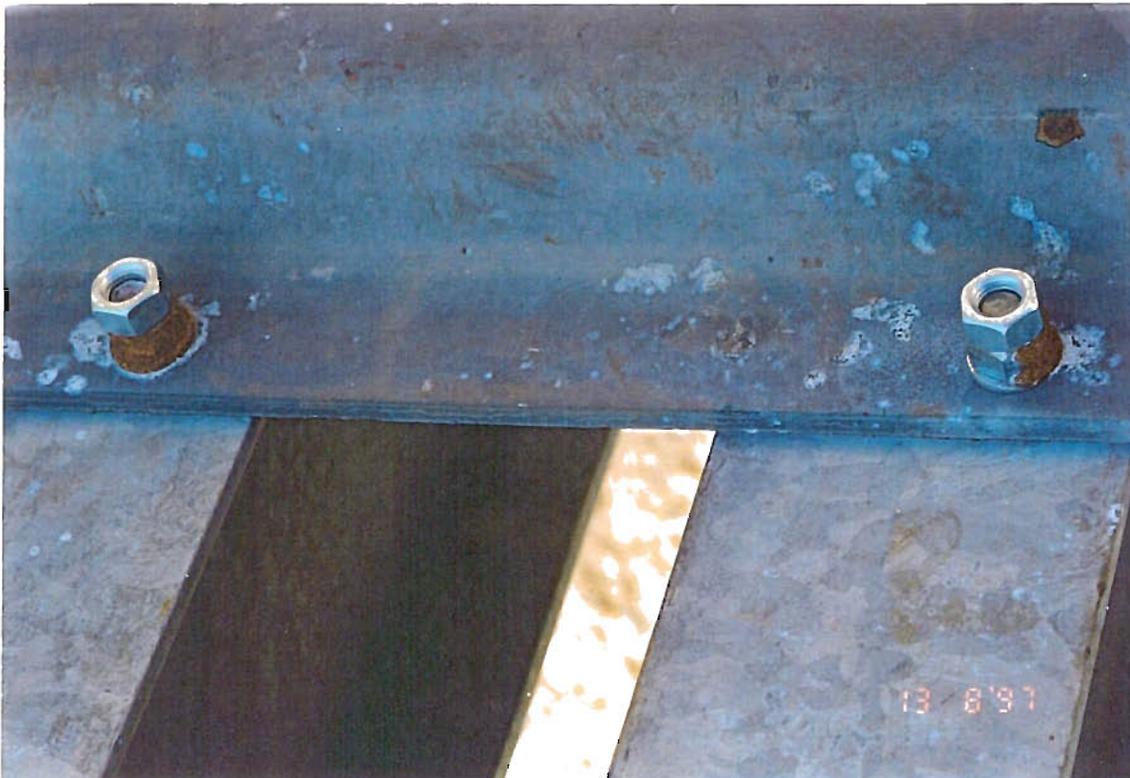
Photograph 6. Rusty nuts and bolts in the steel bridges from J. Martin in Siglufjörður.

All steel parts of snow net constructions, including u-bolt clips, nuts, washers and shackles, should be hot dip galvanised, according to the standard SS 3583, class B, so that rust forming in guy fittings can not start the rusting process in the guy wires.

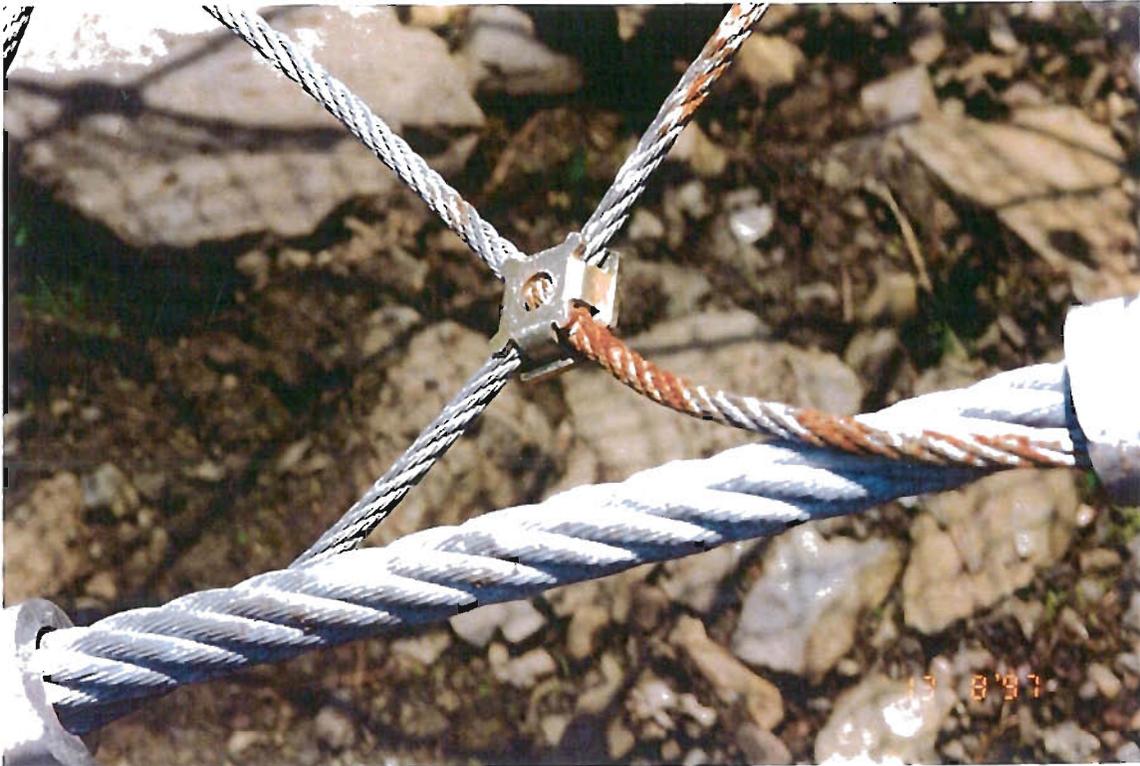
Wires in the net meshes and the "maschengitter" of the snow nets from Geobruigg in Siglufjörður are already starting to rust after the first winter (photograph 7). In addition, a number of the galvanised steel clips, which are used to fasten the wires in the mesh to each other, are rusted after the first

winter. Rust can also be seen in a few spots on perimeter wire ropes and on downhill cables. Zinc thickness measurements of samples from downhill wire ropes, with a diameter of 16 mm and wire diameter of about 1.1 mm, indicate a zinc thickness of only 5-7 μm . This is quite thin for this thickness of wires and not in agreement with the specifications of the manufacturer. Zinc thickness measurements from Siglufjörður are tabulated in the next section.

Photograph 7. Rusty clips and wires from the Geobrug nets in Siglufjörður.

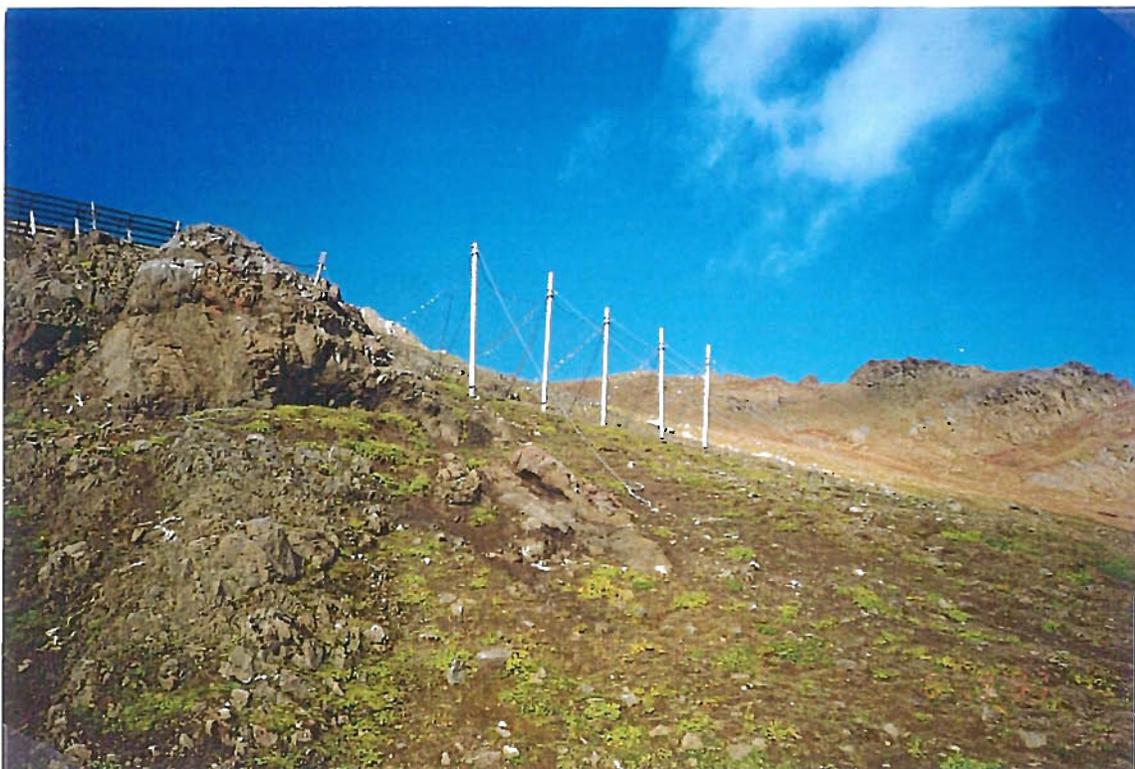
Photograph 8. A part of the EI nets in Siglufjörður showing a net which has been pulled down along the perimeter wire ropes.
