Report 03046

# Report on weather conditions over Snæfellsnes by evening 25 May 2001

Report prepared for Aircraft Accident Investigation Board

VÍ-ÞJ07 Reykjavík Desember 2003

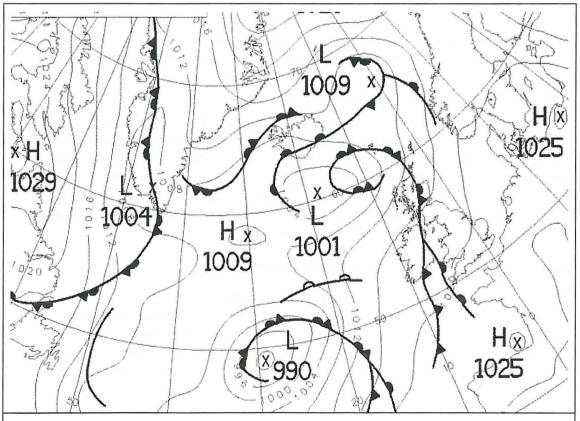
On the synoptic map from midnight, three hours after the incident (fig. 1), one can see that a low-pressure center, 1001 hPa, was some 400 km south of Iceland and a high was over Northeast-Greenland. The low was moving slowly west and the high was increasing. As a result of this development the easterly winds, which were blowing in most parts of Iceland, became gradually stronger, but this process was very slow.

Fig. 1 - Synoptic weather map 26 May 2001 00 UTC. The map is issued by the British Meteorological Office (UKMO)

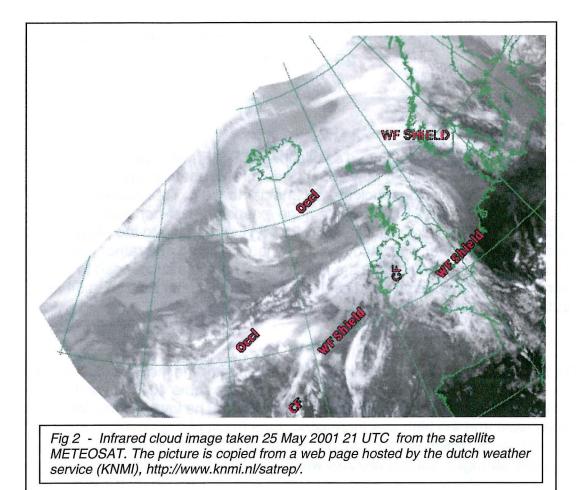
A weak front was lying almost stationary over the southern part of Iceland. The front caused some rain as may be seen in the upper part of fig. 3. Fig. 2 shows the cloud systems over the North Atlantic and there we can see that the cloud layers following the front extended over most of Iceland but in the northern part the weather was mostly dry.

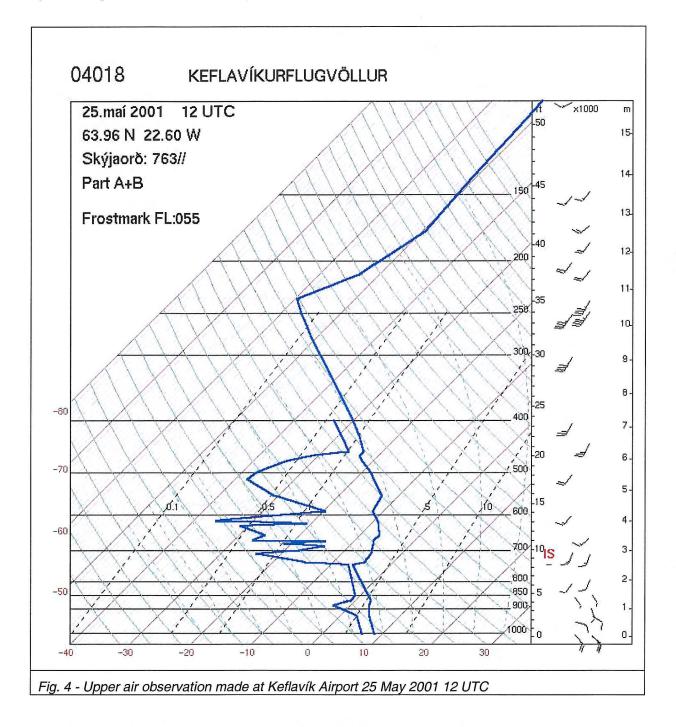
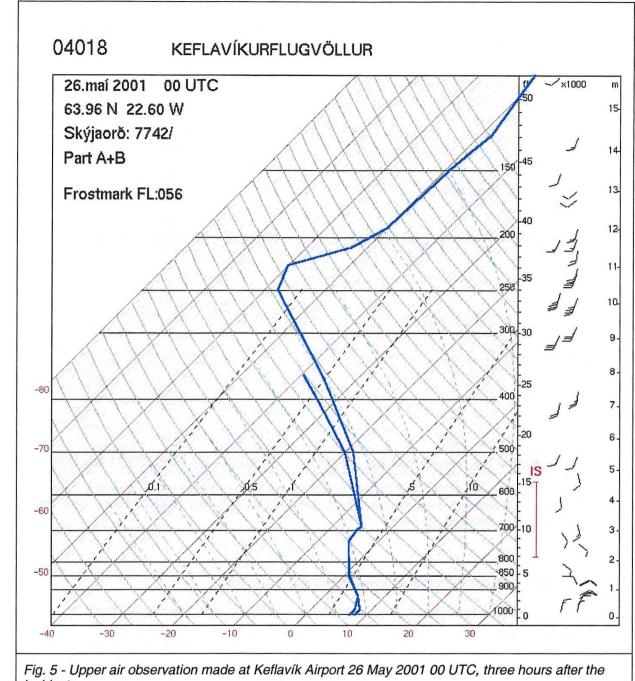
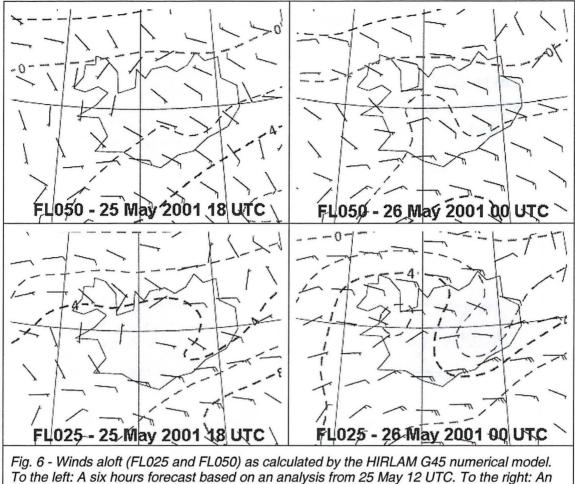
On the maps in fig. 6 we can see calculations of winds aloft made with the HIRLAM G45 numerical weather prediction model run at the Danish Meteorological Institute. This result is in a good agreement with the wind measured over Keflavík Airport. According to the model we should have had light southerly winds over Snæfellsnes in both levels (FL050/850 hPa and FL025/925 hPa), but later in the evening, as shown by the calculation at midnight, the southerly winds should have been replaced by easterly winds. As far as can be seen from observations, f.ex. from Ásgarður as earlier mentioned and from other stations as will be shown later, it seems to be a fact

that during the evening, from 18 UTC to midnight, easterly and northeasterly winds have been advancing slowly against the southerly winds which were prevailing earlier in the inner part of Snæfellsnes.

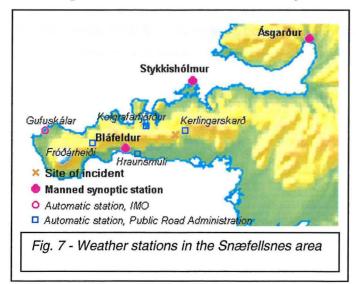
temperature are also available from several automatic stations in the Snæfellsnes area. Most of them are operated by the Icelandic Public Road Administration but one station is operated by the Icelandic Meteorological Office (IMO). The position of these stations is shown in fig. 7.

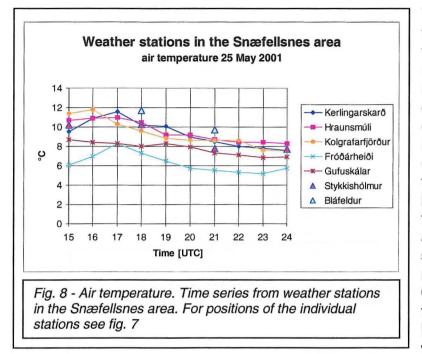
Time series from all the relevant weather stations are shown in figures 8-10. In fig. 8 one can see that there does not seem to have been great difference in temperature between stations on the northern side and the southern side of the mountains. Certainly the temperature at Bláfeldur at 21 UTC was approximately

two degrees higher than in Stykkishólmur at the same time. But the three stations closest to the incident site, Kolgrafarfjörður, Kerlingarskarð and Hraunsmúli, report almost exactly the same temperature.

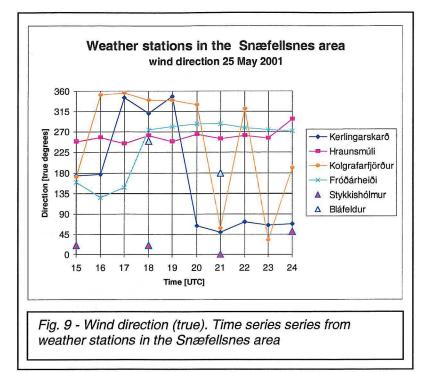
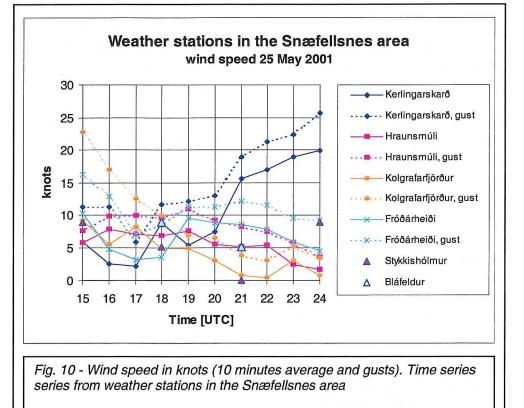
Fig. 9 and fig. 10 should be looked at together to get an overview of the fluctuations in the wind. The most interesting stations are Hraunsmúli, Kerlingarskarð and Kolgrafarfjörður. At Hraunsmúli, on the southern side, there had been continuous southwesterly wind during the afternoon but the wind speed was rather low, 5 to 8 knots most of the time. At Kolgrafarfjörður rather fresh and gusty winds from the south were observed early in the afternoon (15 UTC), then the winds turned to moderating northerly or northwesterly winds. At the time of the incident there was almost calm at Kolgrafarfjörður. At Kerlingarskarð light southerly winds were blowing until 16 UTC but after that the wind direction turned to northwesterly. By 20 UTC there was a marked change in the wind as the wind direction turned towards east-northeast with increasing wind speed. At the time of the incident the wind at Kerlingarskarð was northeasterly 16 knots, gusting to 19 knots.

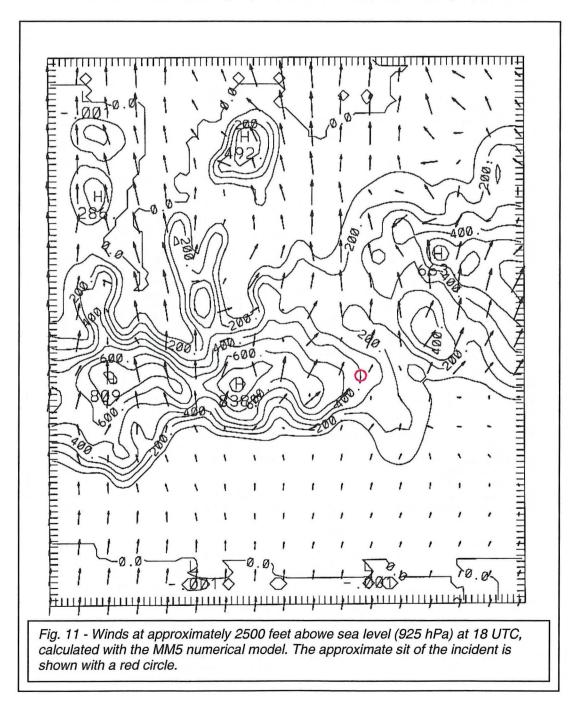
Calculations done with the numerical model MM5 support the hypothesis. On figures 11 and 12 we can se results of these calculations which were made at "Reiknistofa í veðurfræði ehf". The air currents over Snæfellsnes are simulated in a very fine grid, which makes it possible to see the effect of the orography in detail. The calculations are based on an analysis from noon and stop six hours later, at 18 UTC, and that is the situation shown on the maps. In fig. 11 we see the calculated wind in an altitude of approximately 2500 feet above sea level (925 hPa) but fig. 12 shows the calculated wind at surface level.

These maps indicate that at the height of the mountaintops (approximately. 2500 feet) southerly winds have been prevailing but the wind speed was variable due to the influence of the orography. Near Elliðatindar the wind direction seems to have been southwesterly and the wind velocity higher than in most other places. Probably one can conclude that in fact fresh southwesterly surface winds have blown around and over Elliðatindar spreading out over the area to the northeast where the incident happened.

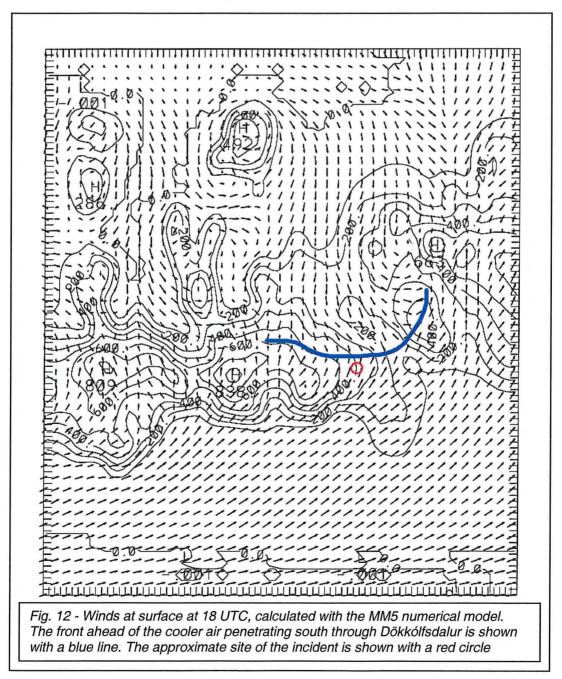
The other map, showing calculated surface winds, gives a quite different picture. Here we can see rather slow but constant southwesterly winds on the southern side of the peninsula but on the northern side we have eddies which are very much formed by the orography. Generally the air seems to be streaming from north in between the mountains where it converges with the air coming from the south. This must have led to upgoing vertical motion and we know that clouds were lying on the highest mountains and somewhat down along the hillsides. One of the strongest northerly currents seem to have been lying in Kolgrafarfjörður and another one to the east of Bjarnarhafnarfjall, over Berserkjahraun and extending further south over Vatnaheiði. In the northeast sides of Elliðatindar this current has become more northwesterly and according to the calculation valid at 18 UTC the front between this current and the air coming from the south should have been just north of the site of the incident. Over the front at surface the previously mentioned southwesterly winds have been blowing.

As already has been mentioned and appears clearly from fig. 12 the surface winds on the northern side of

Snæfellsnes were very much formed by the orography. The front ahead of the air advancing from the east has therefore not been of such nature that we could indicate it with a regular line, straight or curved, as on a traditional weather map. It has been in patches of different length and their orientation and direction of movement has been dominated by the landscape. They have been sharpest where a current met another current but very weak and even invisible where the wind was very slow.

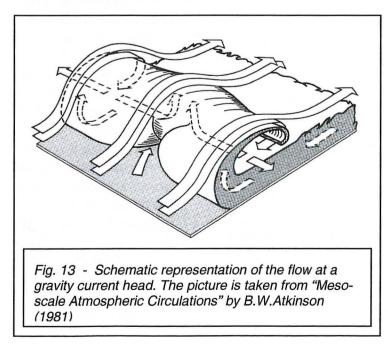
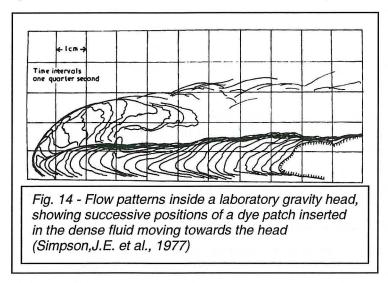
To understand better the behavior of such fronts it is natural to look at conceptual models of sea-breeze fronts, which have been investigated quite well. In fact the flow here could be classified as some kind of sea breeze since the air coming from north advanced against the southerly winds which were over the land in the beginning. In fig. 13 we can see a simple schematic drawing of a seabreeze front where the sea breeze penetrates under the slightly warmer air mass. These ideas are supported by experiments in laboratory tanks and in fig. 14 we can see the results of one such experiment. The dense fluid is

moving from right to left under the less dense fluid. Over the frontal head and just behind the "surface front" we have a layer with well developed eddies. The simplified image in fig. 13 reflects this quite well.

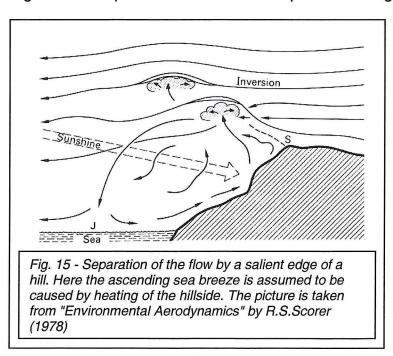
To get an idea on how the fronts might have been influenced by the orography we could look at fig. 15. There we can see how a sea breeze and wind blowing from the opposite direction could behave when they meet at a salient edge on a hilltop. Marked eddies develop near the edge under the

discontinuity between the two currents. The conditions illustrated on the picture are not in every detail like what we would expect to have been in the Snæfellsnes area this evening but nevertheless it could clarify why sea-breeze fronts and other similar fronts can be much sharper near hill edges than elsewhere. The front will be by far sharpest very close to the edge and flying through it very low

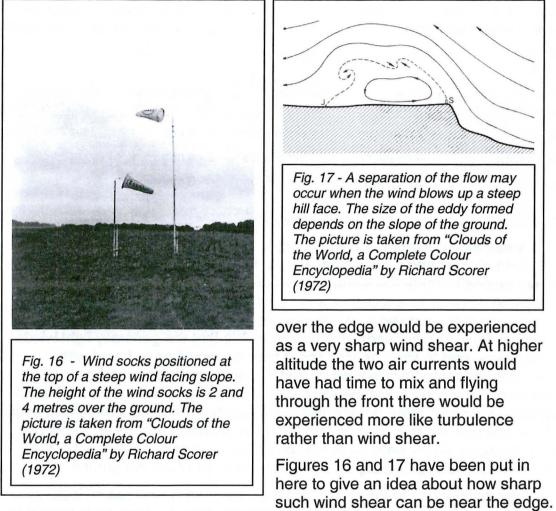
Fig. 16 is a photography of real conditions; one of the wind socks is at 2 m over the ground but the other one at 4 m. The drawing in fig. 17 shows a similar situation.
