Kristján Ágústsson
Tómas Jóhannesson
Siegfried Sauermoser
Hörður Þór Sigurðsson
Esther Hlíðar Jensen

Hazard zoning for Bíldudalur, Vesturbyggð

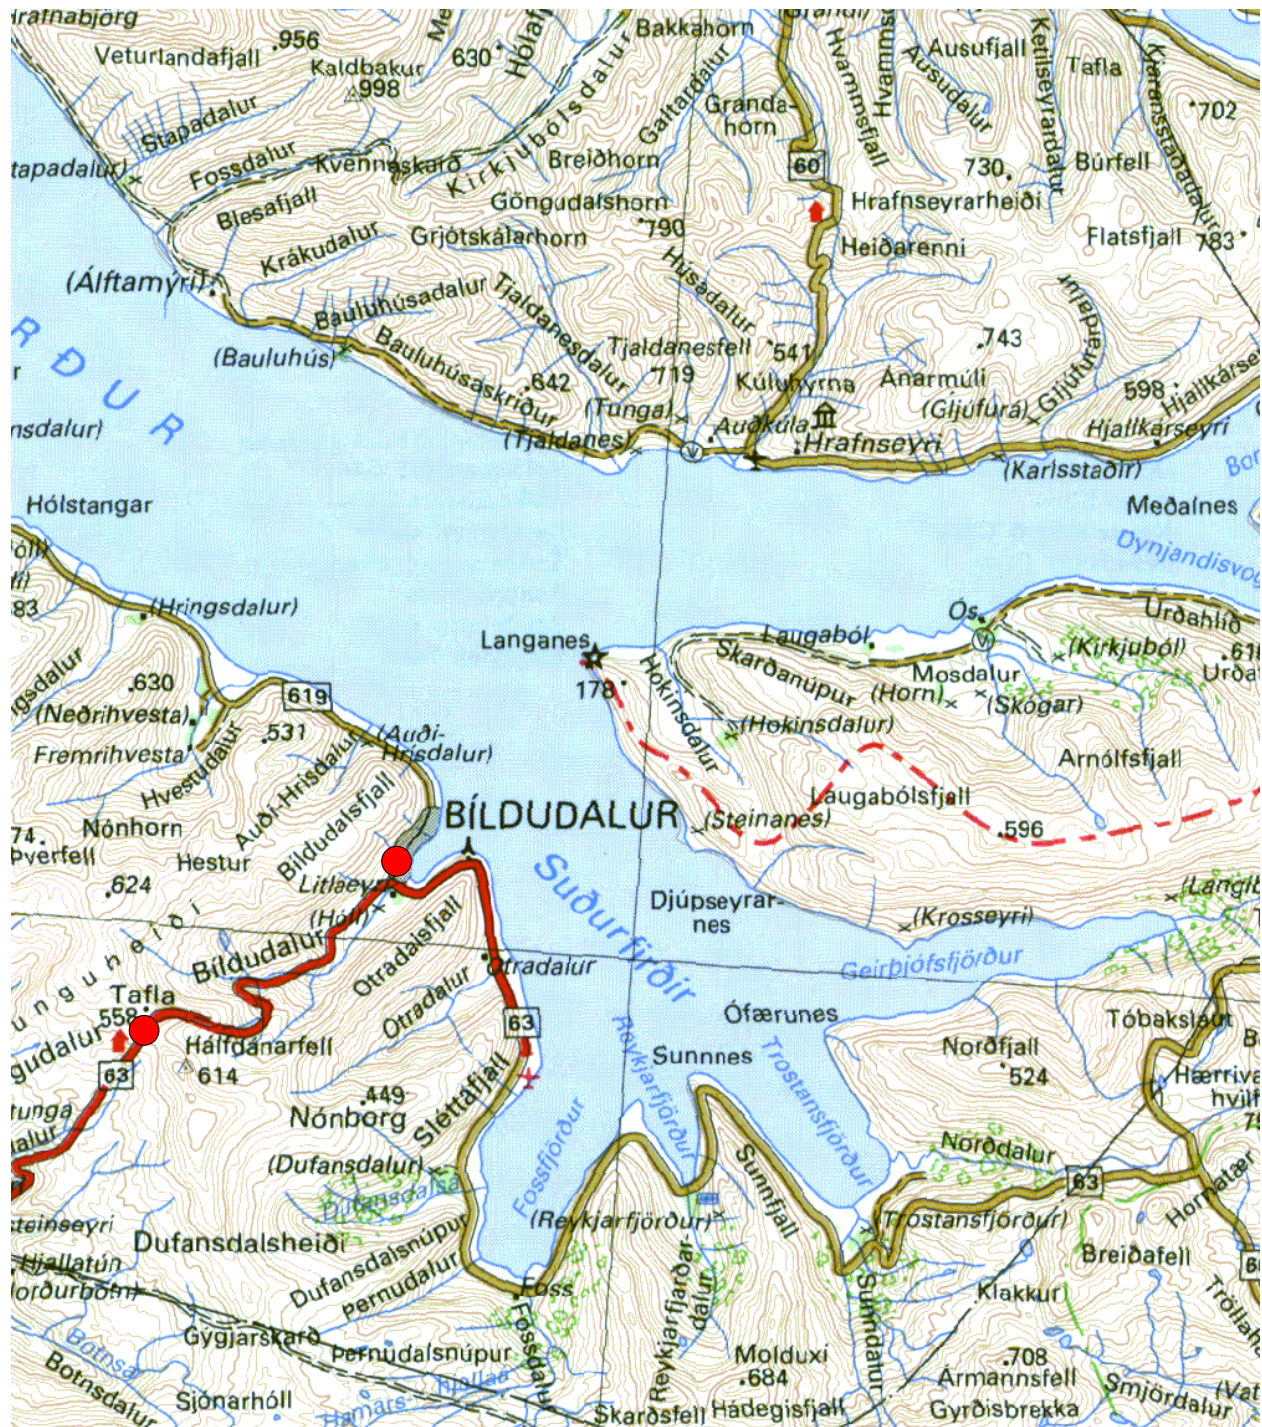
Figure 1. Overview of the area around Bildudalur. Meteorological stations are marked with red circles. © The National Land Survey of Iceland.

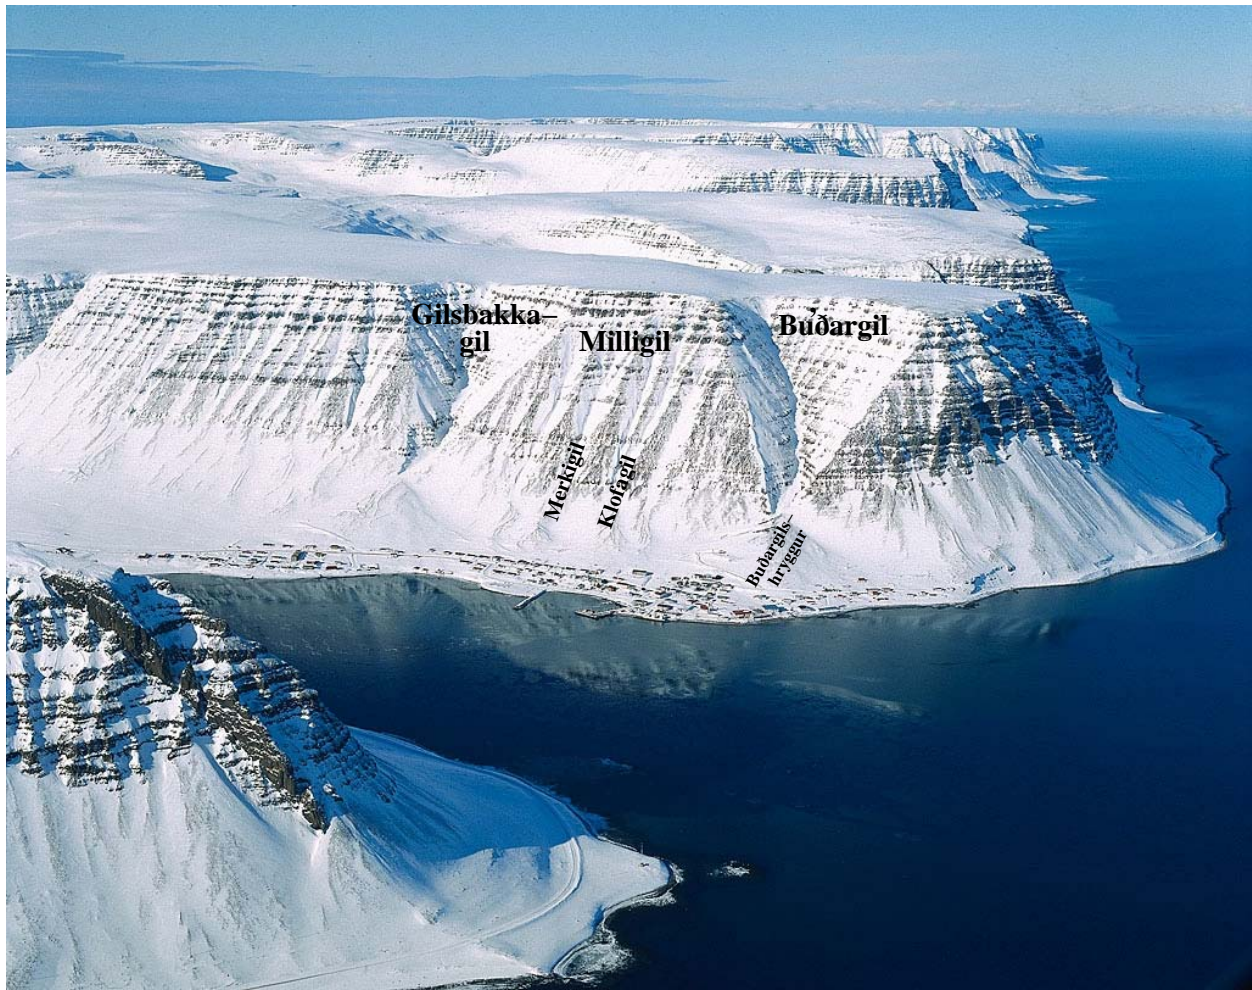
Figure 2. *Bíldudalur and the name of the main landmarks. (Photo: © Mats Wibe Lund).*

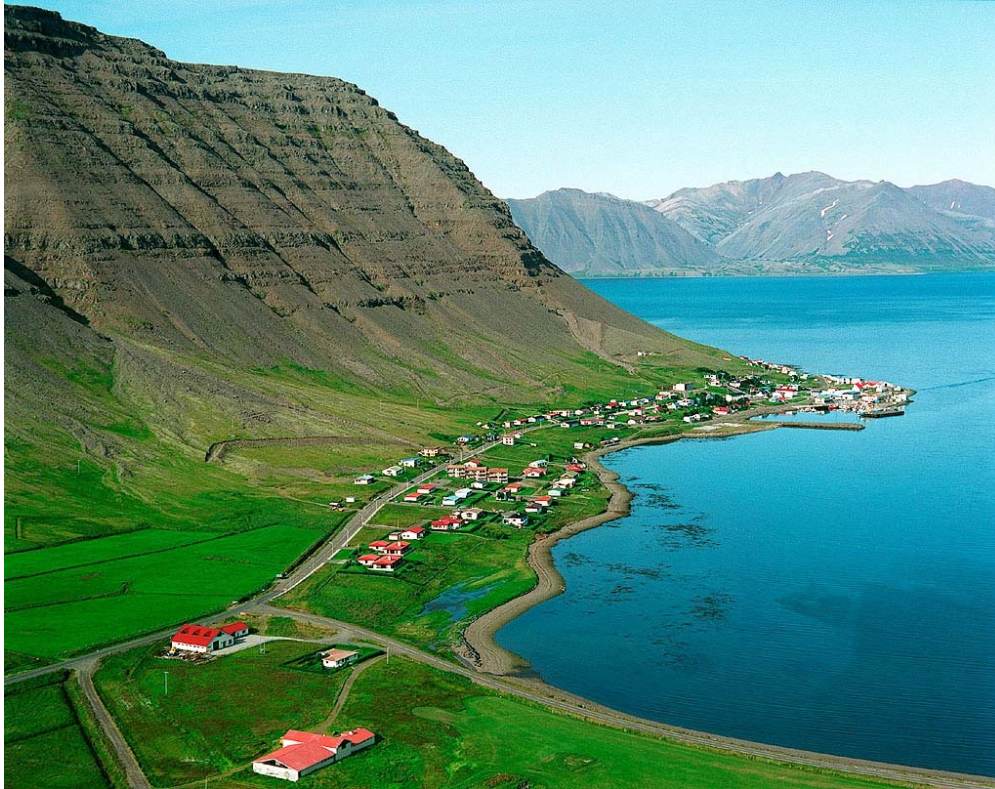
Figure 3. View along Bıldudalsfjall to NE. The Ýrst large gully is Gilsbakkagil and then the Milligil. B'ðargil and its debris cone is above the harbor (Photo: © Mats Wibe Lund).

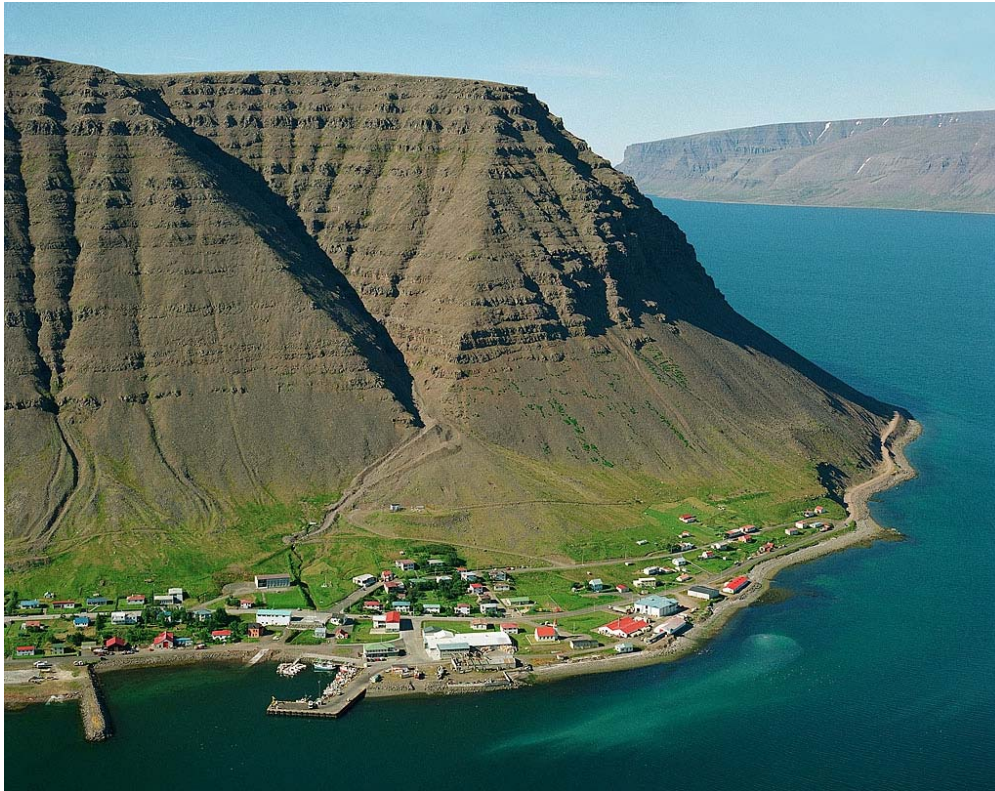
Figure 4. *Búðargil* (Photo: © Mats Wibe Lund).

Búðargil (Fig. 4) is a huge gully and during the settlement history of Bíldudalur avalanches, slush-flows, flashfloods, debris flows and rockfalls have been released in it. On several occasions they have caused severe damage. A large part of the settlement is located on the debris cone of the gully, both residential houses, industrial buildings and official buildings.

The potential starting areas for avalanches in Búðargil are between 250 and 450 m a.s.l. on both sides of the gully. This gully has a shape of a big rounded wedge which is 400 m wide and 250 m deep and reaches an altitude of 450 m a.s.l. The inclination is about 40° . Both sides of the gully are slightly concave and consist of stepped cliffs which interrupt the profile considerably. Two of these cliffbelts are significantly higher than the others. They are at approximately 300 and 400 m a.s.l. Some loose material has accumulated between individual cliffbelts. Further, the sides are cut by deep and narrow subgullies. The outermost parts of the gully, *i.e.* in the proximity of the rim to
