Field observations and laboratory experiments for evaluating the effectiveness of avalanche defence structures in Iceland : main results and future program

T. Jóhannesson

Icelandic Meteorological Office

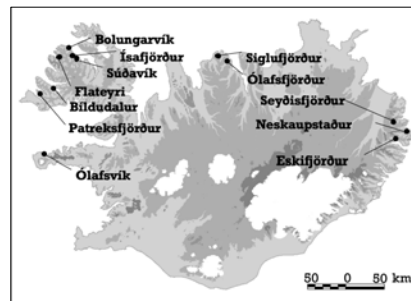
Figure 1. *The most important villages in Iceland that are threatened by avalanches and landslides.*

Snow avalanches and landslides have caused many catastrophic accidents and severe economical losses in Iceland since the country was settled in the ninth century. Figure 1 shows the main villages where avalanches and landslides threaten settled areas and Figure 2 shows locations where avalanches have been reported to cause damage or deaths since the settlement of Iceland (based on Figure 6 in [BJÖ 80]). Although the concentration of the accidents is highest in western, central northern and eastern Iceland, avalanche accidents

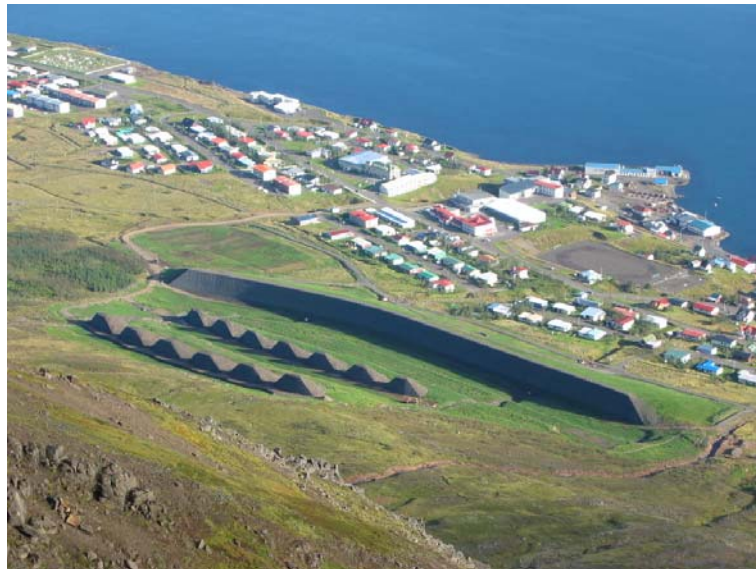
Figure 8. The braking mounds and the catching dam in Neskaupstaður. Each mound is 10 m high and the catching dam has a height of 17 m. Photo: Tómas Jóhannesson.

part of the design of avalanche protection measures for the town of Neskaupstaður in eastern Iceland (Figure 8) [TÓM 98].
