Avalanche protection measures in Iceland

International Symposium
on
Mitigation Measures against Snow Avalanches
and other Rapid Gravity Mass Flows
3. - 5. April 2019, Siglufjörður Iceland

Deflecting dams, catching dams and braking mounds

Supporting structures and snow fences

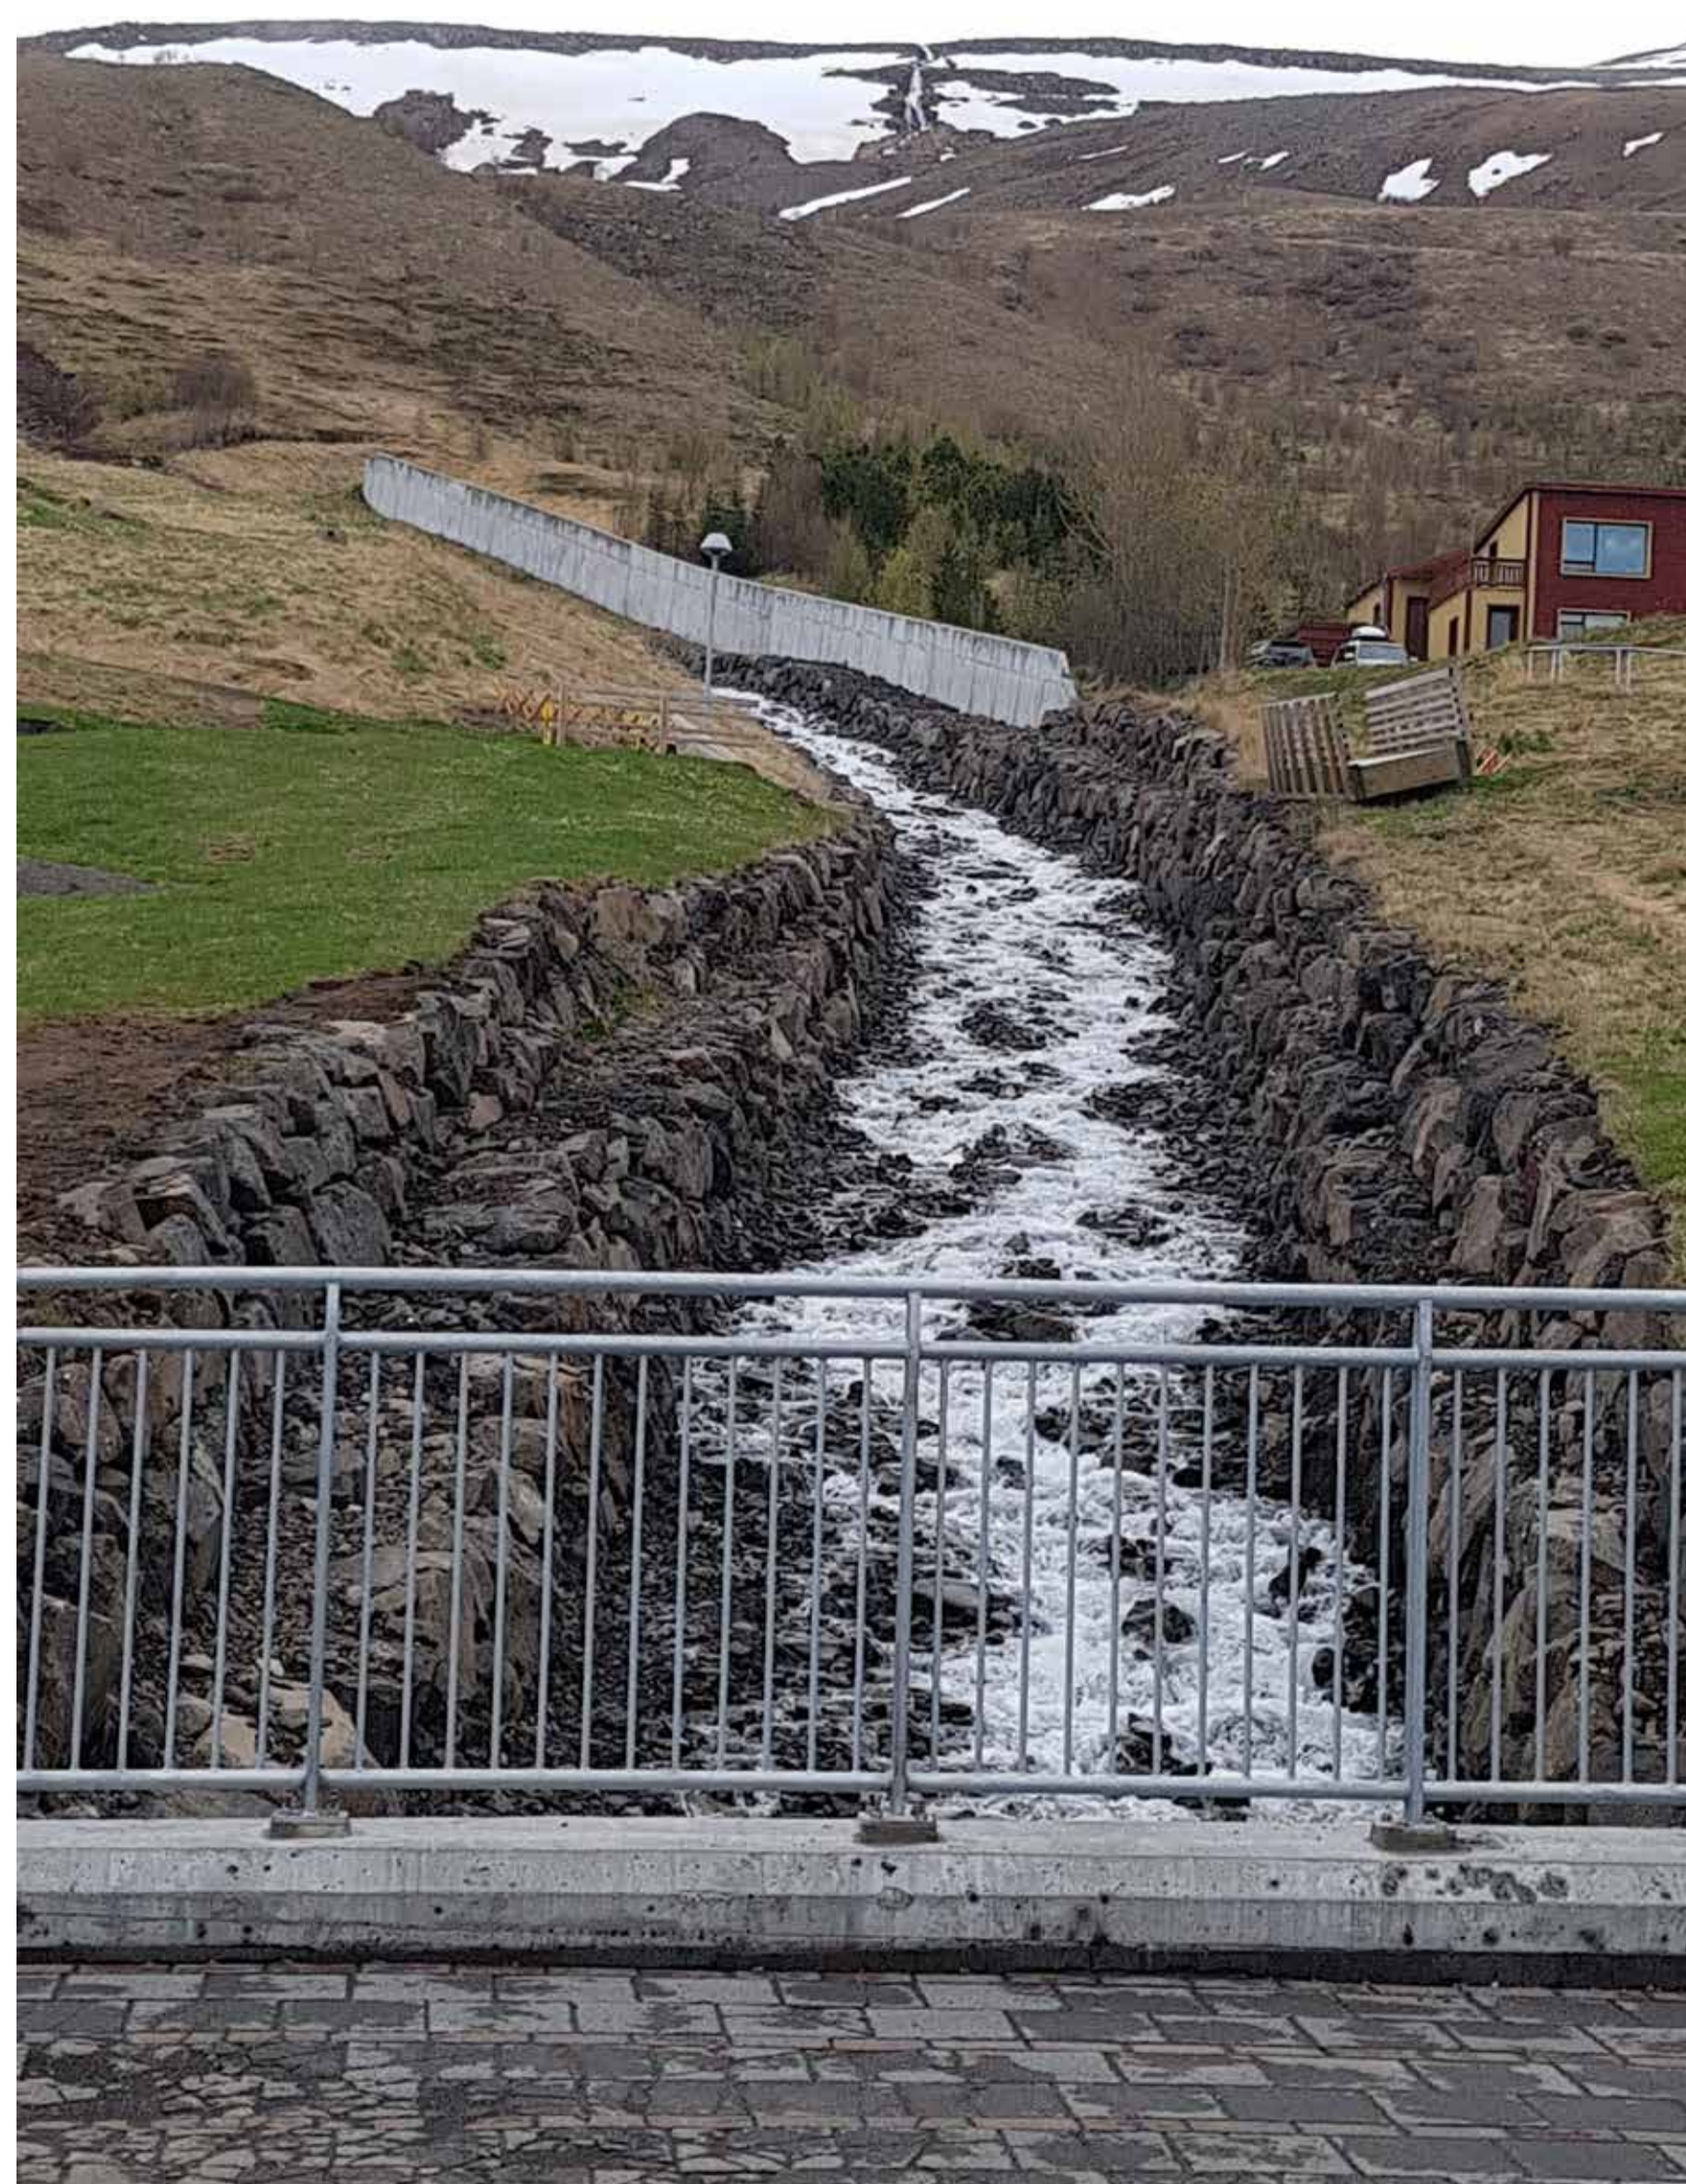
Figure 1. Slushflow protection measures in the river Hlíðarendá in Eskifjörður, E-Iceland.

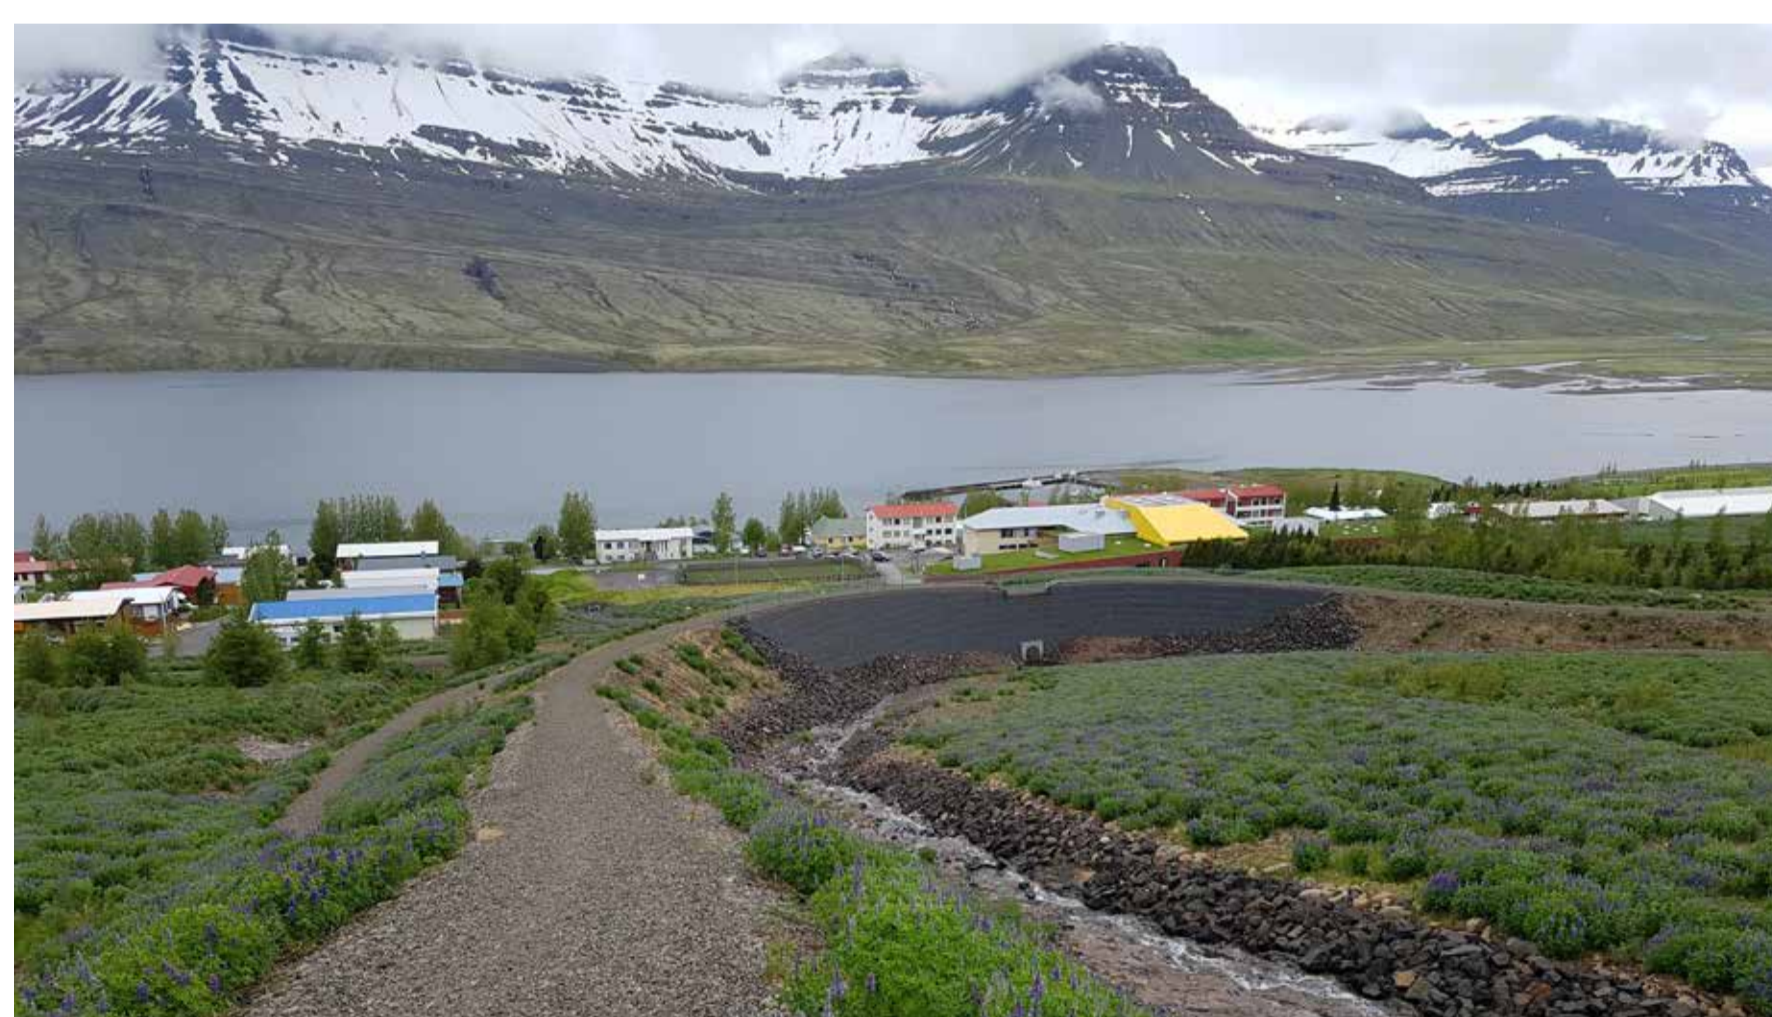
Figure 2. Slushflow protecting measures in Fáskrúðsfjörður, E-Iceland.

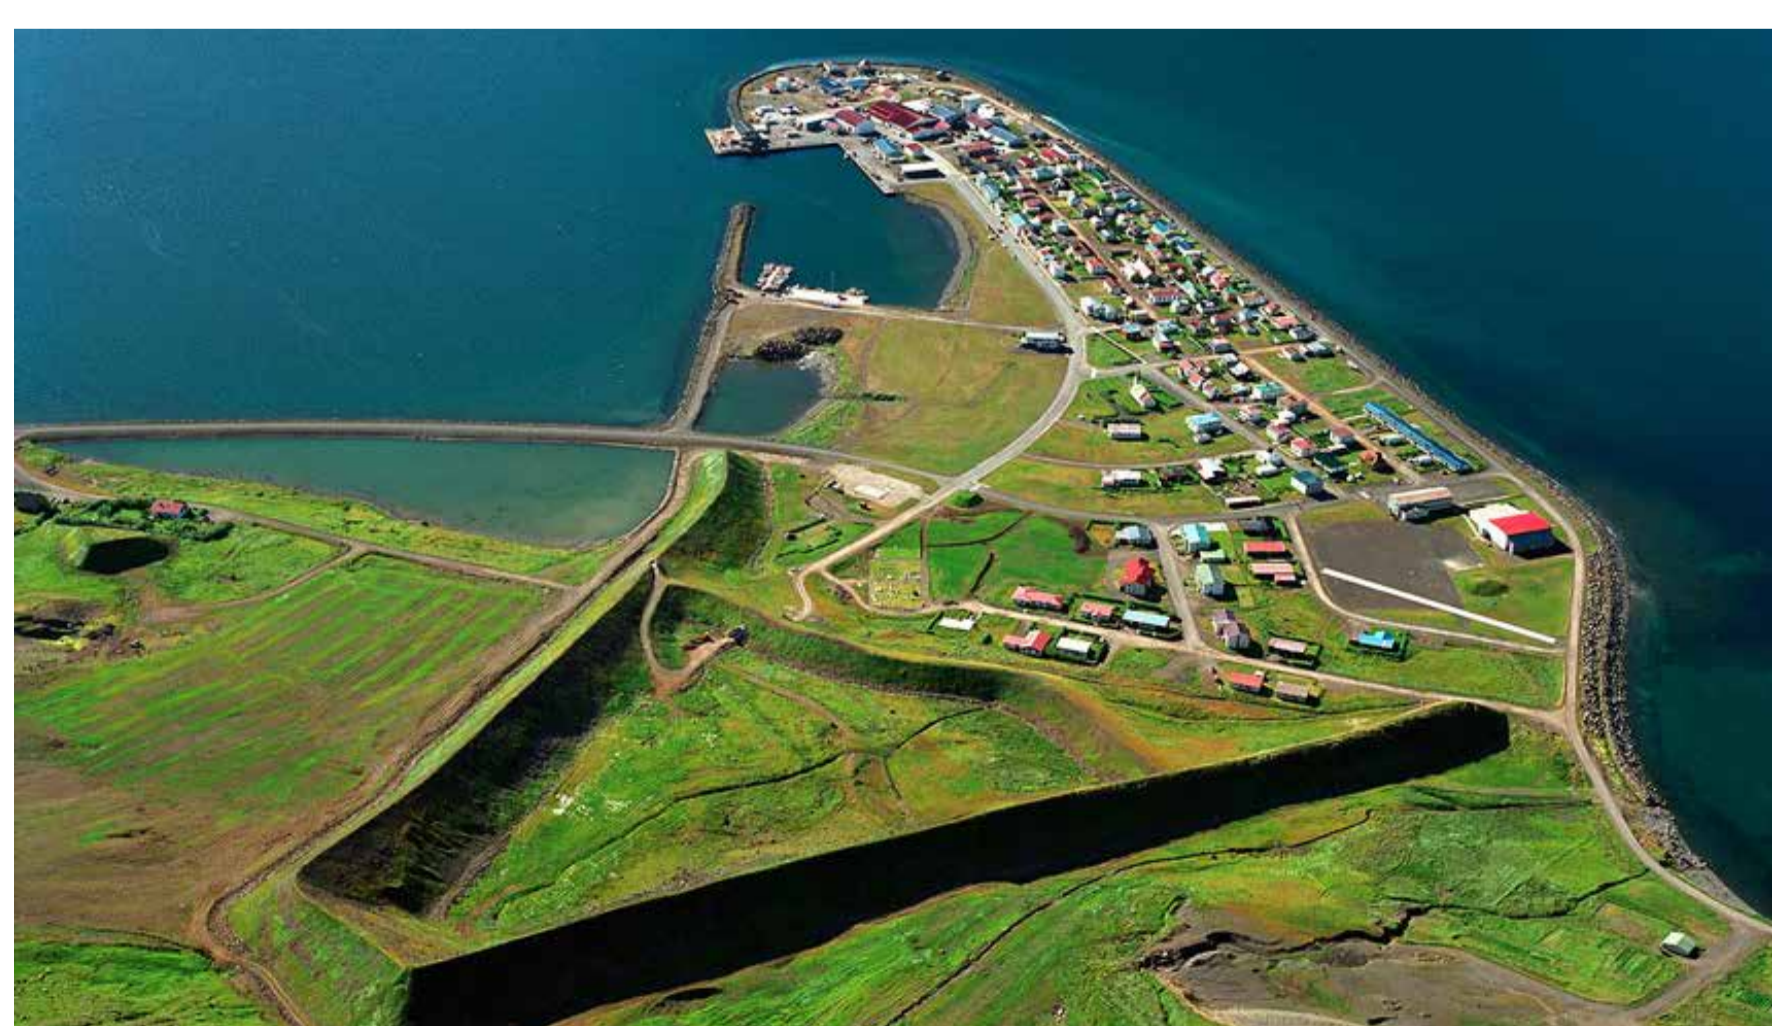
Figure 3. Deflecting dams at Flateyri, W-Iceland.

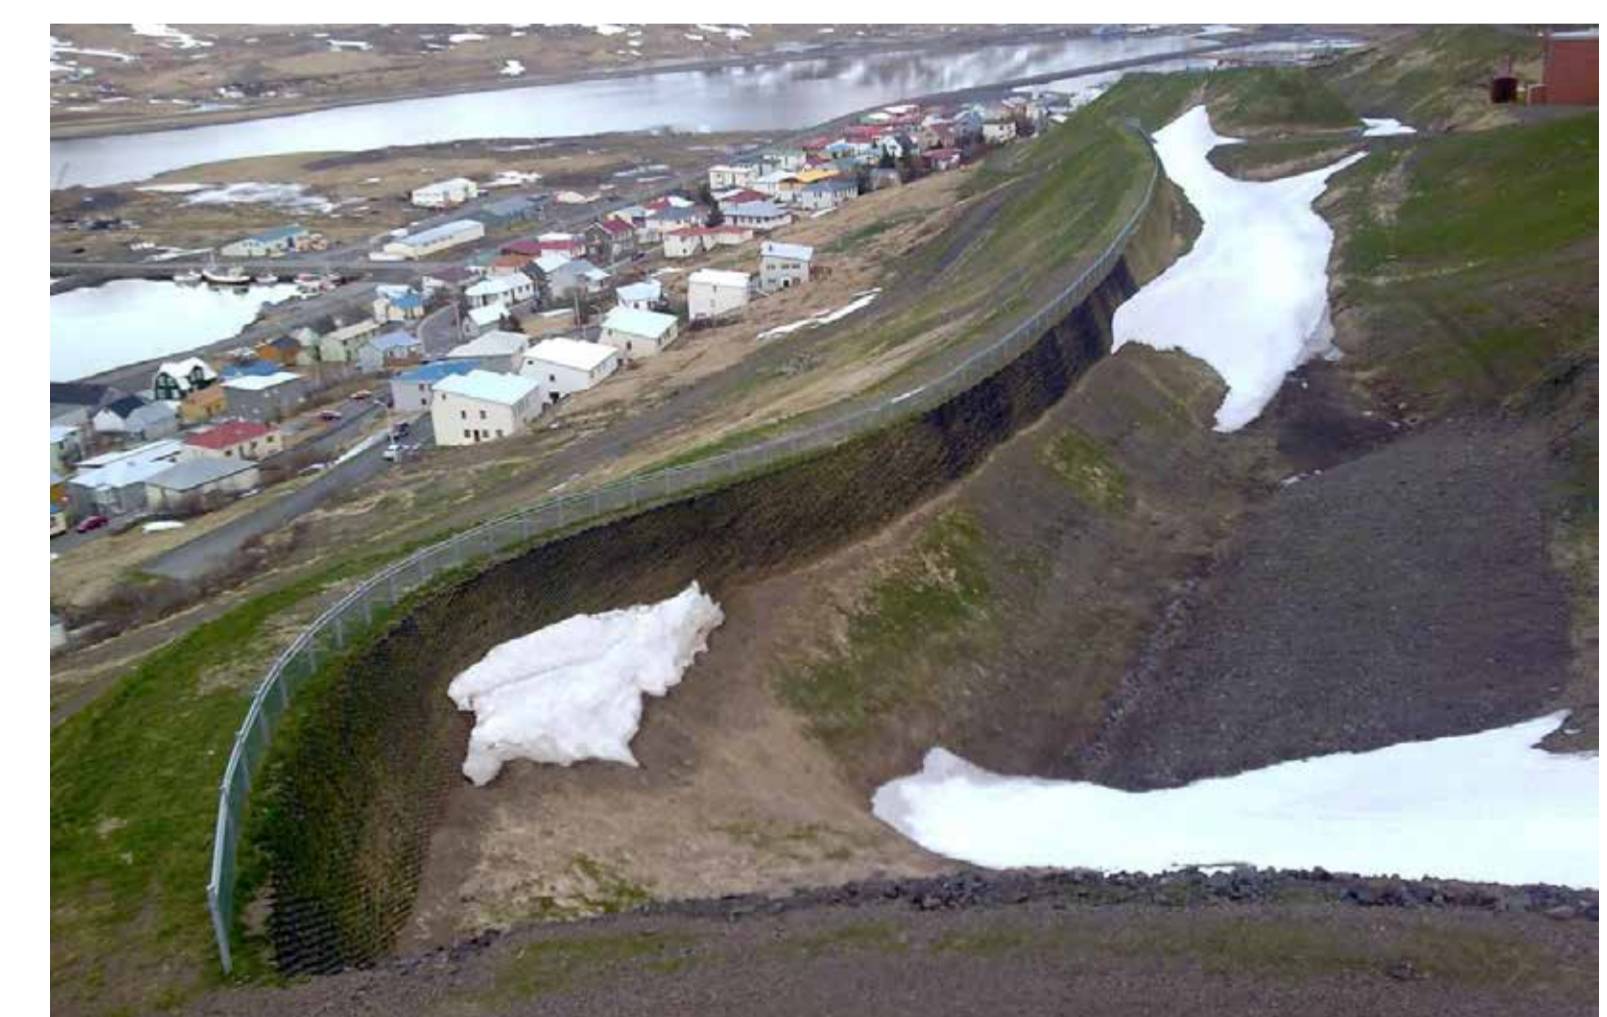
Figure 4. Catching dams in Siglufjörður, N-Iceland.

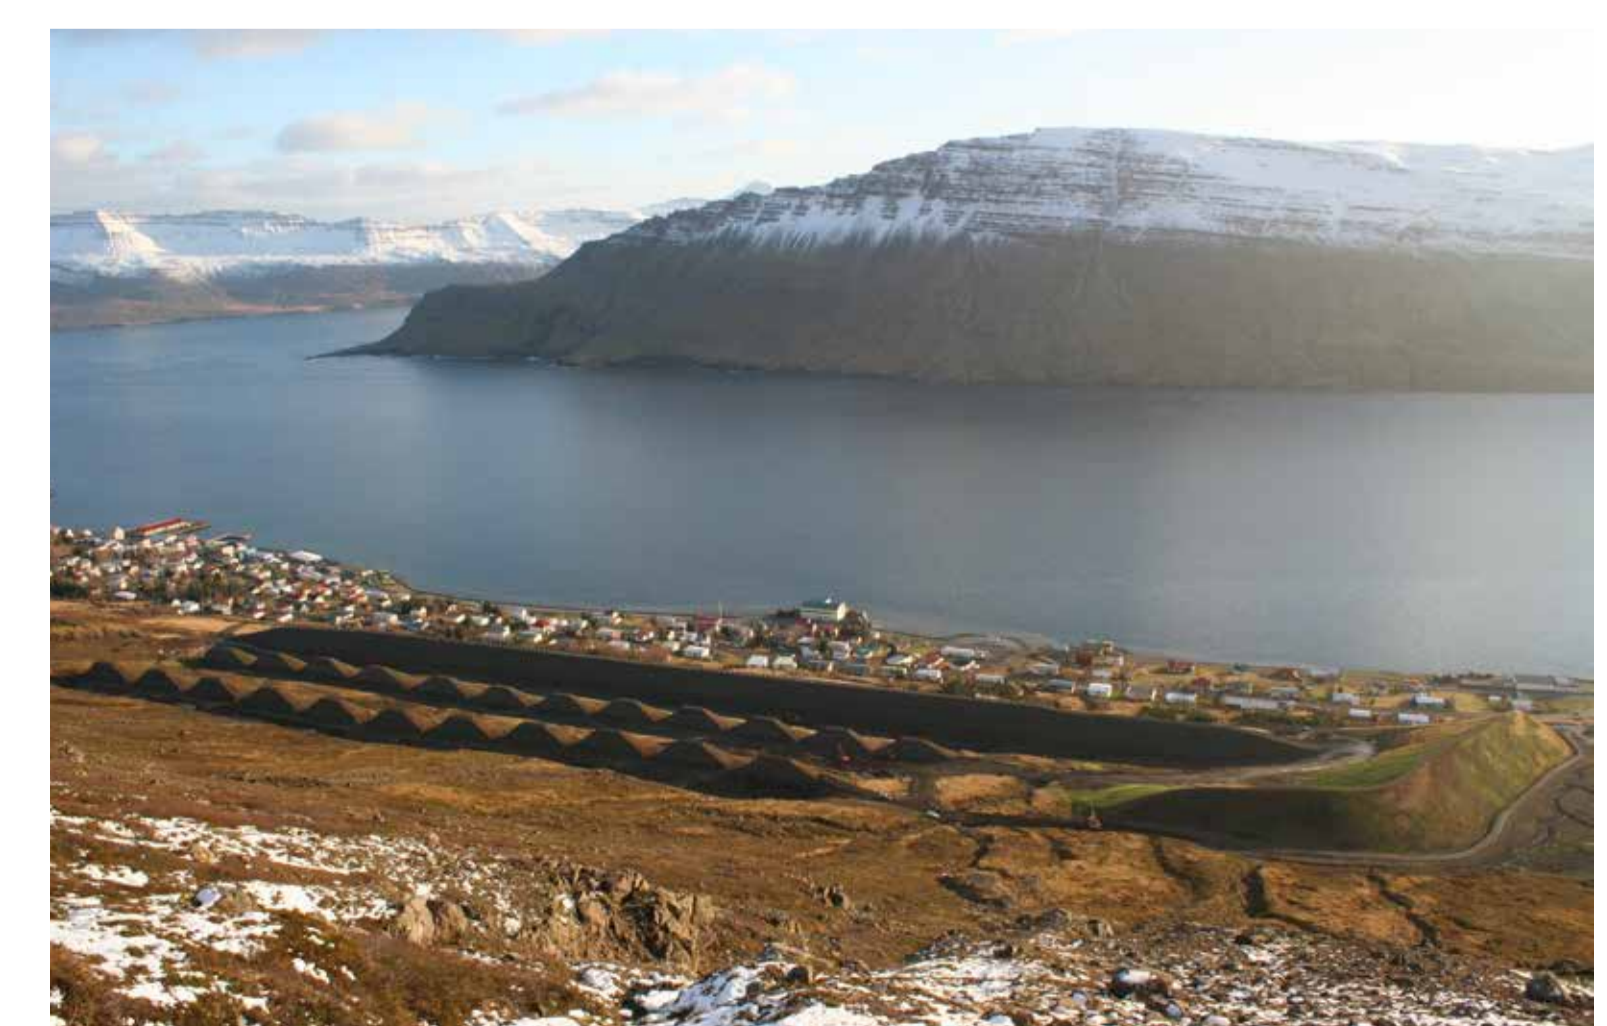
Figure 5. Catching dam, deflecting dam and braking mounds in Neskaupstaður, E-Iceland.

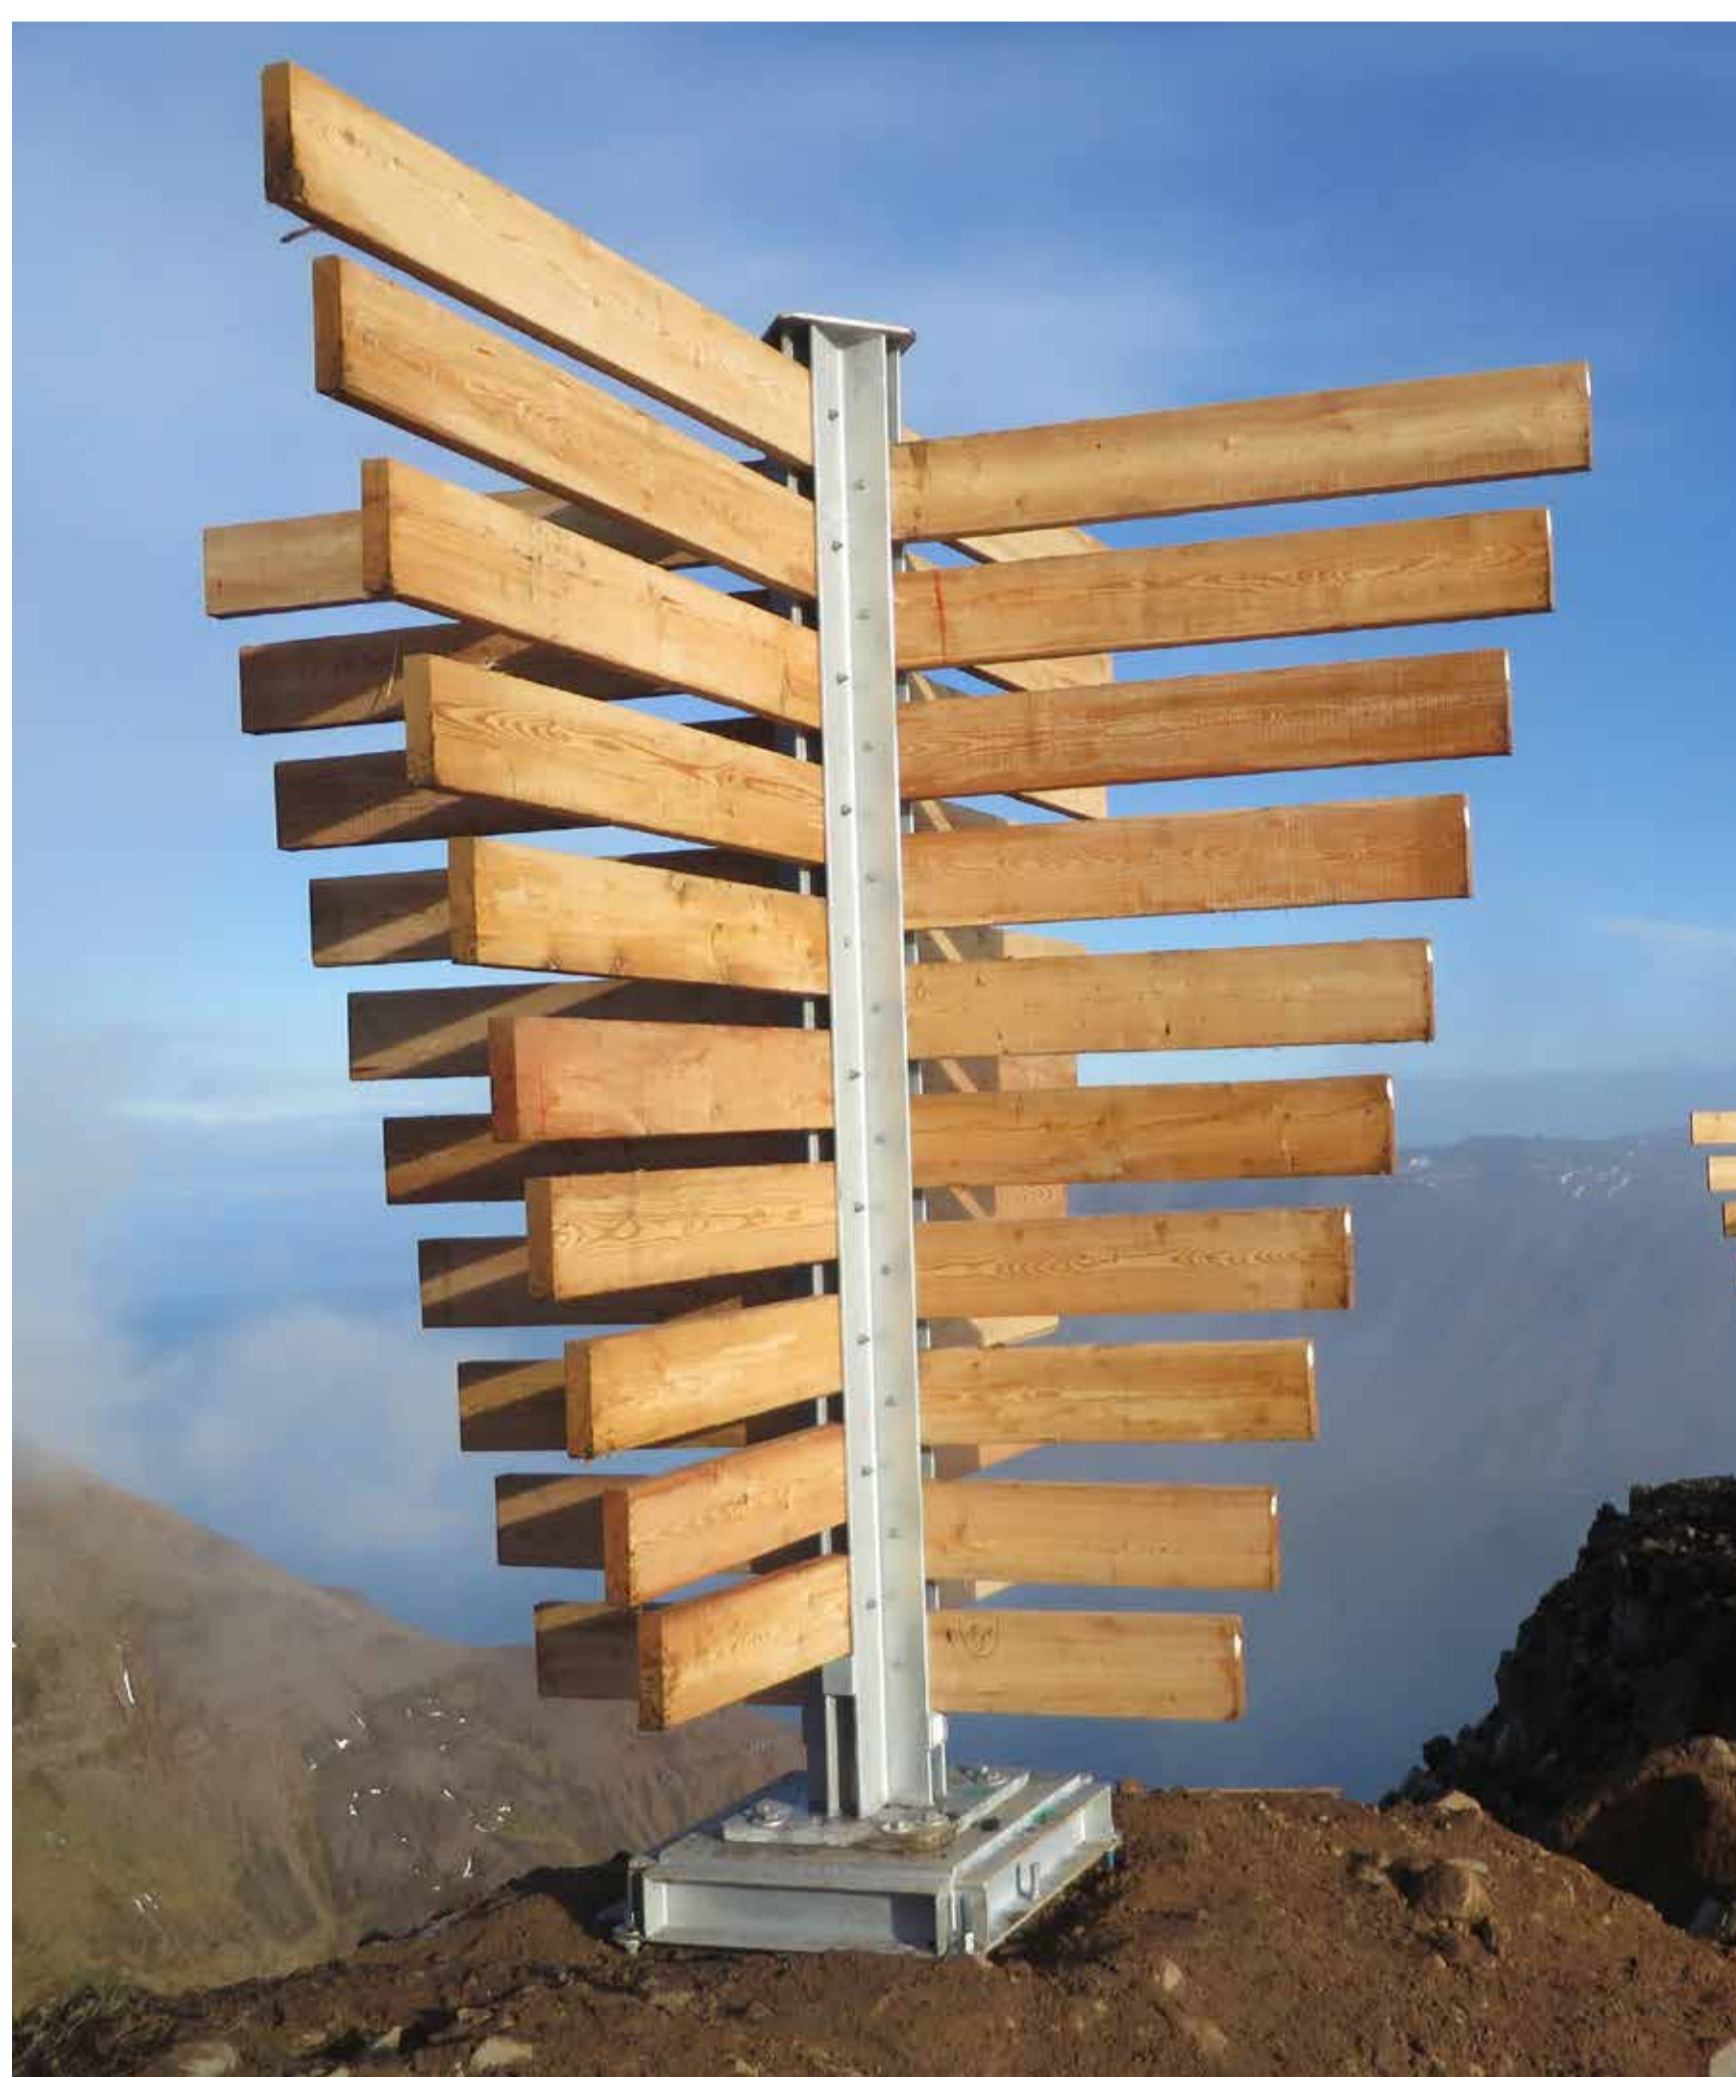
Figure 1. Windbreaker in Siglufjörður, N-Iceland.

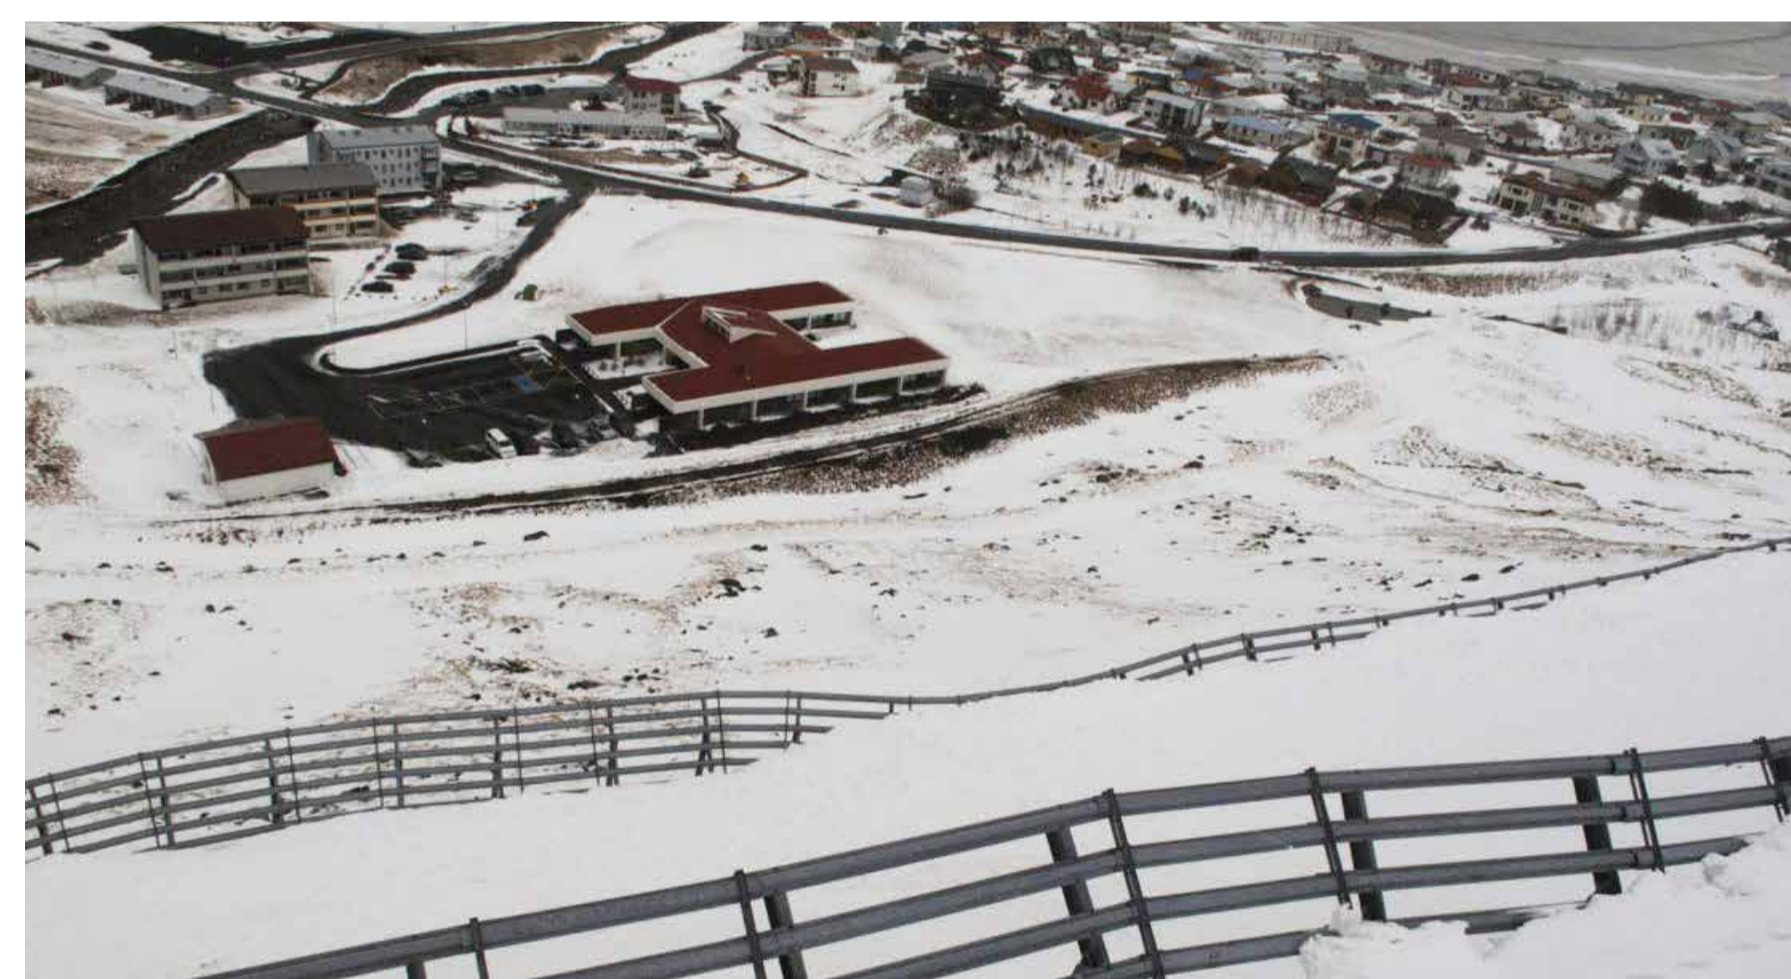
Figure 2. Supporting structures in Ólafsvík, W-Iceland.

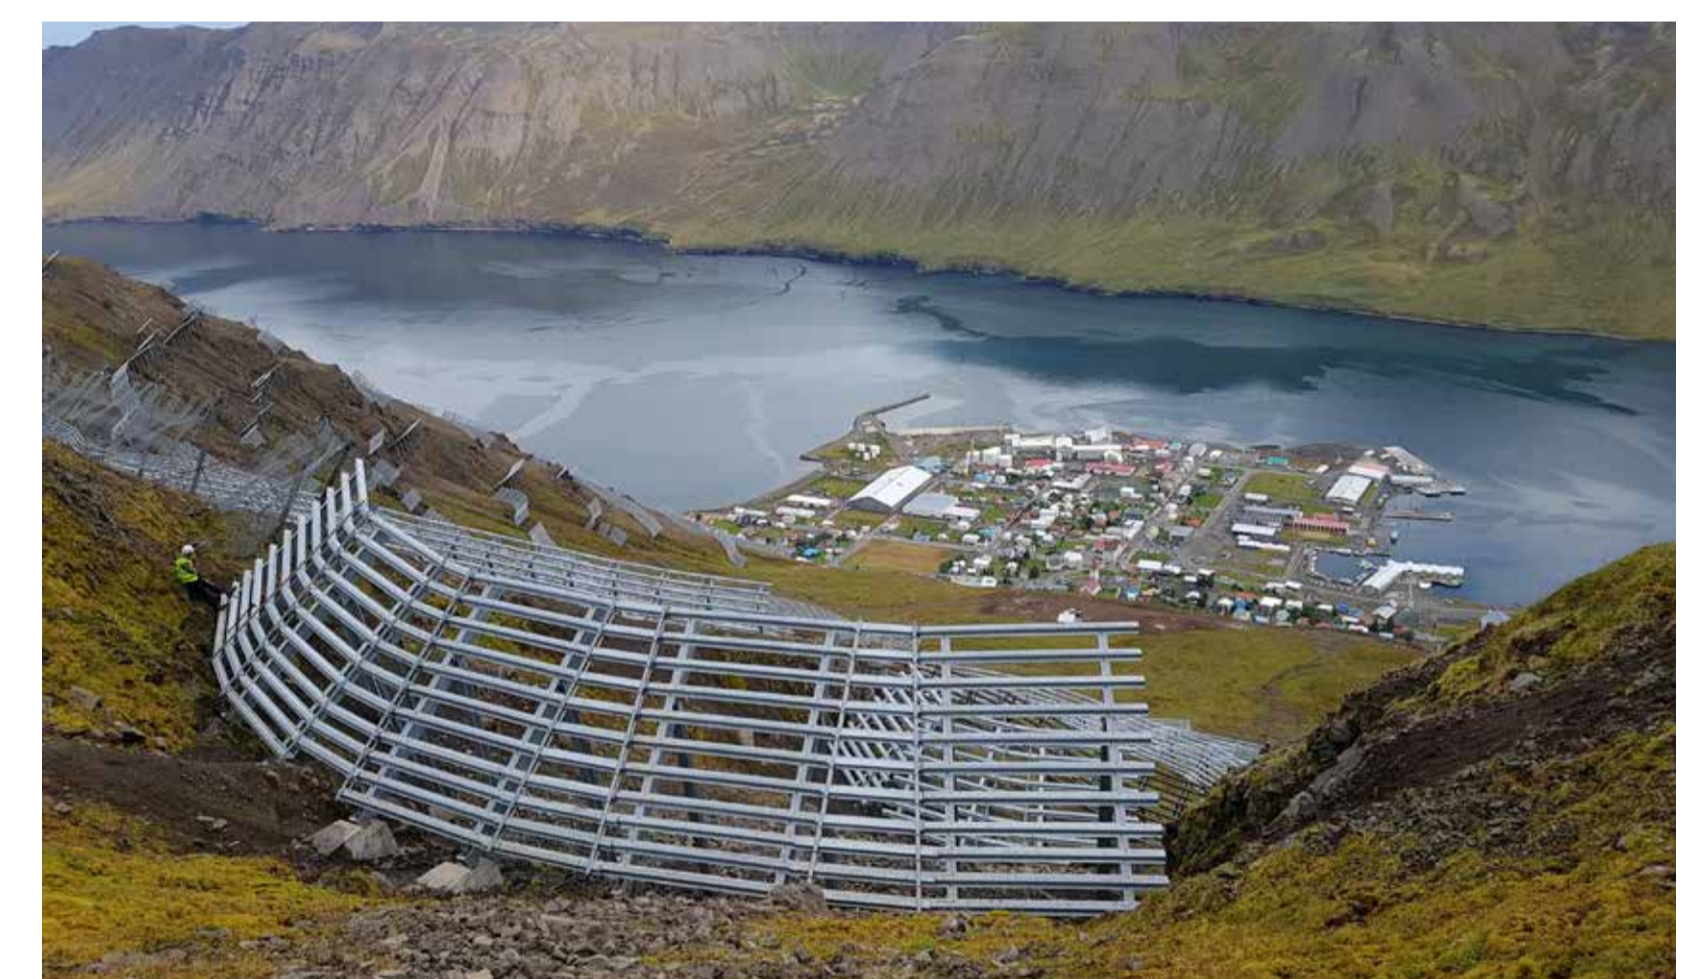
Figure 3. Supporting structures in Siglufjörður, N-Iceland.

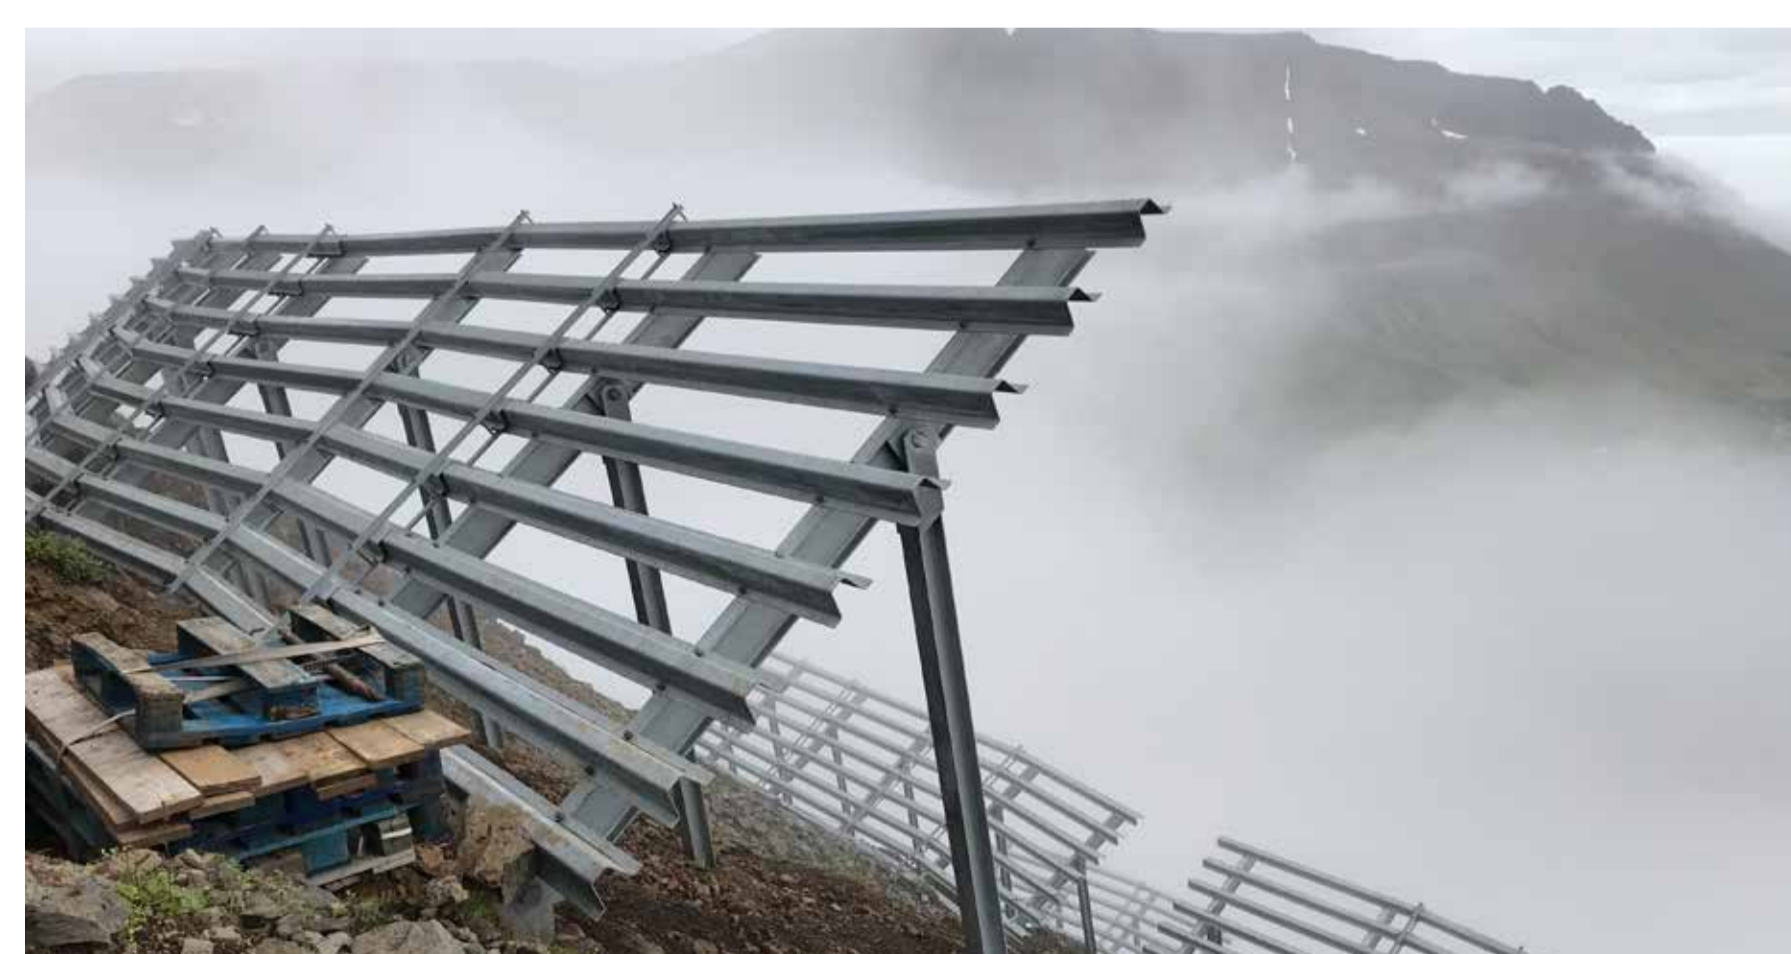
Figure 4. Supporting structures in Ísafjörður, NW-Iceland.

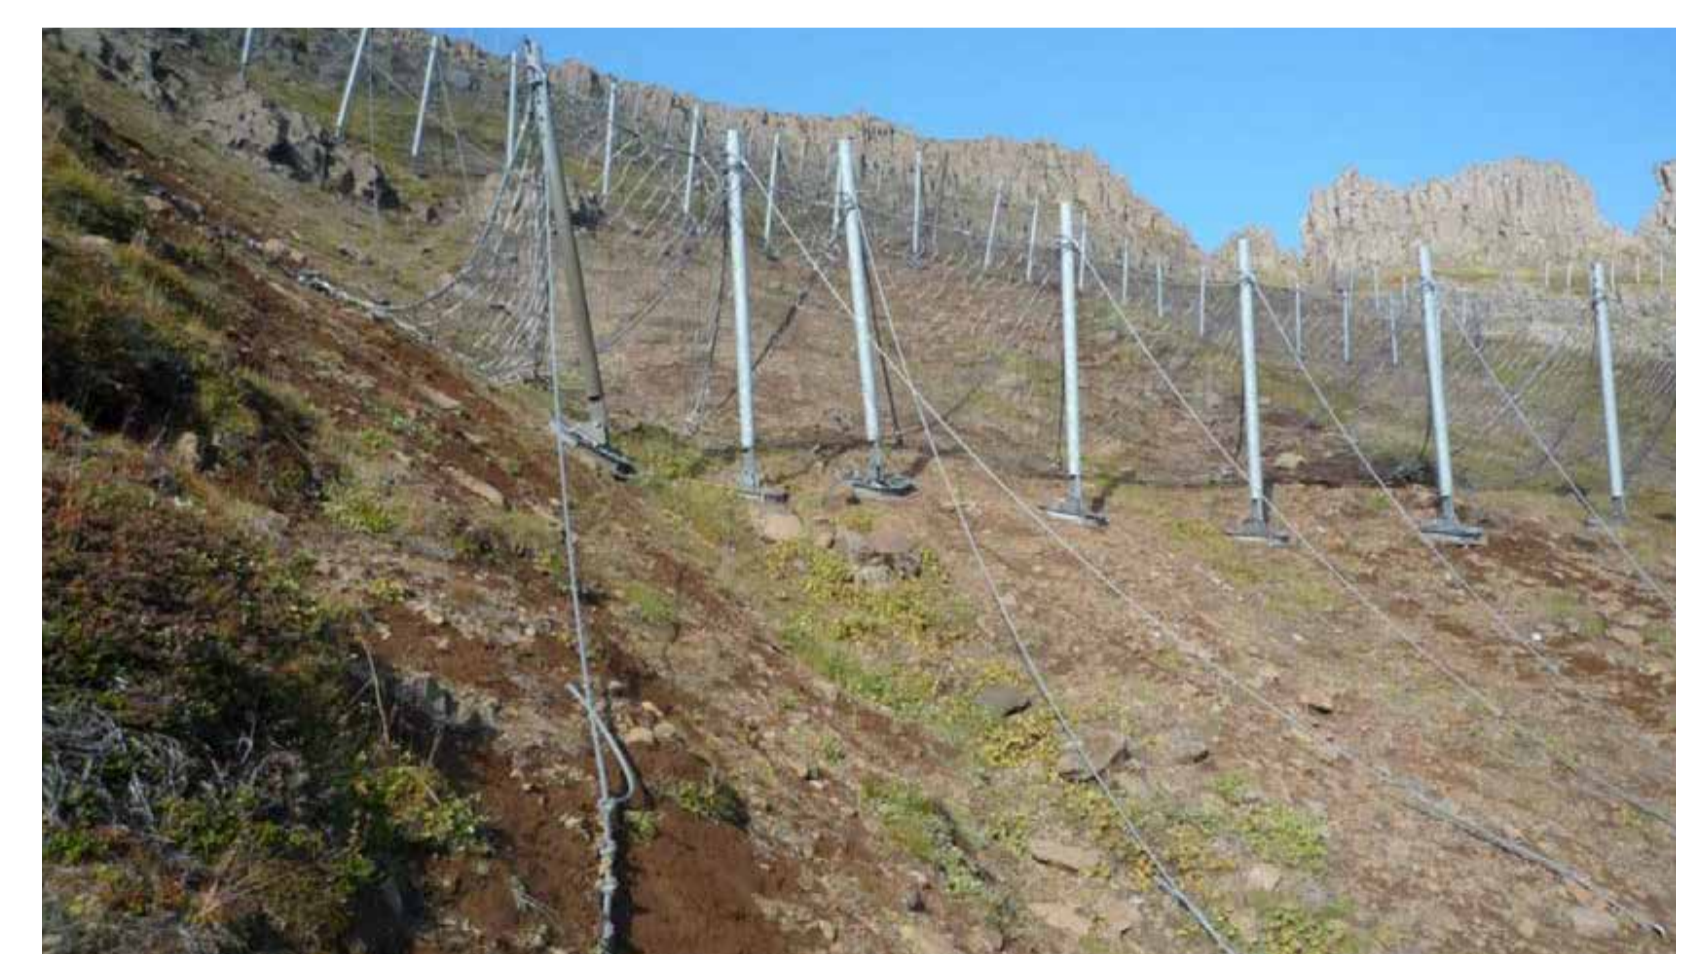
Figure 5. Snow nets in Neskaupstaður, E-Iceland.

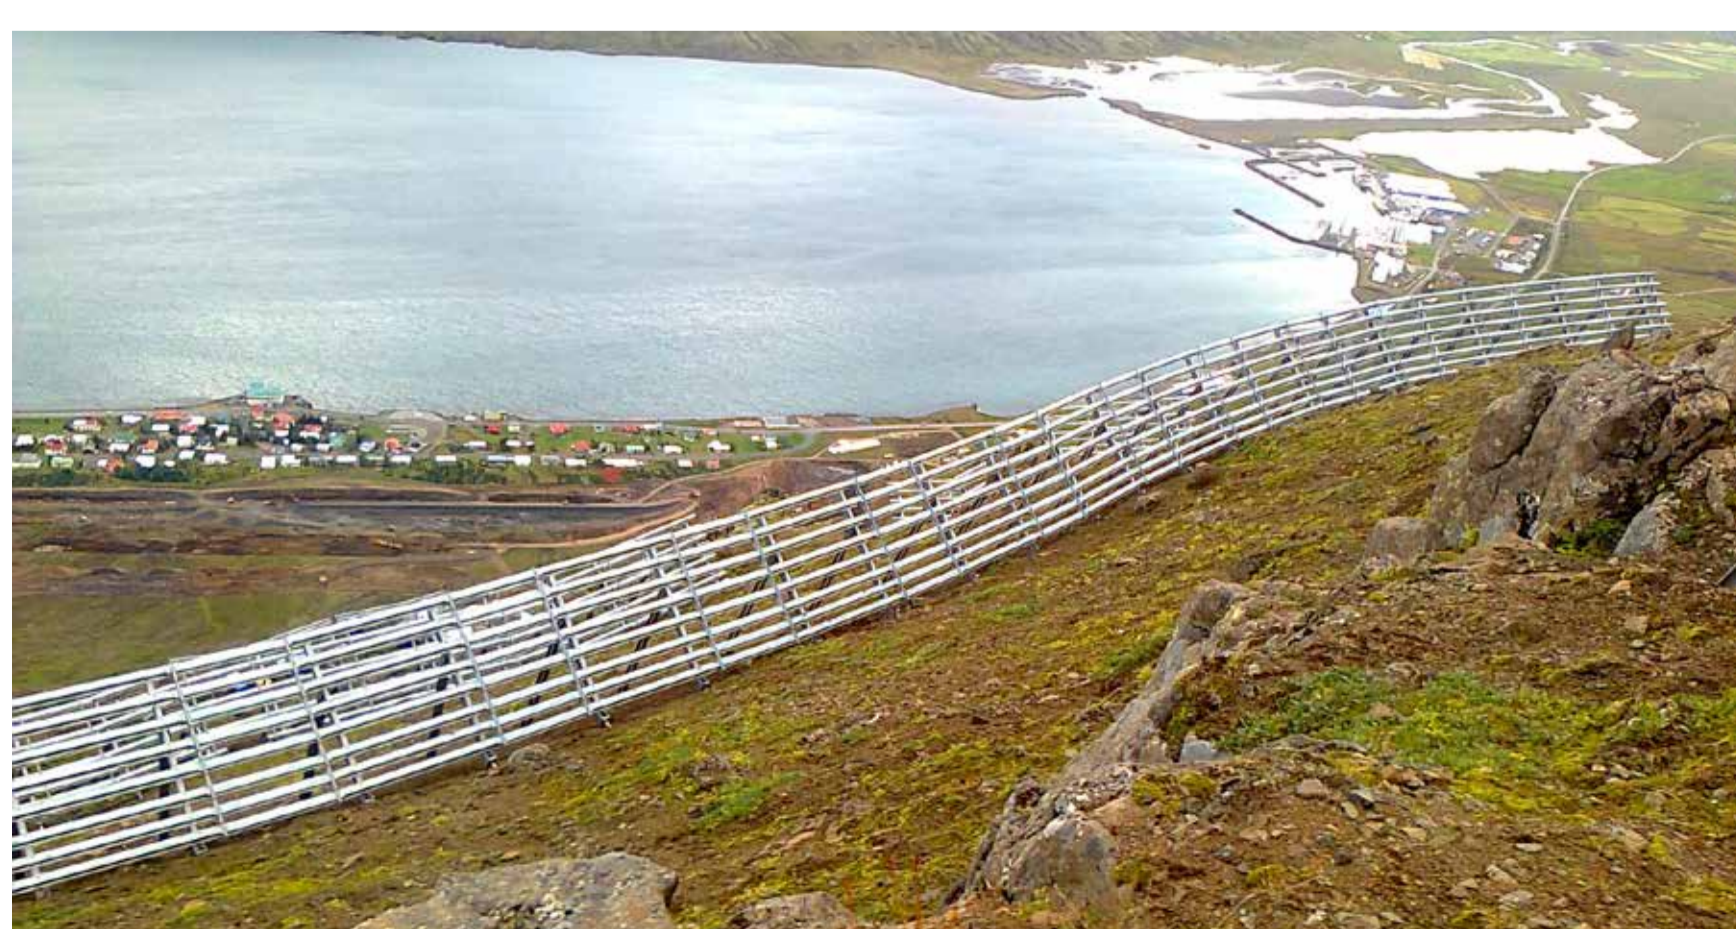
Figure 6. Supporting structures in Neskaupstaður, E-Iceland.
