Avalanche protection measures in Iceland

International Symposium
on
Mitigation Measures against Snow Avalanches
and other Rapid Gravity Mass Flows
3. - 5. April 2019, Siglufjörður Iceland

Deflecting dams, catching dams and braking mounds

Supporting structures and snow fences

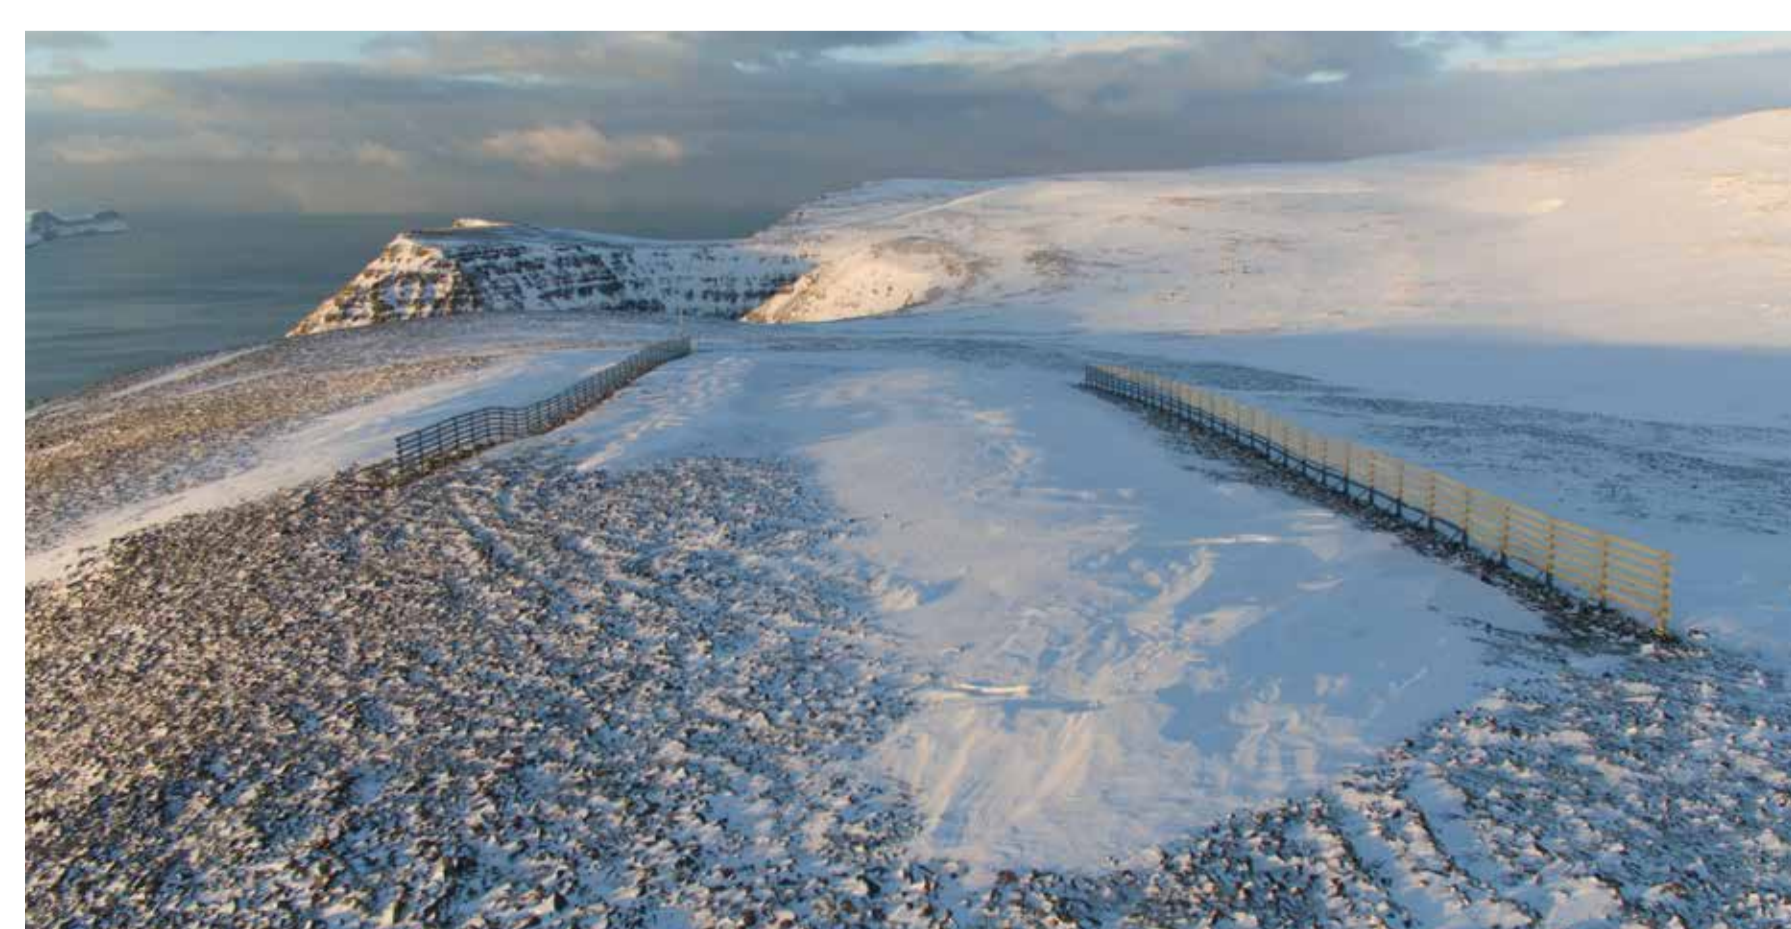
Figure 7. Snow fences in Patreksfjörður, NW-Iceland.

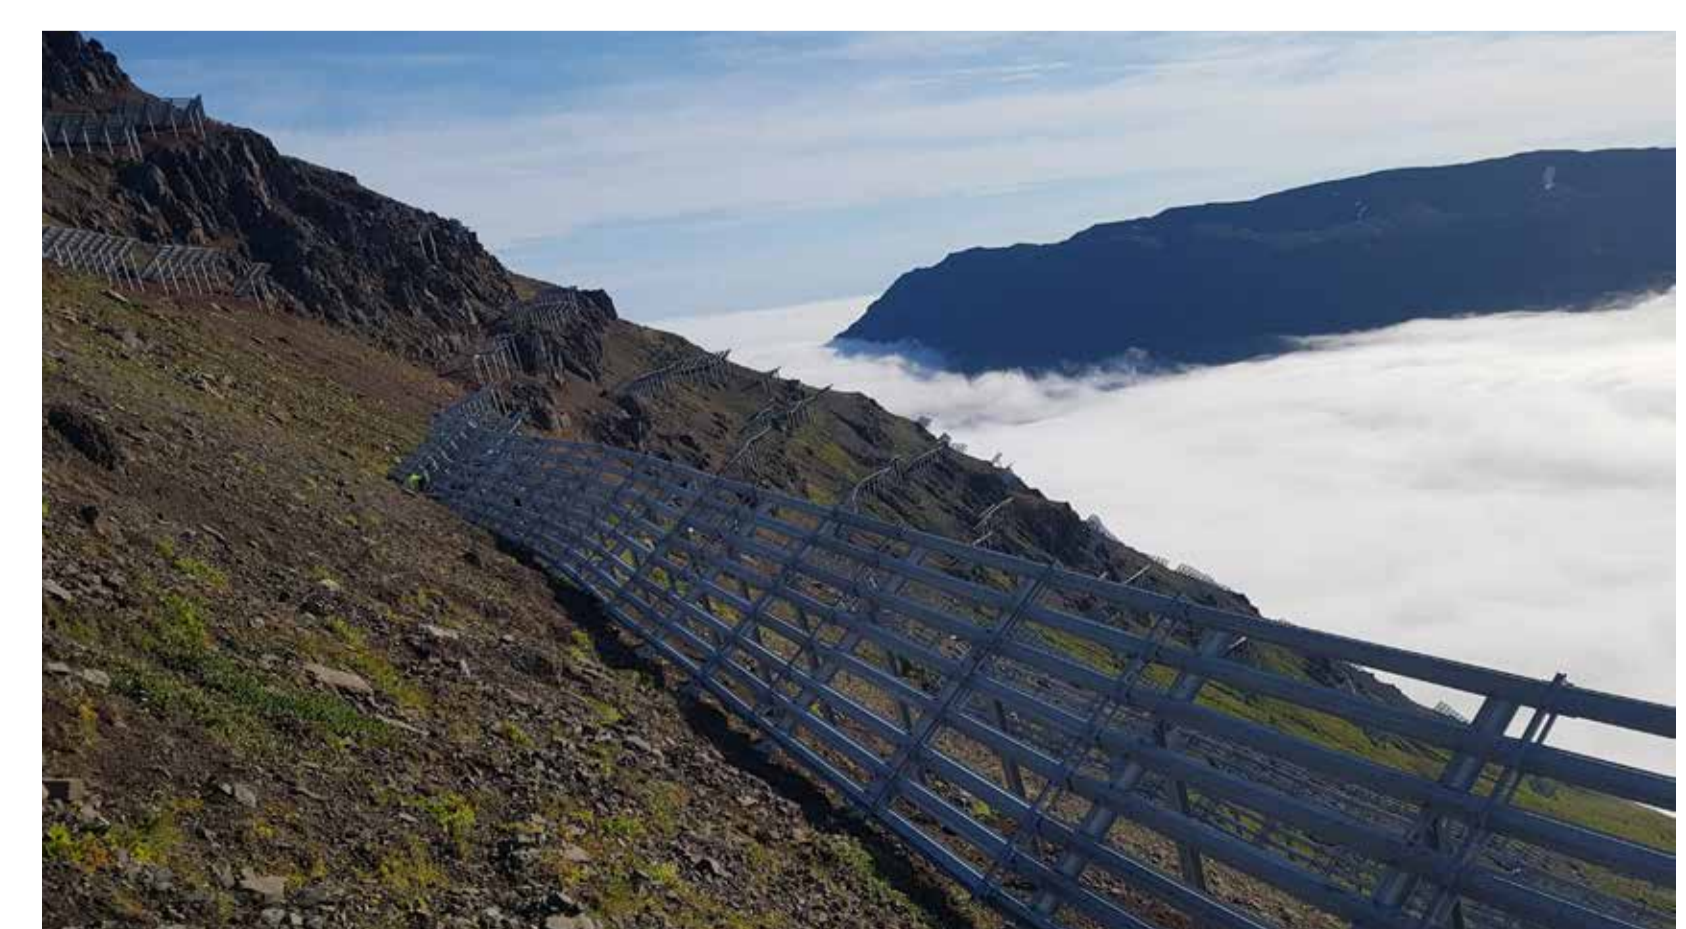
Figure 8. Supporting structures in Siglufjörður, N-Iceland.

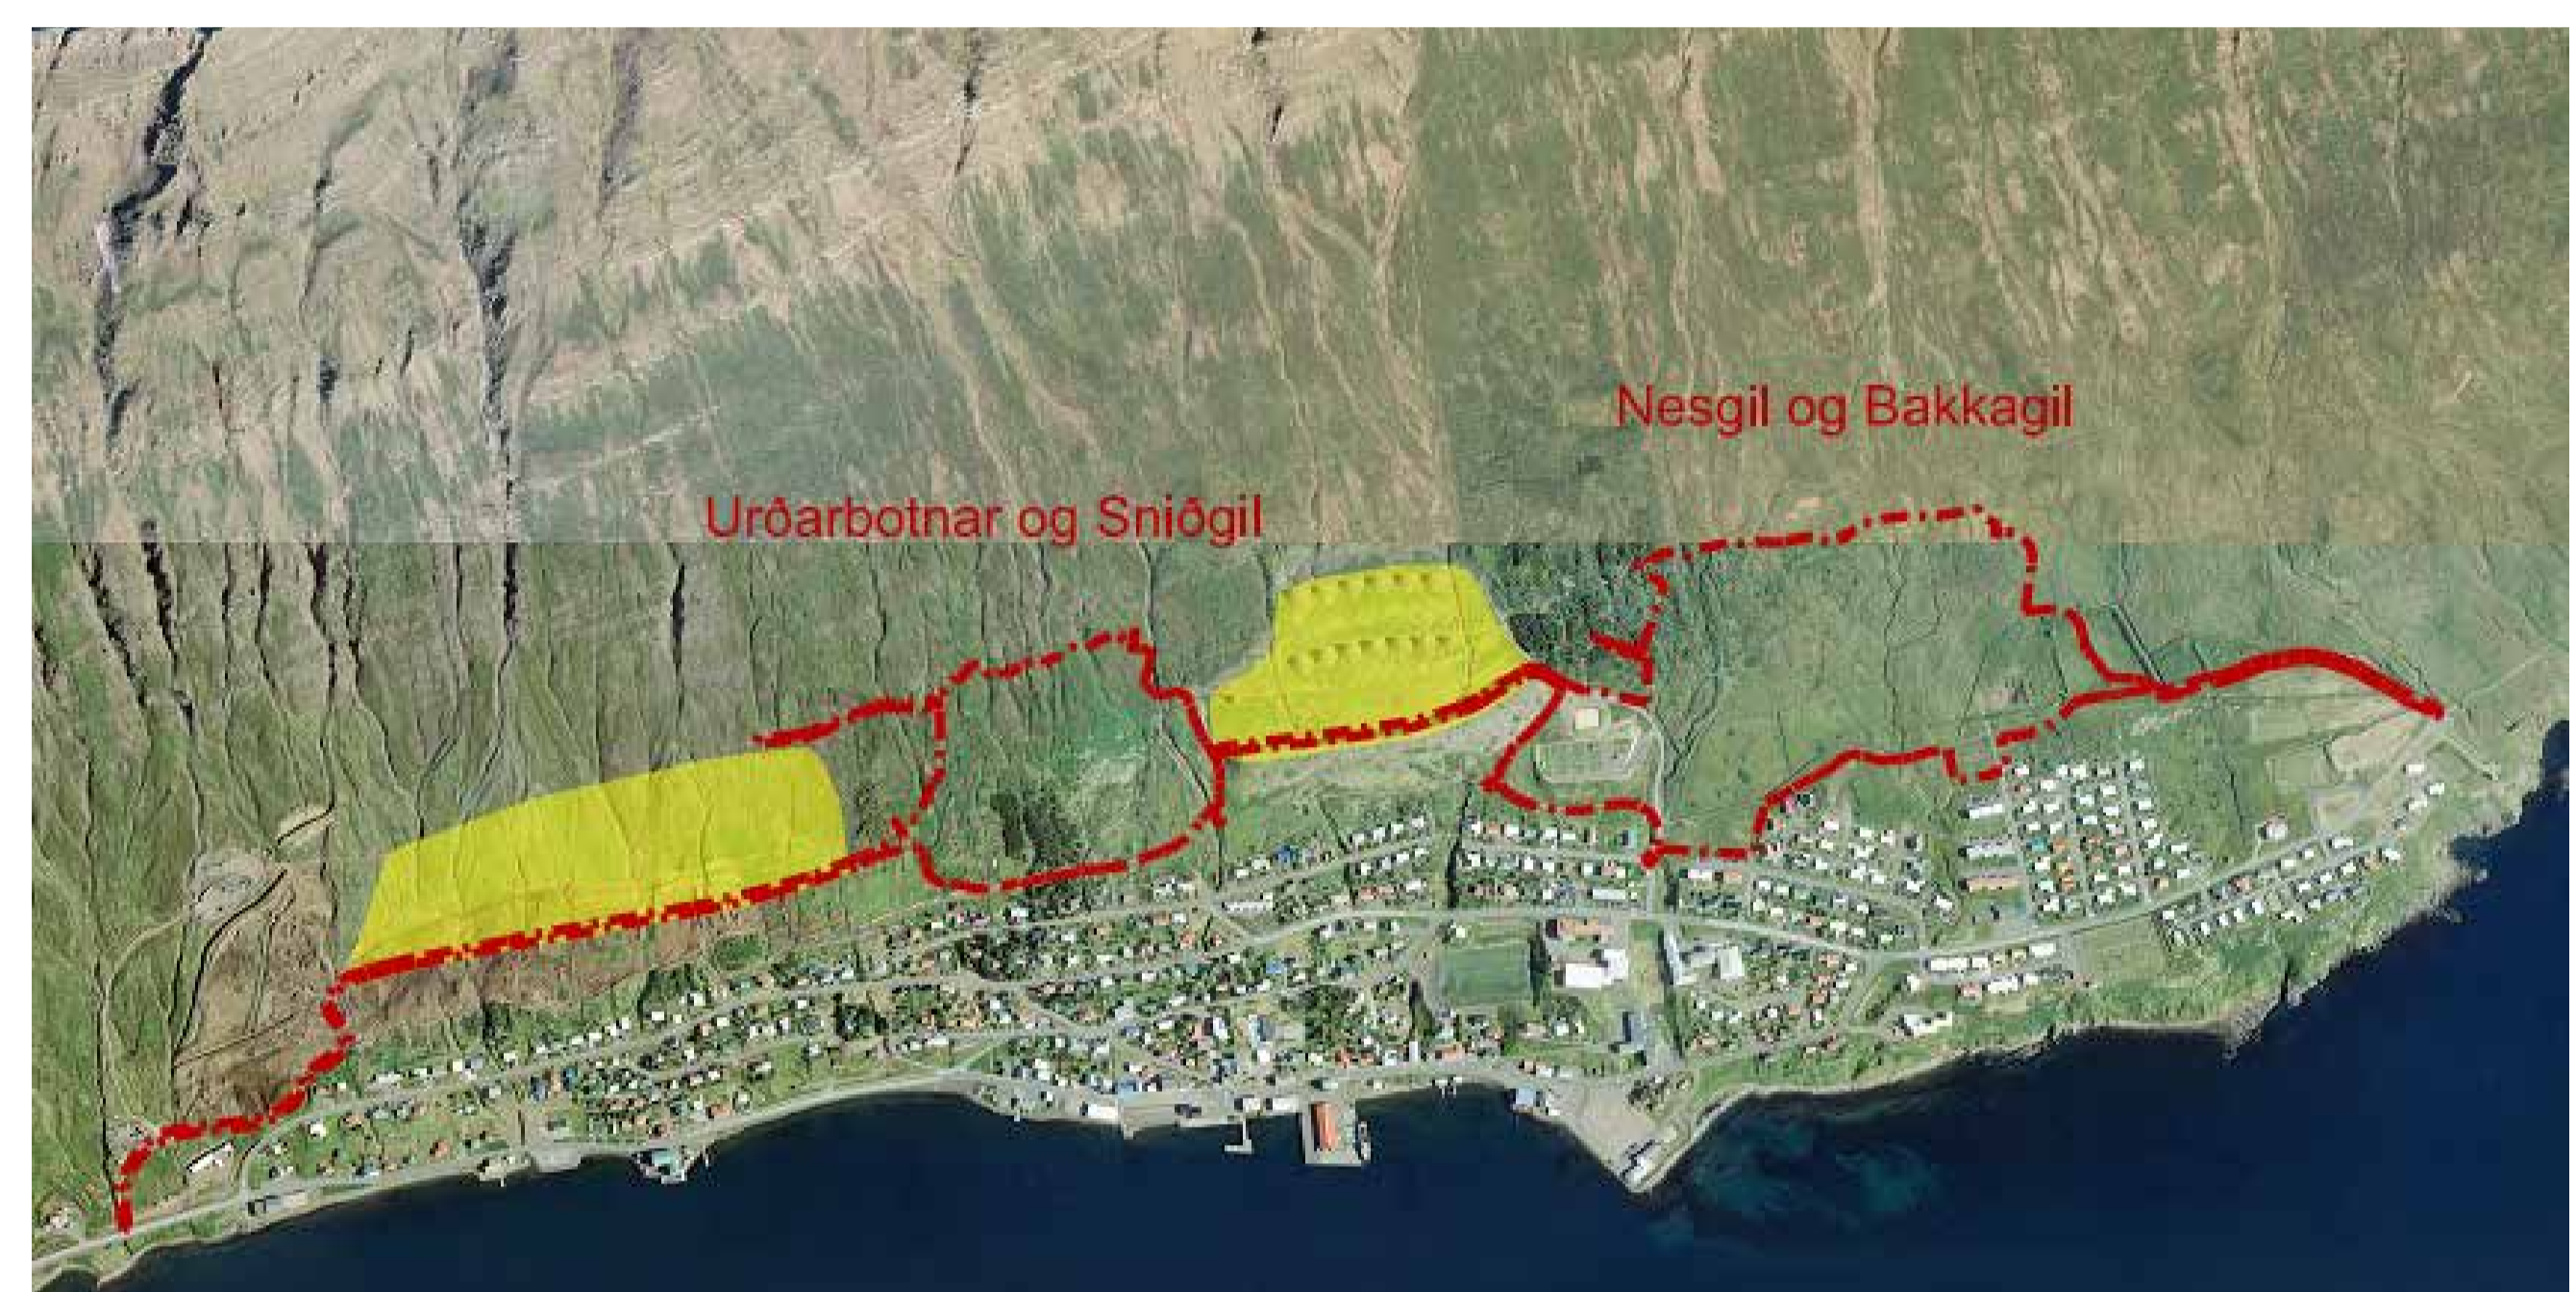
Figure 1. Planned catching dams and braking mounds under Urðarbotnar and Sniðgil and Nes- and Bakkagil in Neskaupstaður, E-Iceland.

Catching dams and braking mounds under Urðarbotnar and Sniðgil and Nes- and Bakkagil in Neskaupstaður, E-Iceland. Deflecting dams and catching dams at Urðir, Hólar and Mýrar in Patreksfjörður, NW-Iceland, at Aldan and Bakkar in the Bjölfur area in Seyðisfjörður, E-Iceland, and in several areas in Bíldudalur, NW-Iceland. Deflecting dams in Tálknafjörður, NW-Iceland, and supporting structures in Siglufjörður, N-Iceland, and in Hnífsdalur, NW-Iceland. Furthermore, some torrent protection measures in the rivers Lambeyrará and Grjóta in Eskifjörður, E-Iceland.

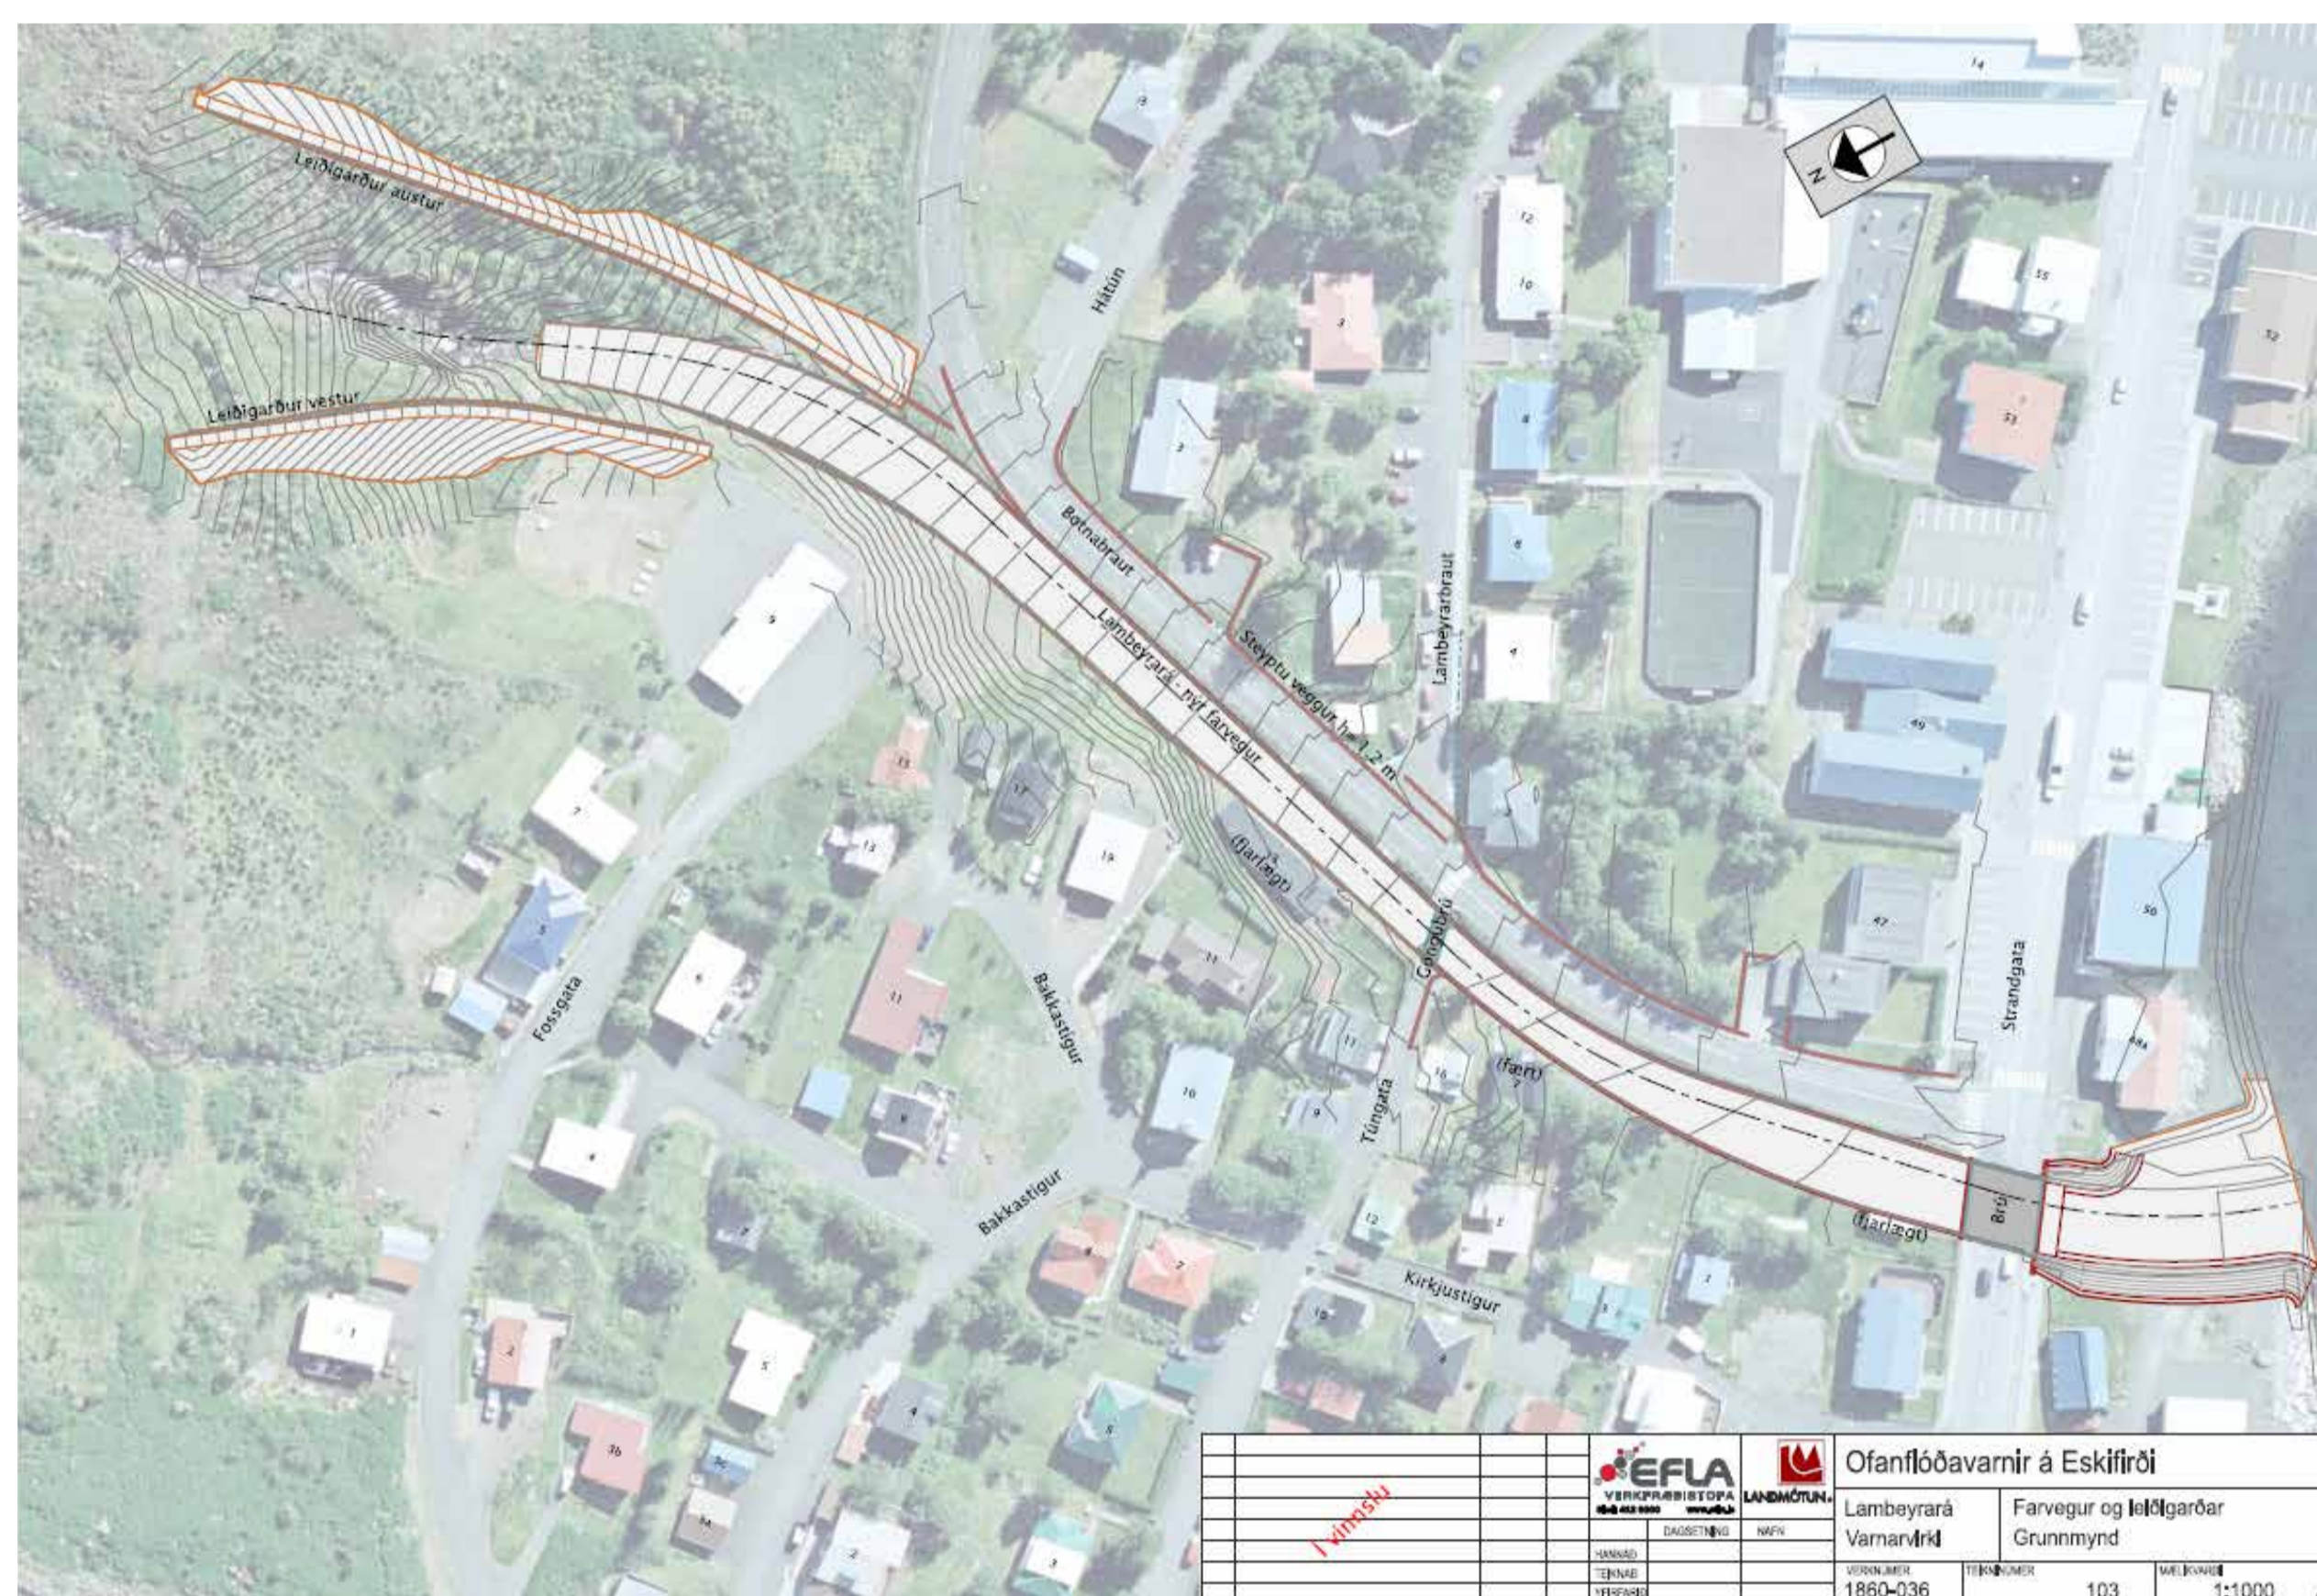
Figure 2. Planned slushflow protection measures in the river Lambeyrará in Eskifjörður, E-Iceland.

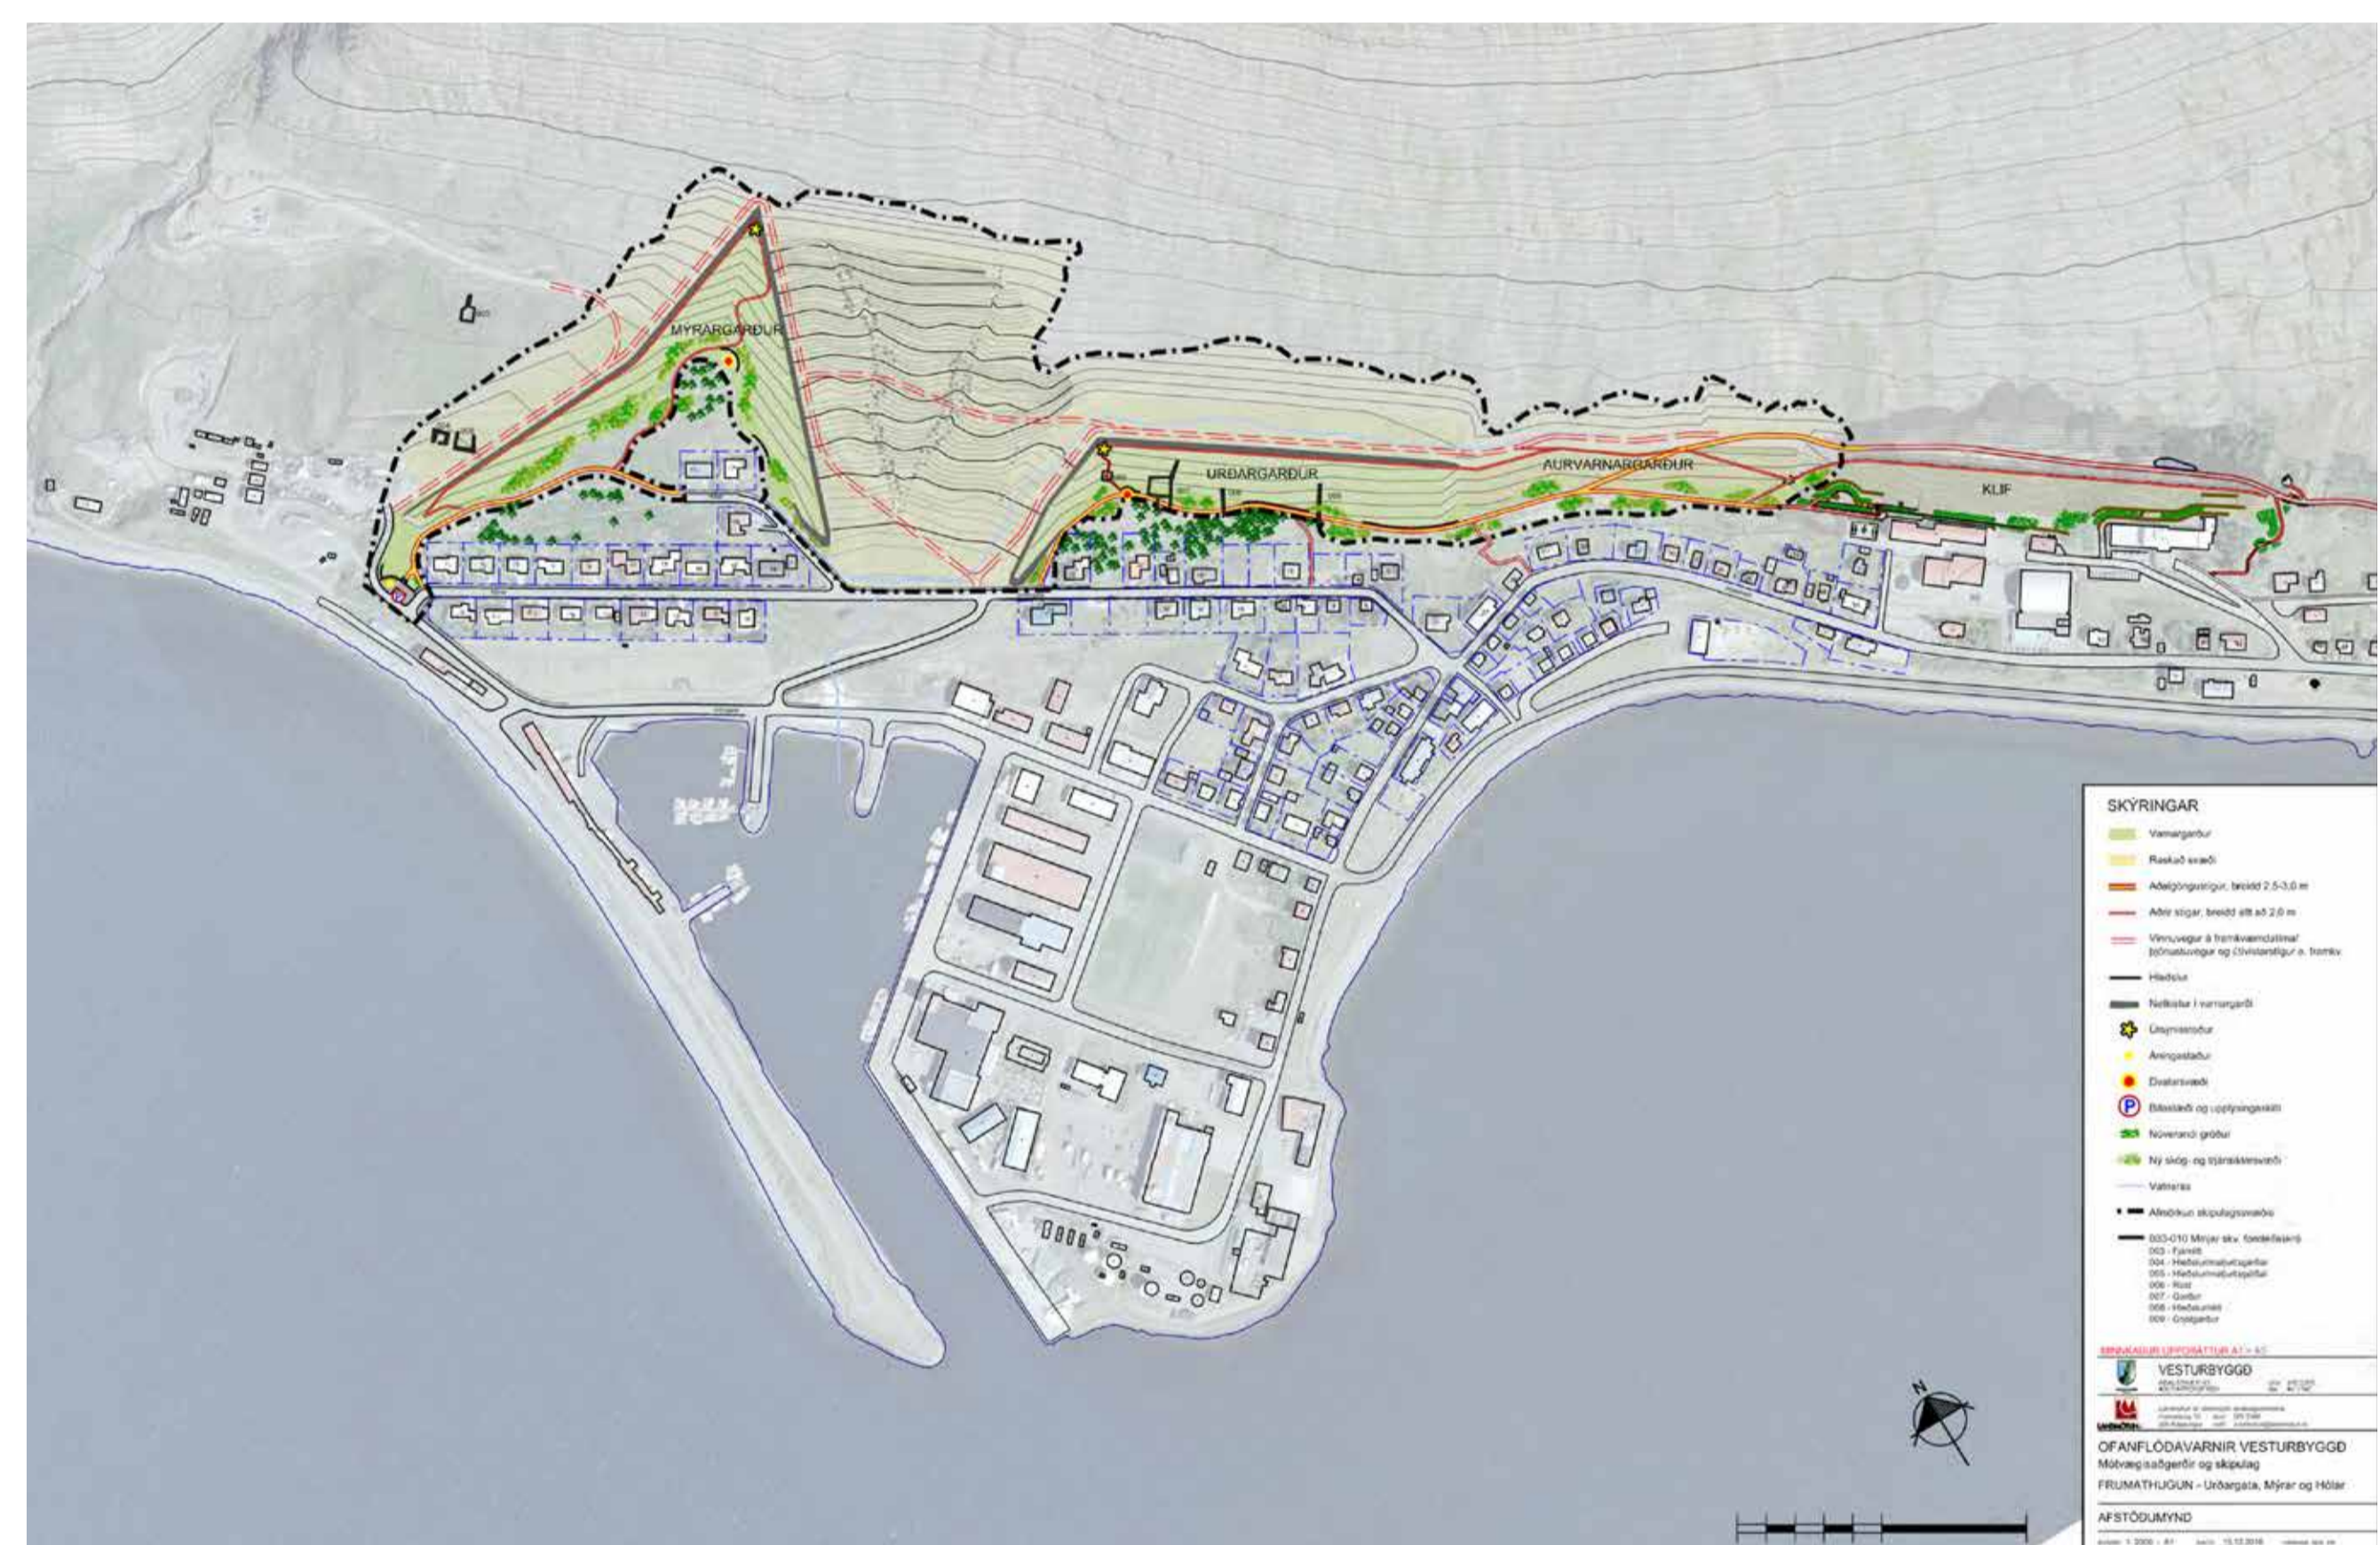
Figure 3. Planned deflecting dams and catching dams in Patreksfjörður, NW-Iceland.

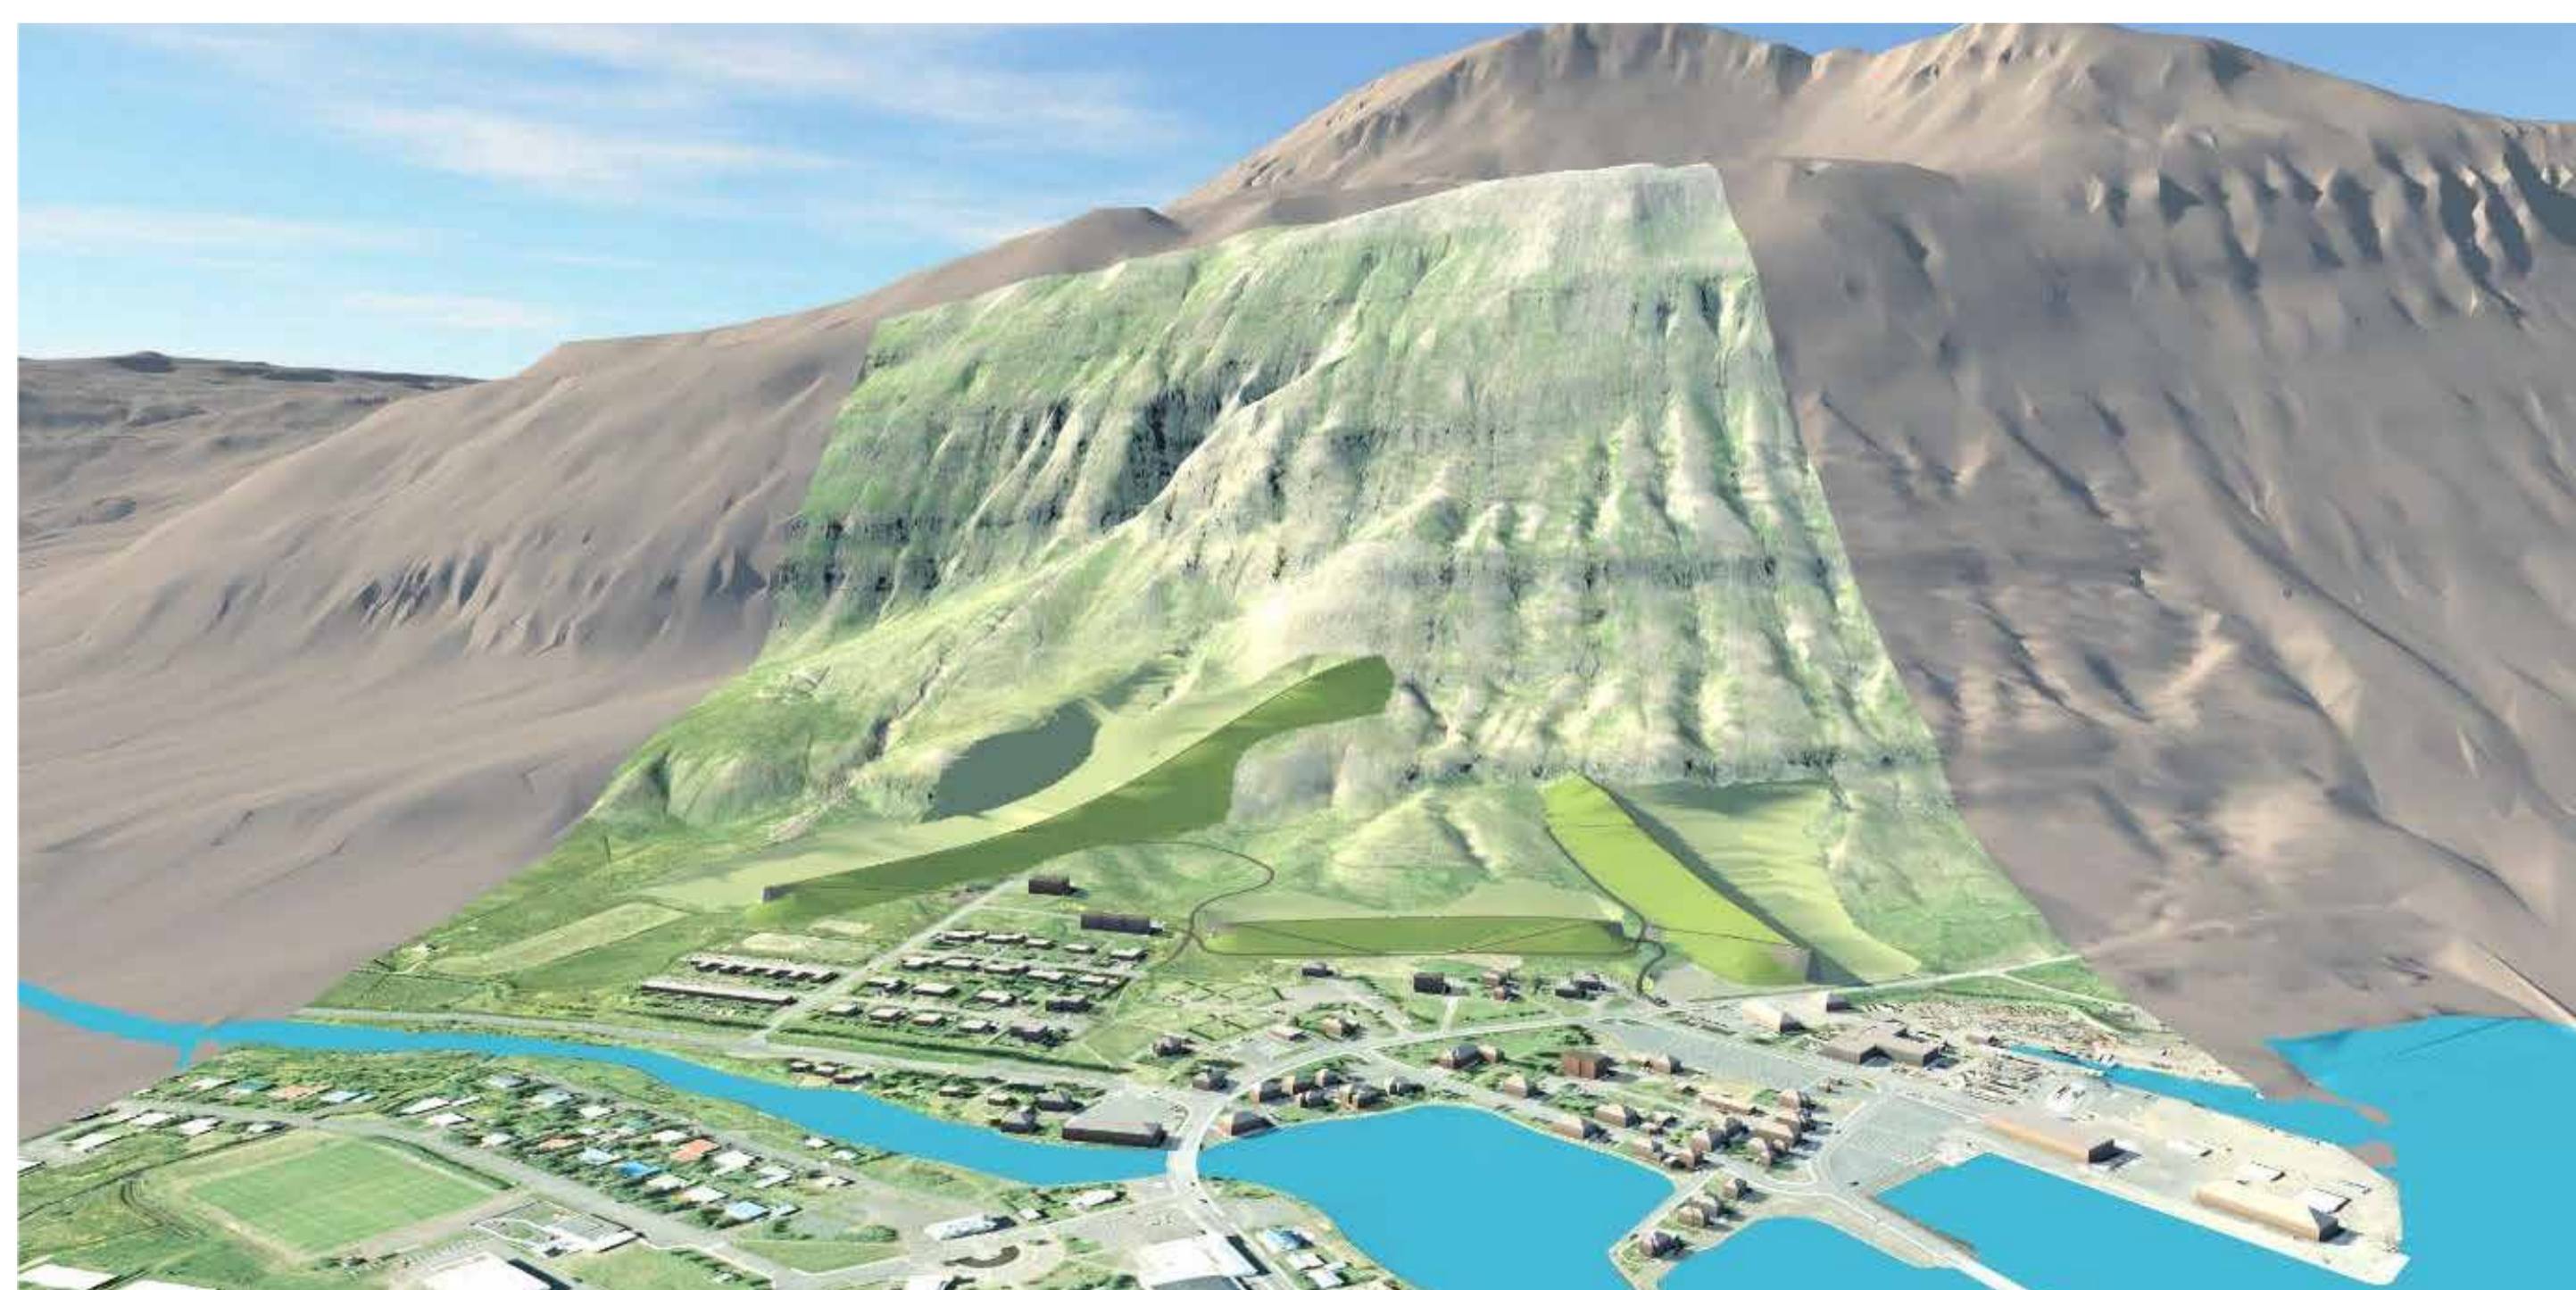
Figure 4. Planned deflecting dams and catching dams in Seyðisfjörður, E-Iceland.

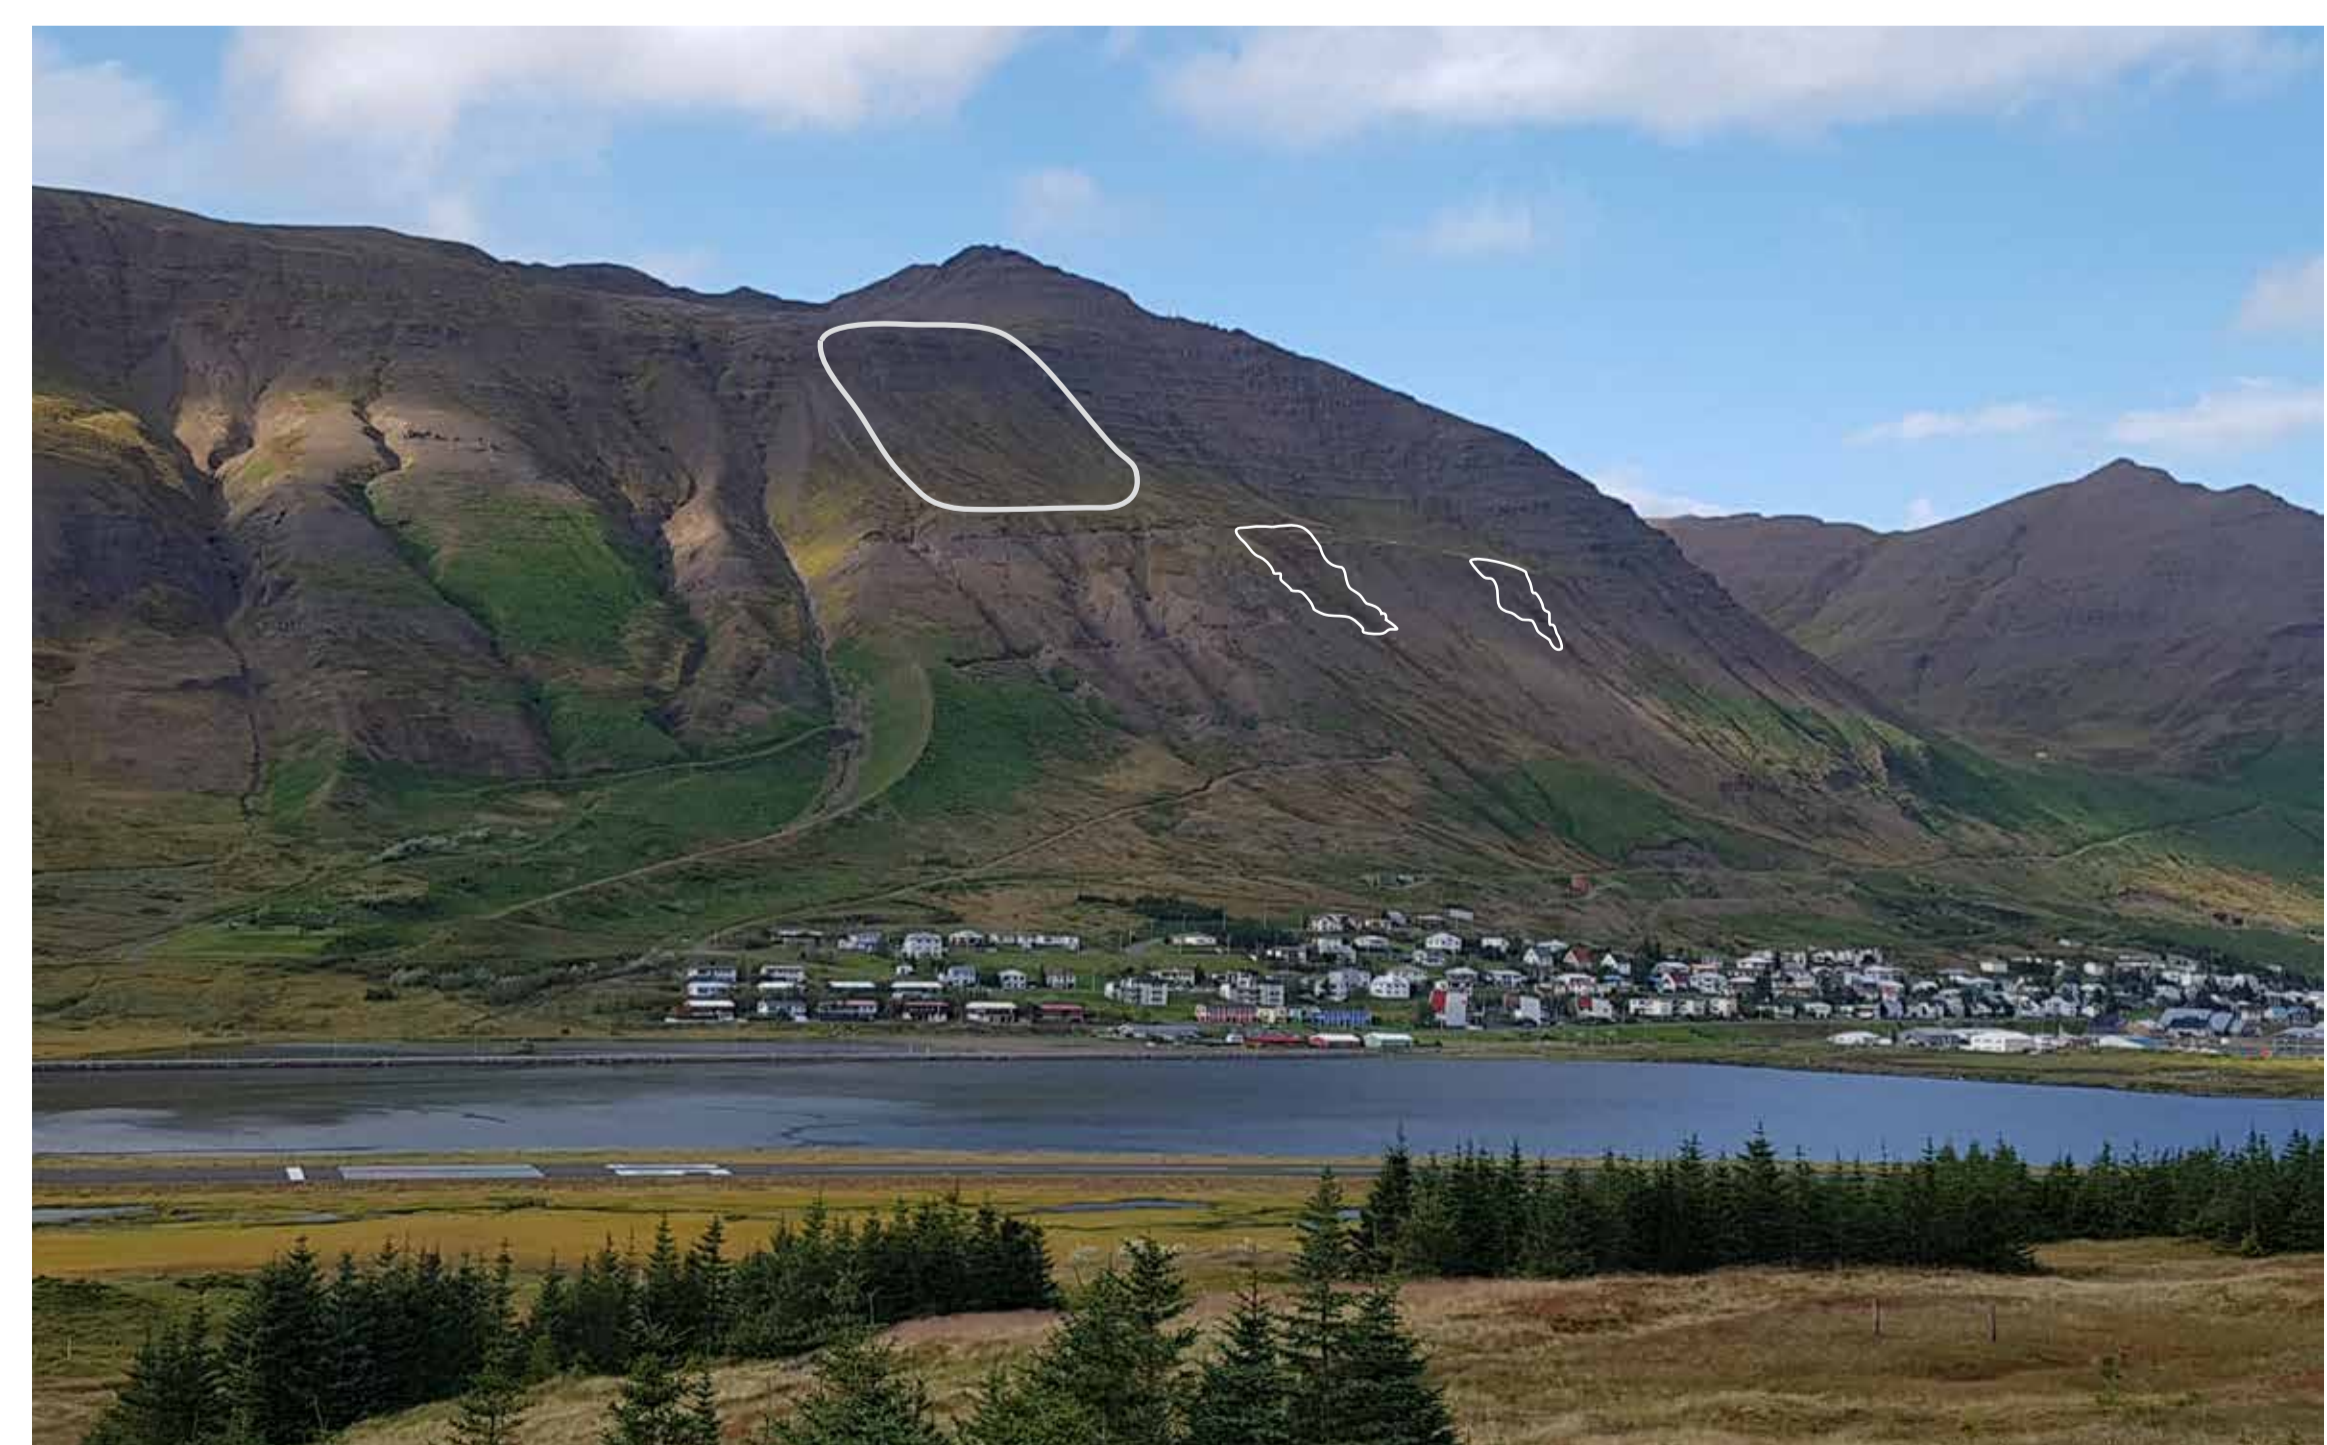
Figure 5. Plan for phase 4 of supporting structures in Siglufjörður, N-Iceland.
