# BLONS IN VORARLBERG, AUSTRIA- 60 YEARS SUSTAINABLE AVALANCHE PROTECTION: EXPERIENCE, SETBACKS AND LESSONS LEARNED

## ABSTRACT:

This article provides an overview of the natural conditions of the Great Walser Valley (Vorarlberg / Austria) and explains the events of the year 1954. Subsequently it reports about the forest and technical protection measures taken over time and the associated risk assessments.

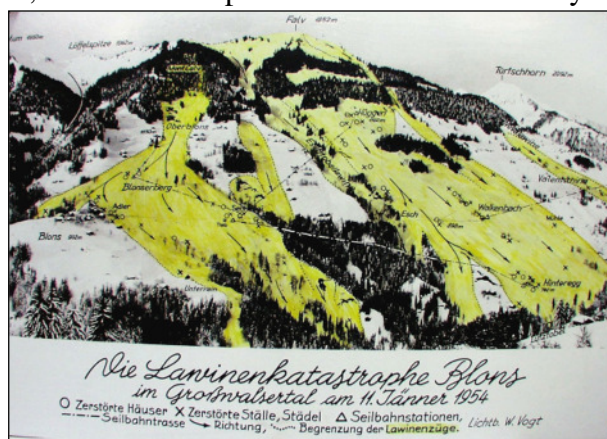
Figure 1: The avalanche disaster of Blons in Vorarlberg on 11.01.1954 [Source WLV Vorarlberg].

In the avalanche winter of 1954 in Vorarlberg 125 people were killed, 57 of them in Blons in the Great Walser Valley. In total, 13 avalanches occurred there. The avalanche paths are shown in the event picture of 1954 (Figure 1).

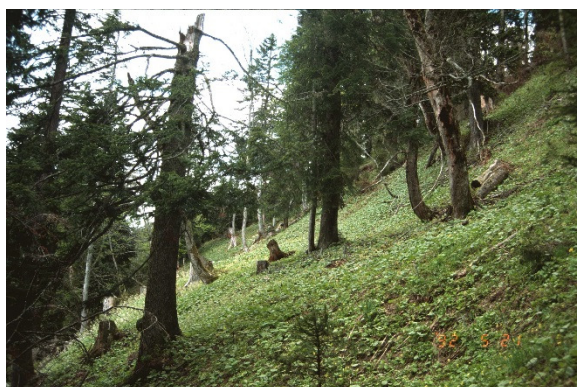
Figure 2: Outmoded protection forests in the high montane / subalpine altitude are in the decay phase and very difficult to rejuvenate [Source: WLV Vorarlberg].

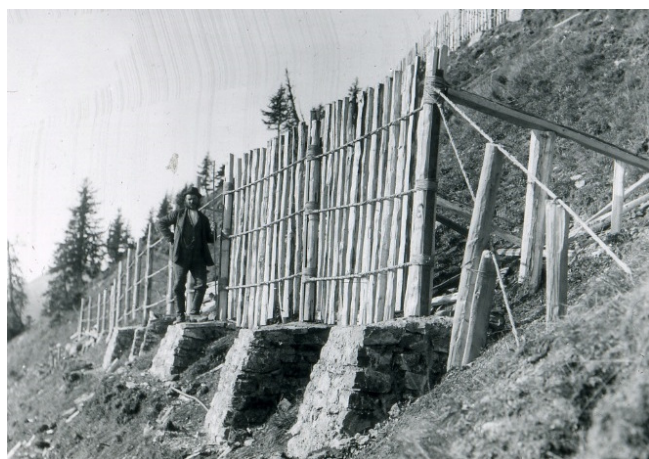
Figure 5: Arlberg Rake in the avalanche starting zone of the Hüggenlawine in the year 1906 [source: WLV Vorarlberg].

The first avalanche protection measures in Blons were probably object protection measures such as roof terraces and splitting wedges. More details are not known. First organized avalanche protection measures in the avalanche starting zones of Blons were established between the years 1906 and 1908. These were Arlberg Rakes (Arlbergrechen) over a length of 1.2 km. Figure 5 shows this type of construction with an effective height of 2 - 2.5 m. The partially already ailing support structures were largely destroyed during the avalanche winter of 1954. The securing of the "Hüggen avalanche" was resumed in 1954. In the process, further types of constructions were developed. The so-called "snow-hanging bridges" (Schneehängebrücken in Figure 6) and, subsequently, the basic structure of the still common snow bridges made of steel. Significant development steps in this type of construction can be found in the foundation. Thus, the originally concreted foundations for micropile foundations and shallow foundations have developed (Figure 7).

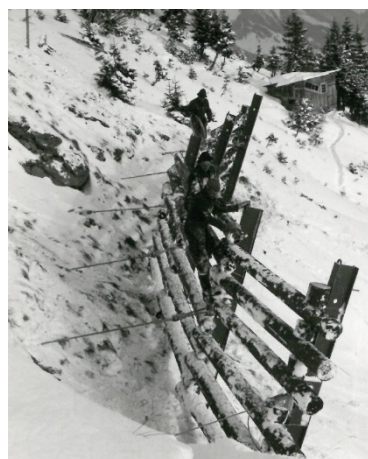
Figure 6: "Snow-hanging bridges",  $D_k = 3\text{m}$ , mounting after snowfall in the 60s of the last century in the avalanche starting zone of the Hüggen avalanche [Source: WLV Vorarlberg]

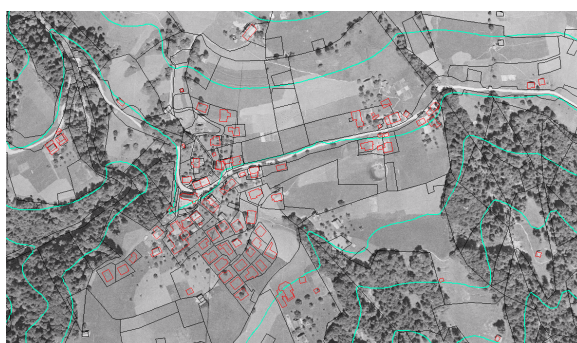
Figure 9: Settlement concentration at the avalanche technically safest place in Blons. The red framed areas are the residential buildings as of 2016. The aerial photo is from the 1950s. The turquoise lines represent contour lines. [VOGIS]

Hazard zoning is an important planning tool. This applies both to in-house planning (setting of measures, financing, expert activity, etc.) and to external planning such as spatial planning or construction. Consideration in spatial planning ensures that no new settlements are built in hazardous areas. Here is the principle of avoiding the danger. The consequence for Blons was a partial abandonment of scattered settlements and a concentration of residential properties in the most avalanche safe places (Figure 9).
