A Survey of Active Slope Movements in Central-North Iceland from Satellite Radar Interferometry

Sigurjón Jónsson, ETH Zürich

Skýrsla nr.: VÍ 2009-002	Dags.: Júní 2009	Dreifing: Opin <input checked="" type="checkbox"/> Lokuð <input type="checkbox"/>
		Skilmálar:
Heiti skýrslu / Aðal- og undirtitill: A survey of active slope movements in Central-North Iceland from satellite radar interferometry		Upplag: 26
		Fjöldi síðna: 78
Höfundar: Sigurjón Jónsson, ETH Zürich		Verkefnisstjóri: Þórður Arason
Gerð skýrslu/Verkstig: Lokaskýrsla		Verknúmer: 2341-0-0002
Unnið fyrir: Ofanflóðasjóð		
Samvinnuaðilar:		
Útdráttur: Lýst er könnun á notagildi bylgjuvíxlmælinga úr ratsjargervitunglum til að mæla örliðlar hreyfingar á lausum jarðefnum í fjallshlíðum, sem geta verið aðdragandi skriðufalla. Aðferðin hentar vel til að kortleggja virkar skriður í heilum landshlutum og finna a.m.k. 100–200 m stór svæði í fjallshlíðum sem hníga fram um 1–5 cm/ári. Fjallað er um mælingar á slíkum hreyfingum í fjallshlíðum á Mið-Norðurlandi. Höfundur hefur áður gefið út niðurstöður svipaðrar rannsóknar fyrir Austurland í greinargerð Veðurstofunnar 07004.

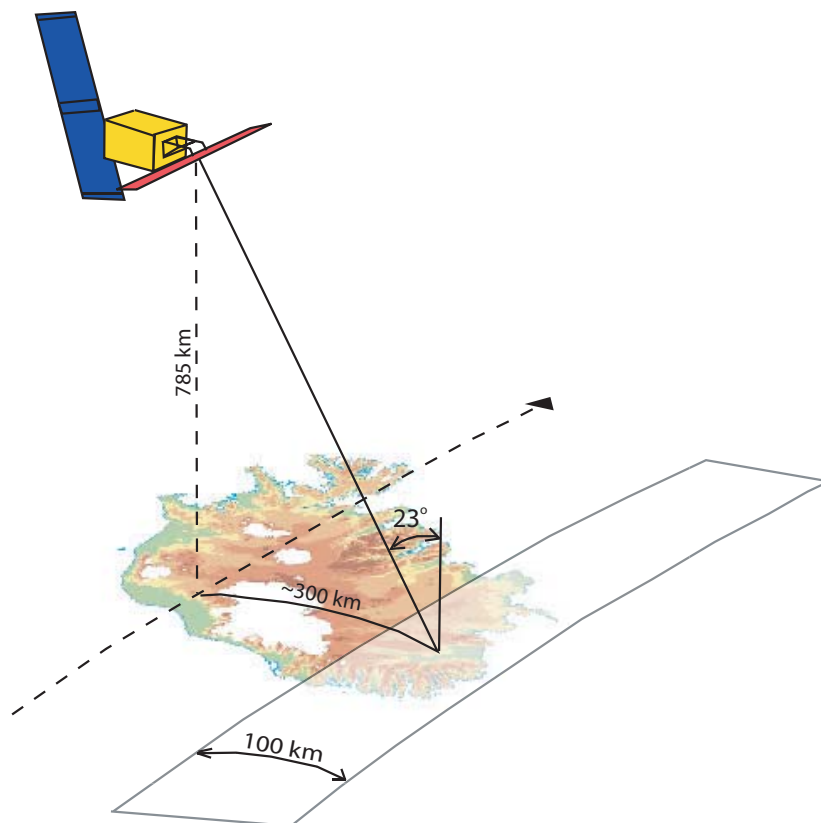
Figure 1. Schematic figure of an ERS-2 ascending pass covering East Iceland. The incidence angle is 23° in the middle of the 100 km wide swath the satellite covers in each pass. The viewing direction during ascending passes is about $N78^\circ E$ for ascending passes and $N78^\circ W$ for descending passes.

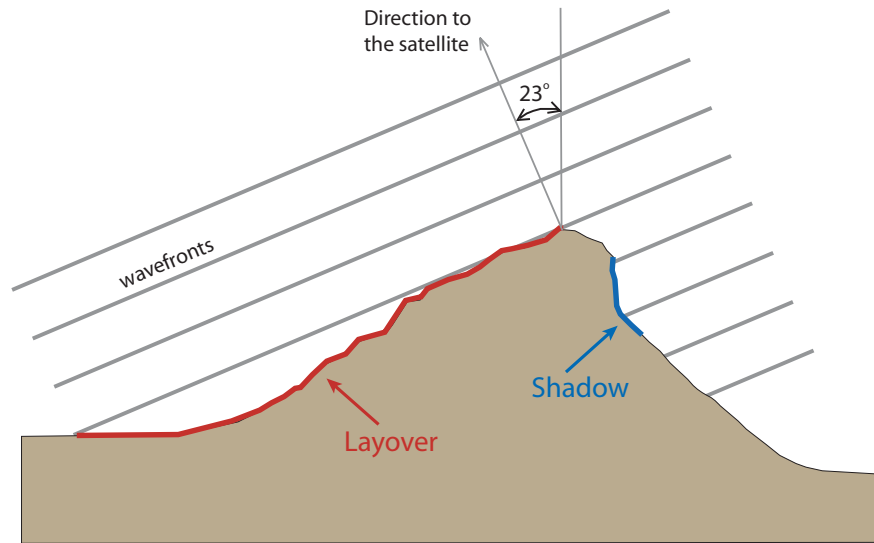
Figure 2. Schematic figure showing shadowing and layovers in radar imaging. The gray straight lines indicate incoming wavefronts from a radar satellite looking down from the left. When slopes facing the satellite are steeper than 23° reflected signals from the top of the mountain return before reflections from further down the slope, resulting in a "layover". Slopes facing away from the radar are better imaged, although shadowing can occur on very steep slopes.

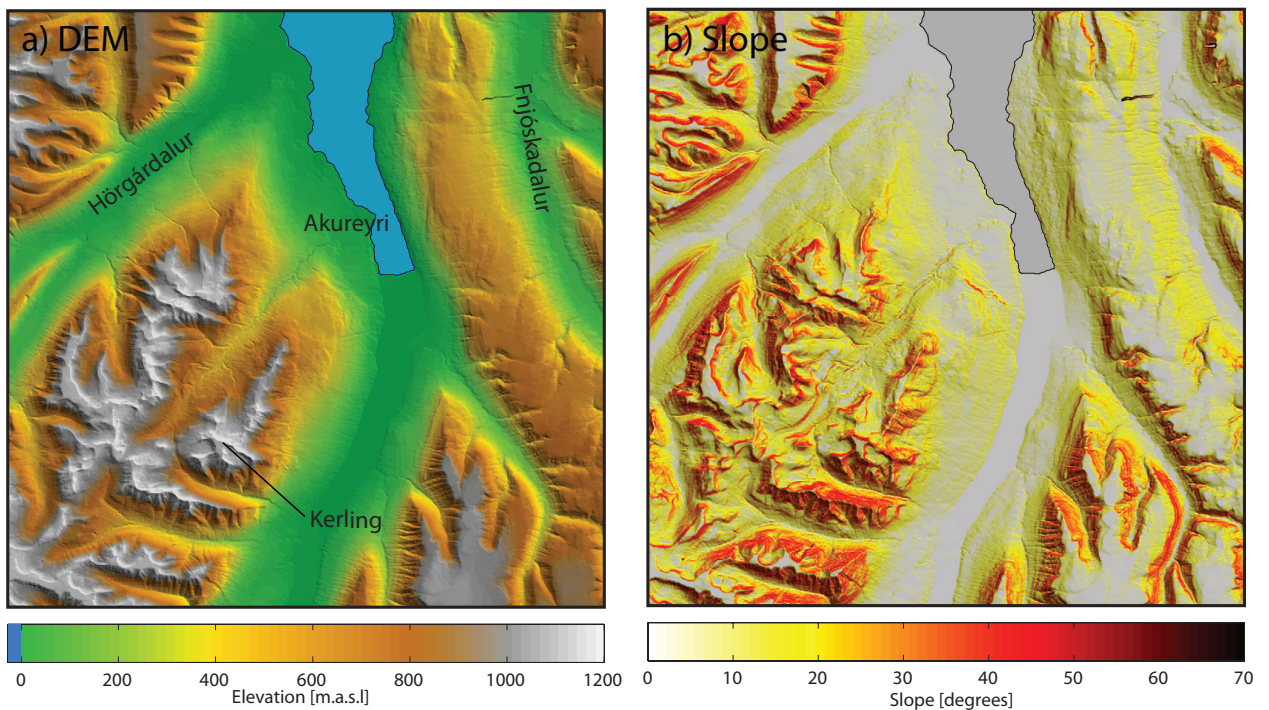
Figure 3. An example of the topography (left) and slopes (right) near Akureyri in North Iceland. The topography of the North Iceland is typically rough with many steep slopes. The colorscale in a) is saturated at 1200 m.a.s.l., but the highest mountain on this map is Kerling (1534 m.a.s.l.).

The topography of Central-North Iceland is relatively rough with steep-sided valleys and fjords and with mountains exceeding 1200 m in elevation (Figure 3). A large part of the area consists of slopes exceeding 23° and some slopes even exceed 67° . Figure 4a-b shows a map of predicted layovers near the town of Akureyri in Central-North Iceland the ascending and descending viewing directions, assuming the average ERS incidence angle of 23° . The steep topography clearly limits the capability of the radar imaging at many slopes, showing that slopes facing ESE result in a layover during descending passes and WSW slopes cannot be imaged during ascending passes.

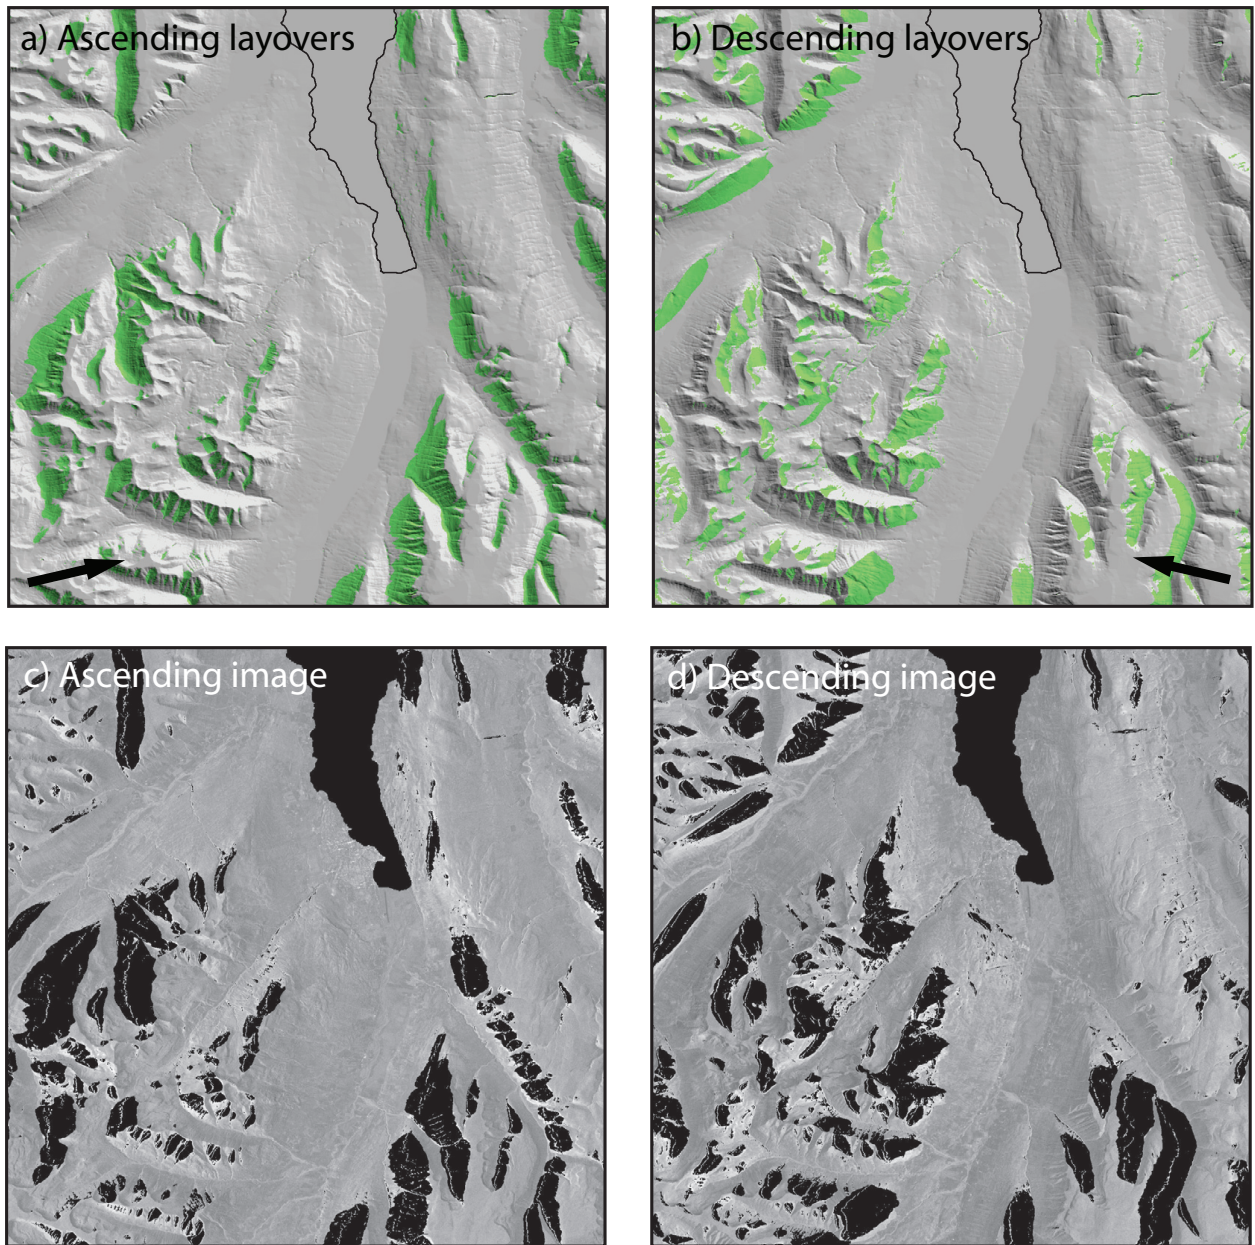
Figure 4. Map of ERS-1/2 layovers (shown as green) from the a) ascending and b) descending viewing directions for the same area as in Figure 3. Black arrows indicate the look direction of the satellite. The figures show clearly that many slopes cannot be imaged using only one look direction. c-d) show the corresponding geocoded amplitude images with layover areas masked out.

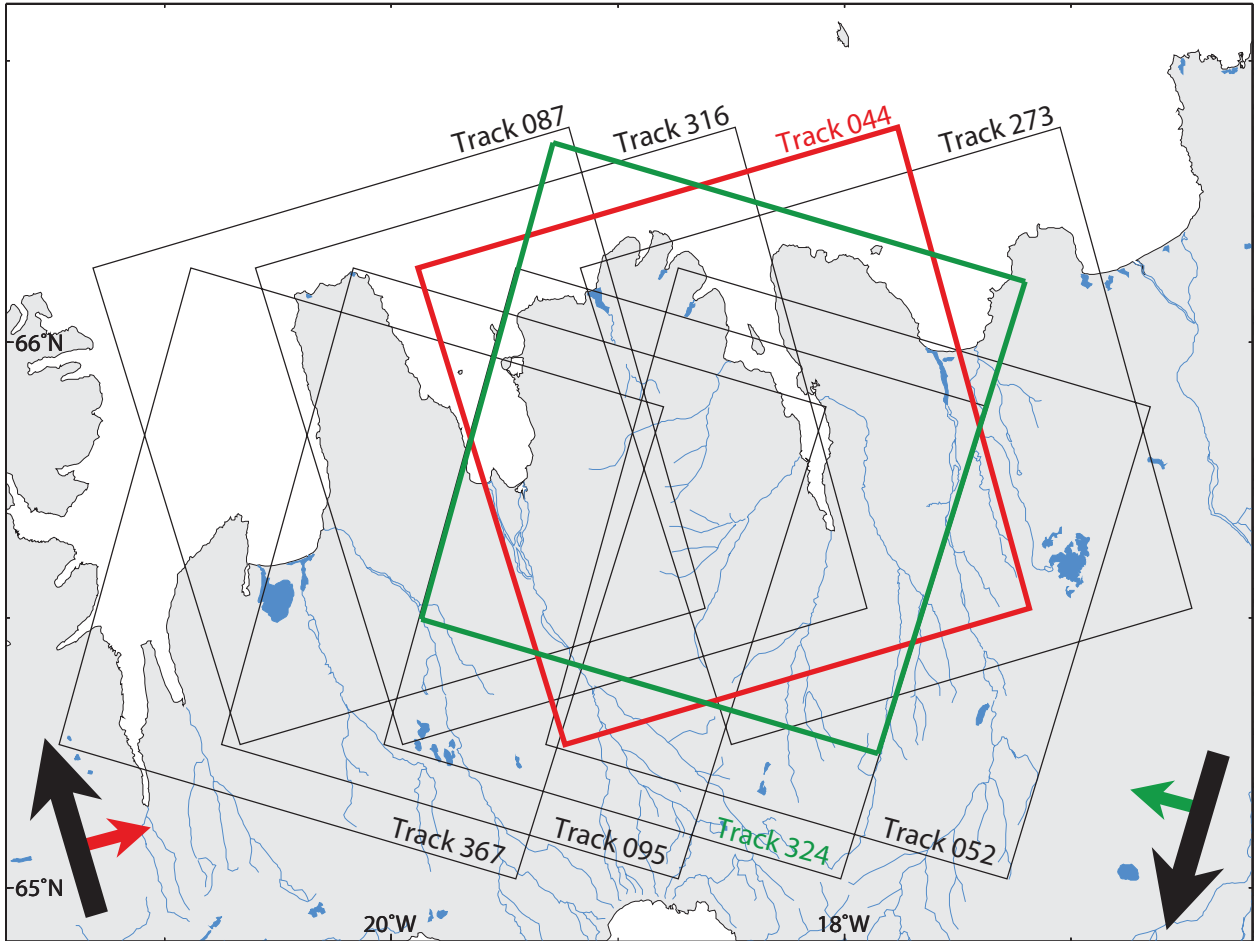
Figure 5. Map of North Iceland showing the coverage of four ascending tracks (87, 316, 44, and 273) and four descending tracks (367, 95, 324, and 52), for the standard ascending frame 1323 and descending frame 2277. I ordered ERS-1/2 ascending data from track 44 (red rectangle) and descending data from track 324 from a shifted frame (2272) as indicated by the green rectangle. The large black arrows show the ascending and descending satellite flying directions and indicate into what direction the right-looking radar antenna is pointing (colored arrows). The Envisat data used in this project are from ascending track 2044 and descending track 2324 and these data cover approximately the same area as indicated by the red and green rectangles.

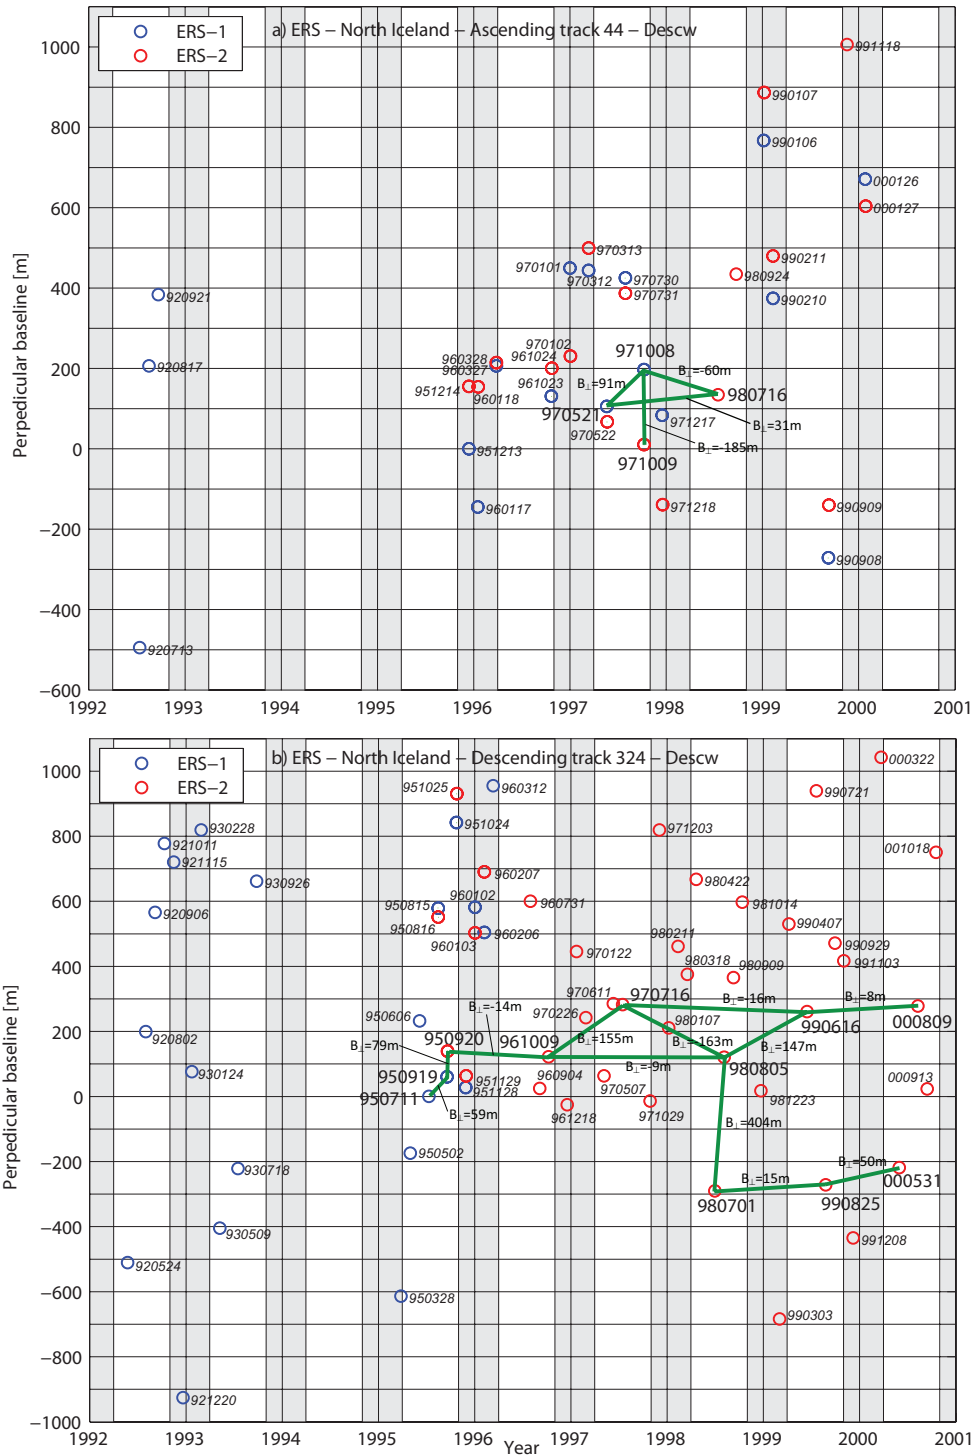
Figure 6. Spatio-temporal baseline information for ERS ascending track 44 and descending track 324 for the time period 1992-2001. The information comes from ESA's Descw database. Scenes labeled in non-italic were ordered for the project and green lines indicate the interferograms formed. Also shown is the perpendicular baseline (B_{\perp}) as calculated from the precise Delft orbital information.

The amount of acquired descending data is larger, especially for tracks 324 and 52 (Figures 34-35). The spatio-temporal baseline distribution indicates that many potentially usable interferograms can be formed using data from any of the four descending tracks. Due to the better spatial coverage of track 324, compared to track 52, data from this track were ordered for this project. The ordered data were acquired mainly during summers of 1995-2000 (Figure 6b), but a few additional scenes were ordered 2002-2003, which turned out to be unusable due to the ERS-2 steering problem. The data were selected based on acquisition date (summer) and the possibility to combine multi-month and multi-year scenes with a relatively small perpendicular baseline (<200 m) due to the steep topography in North Iceland. In addition, two one-day tandem pairs (one ascending and one descending) were ordered to generate a high-resolution DEM of the area. However, in the end a 25 m DEM of North Iceland was used in the data processing. From the descending images I generated 12 interferograms with variable perpendicular baselines from 10 m to 400 m and with temporal baselines from one day to two years (Figure 6b).

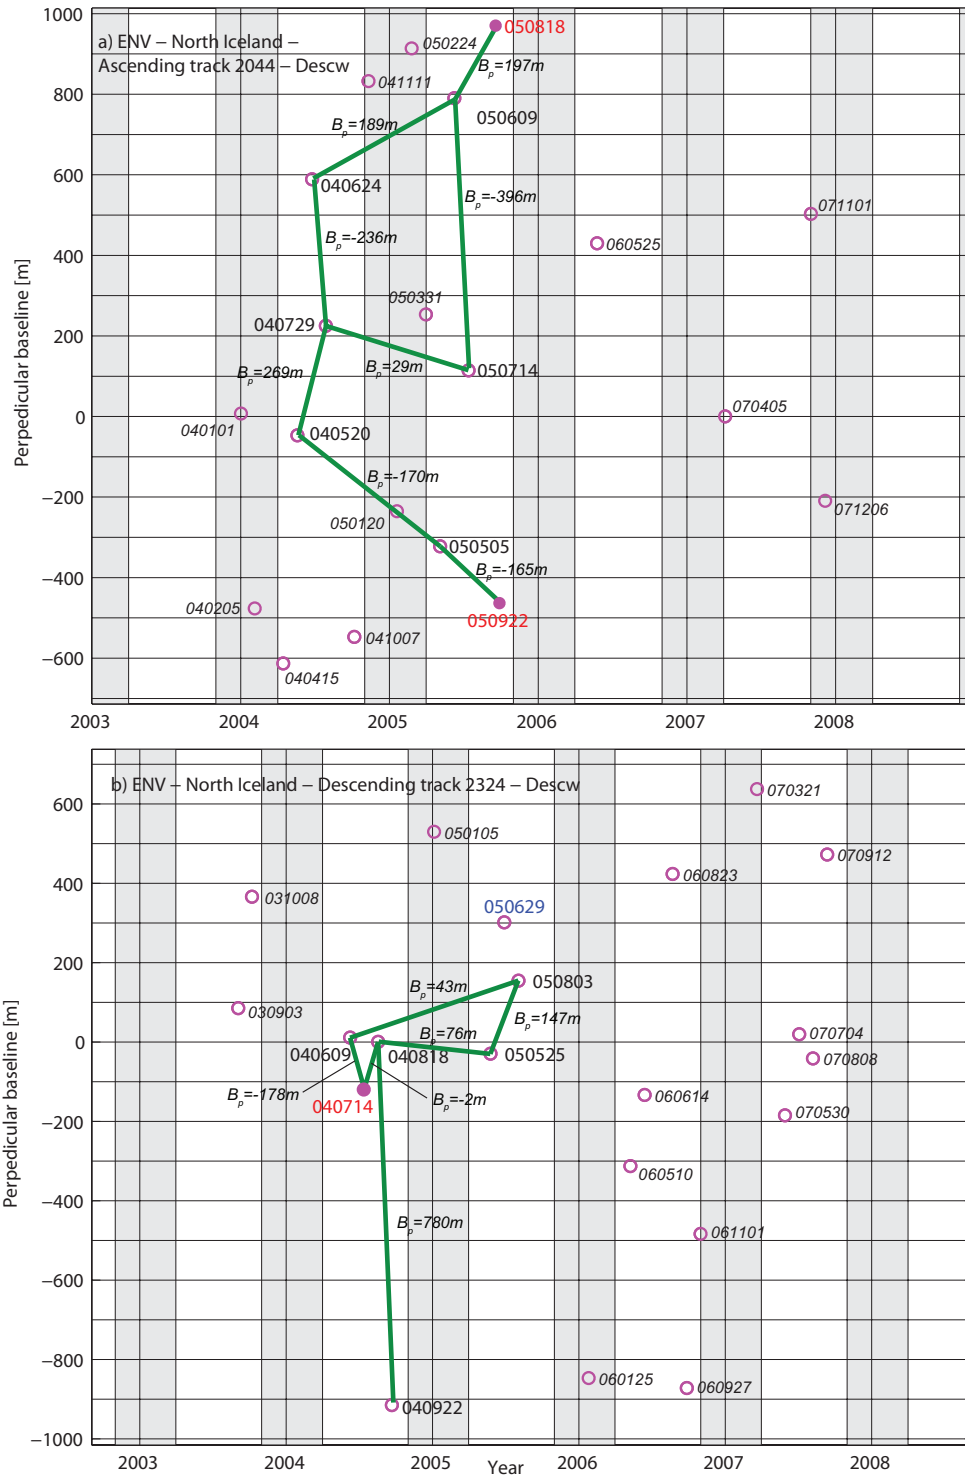
Figure 7. A spatio-temporal baseline diagram for Envisat radar data acquired along ascending track 2044 and descending track 2324. Green lines show which interferograms were formed. Scenes in italic script exist, but were not ordered for this project. Scenes labelled in red exist, but are missing in ESA’s Descw catalogue, while the scene in blue (29 June 2005) is listed in the Descw, but does not exist.

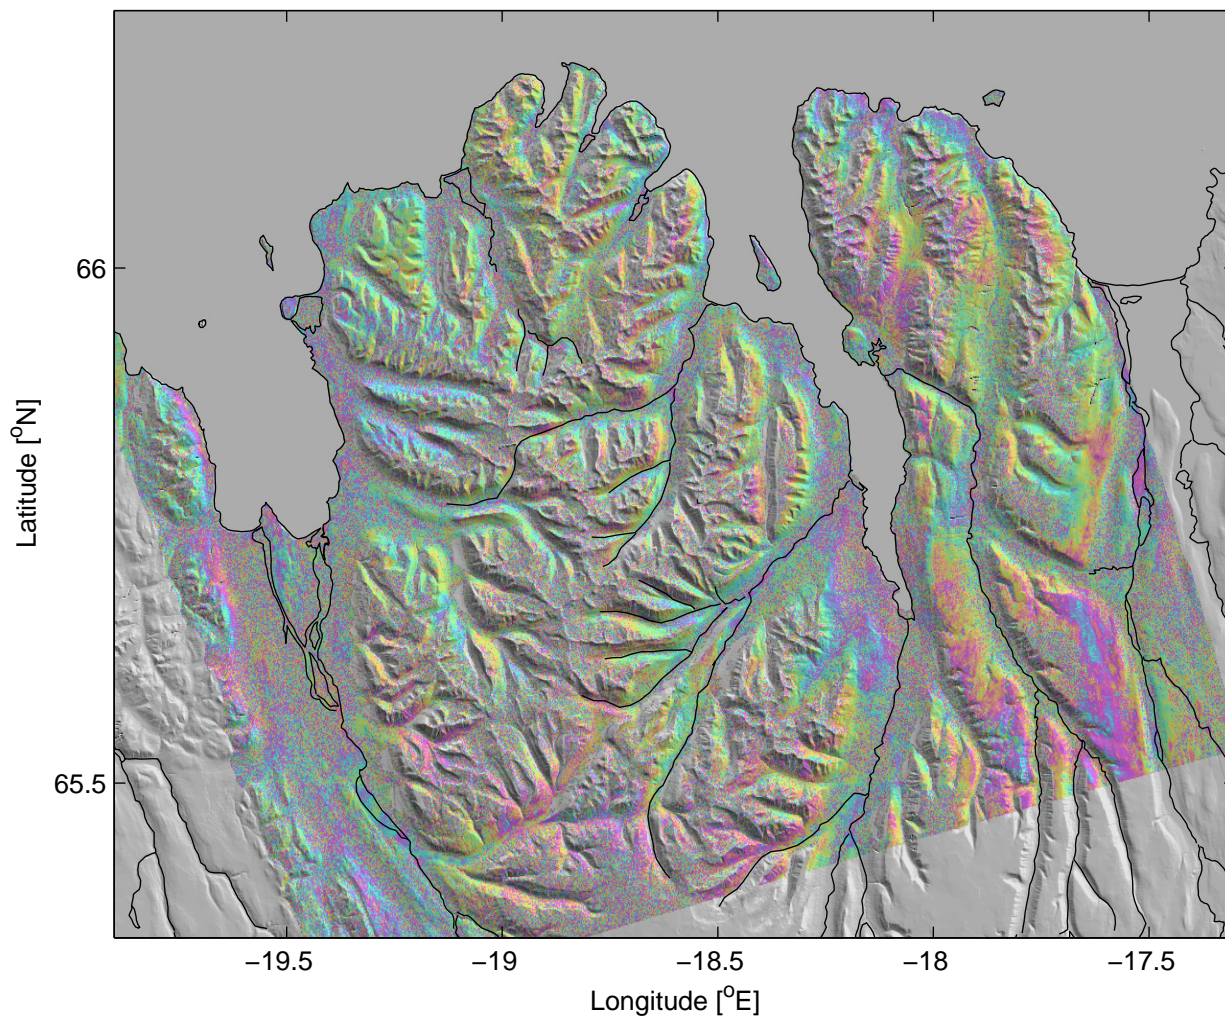
Figure 8. *Example of a geocoded ascending Envisat interferogram of North Iceland (9 June - 18 August, 2005). The displayed area is too large to see any details in the data. However, one can see that the interferogram is decorrelated at the lowest elevations, due to vegetation growth and agricultural activities, and at the highest elevations too, presumably due to snow. The main phase variations are from atmospheric effects that correlate with the topography in some places. ©ESA.*

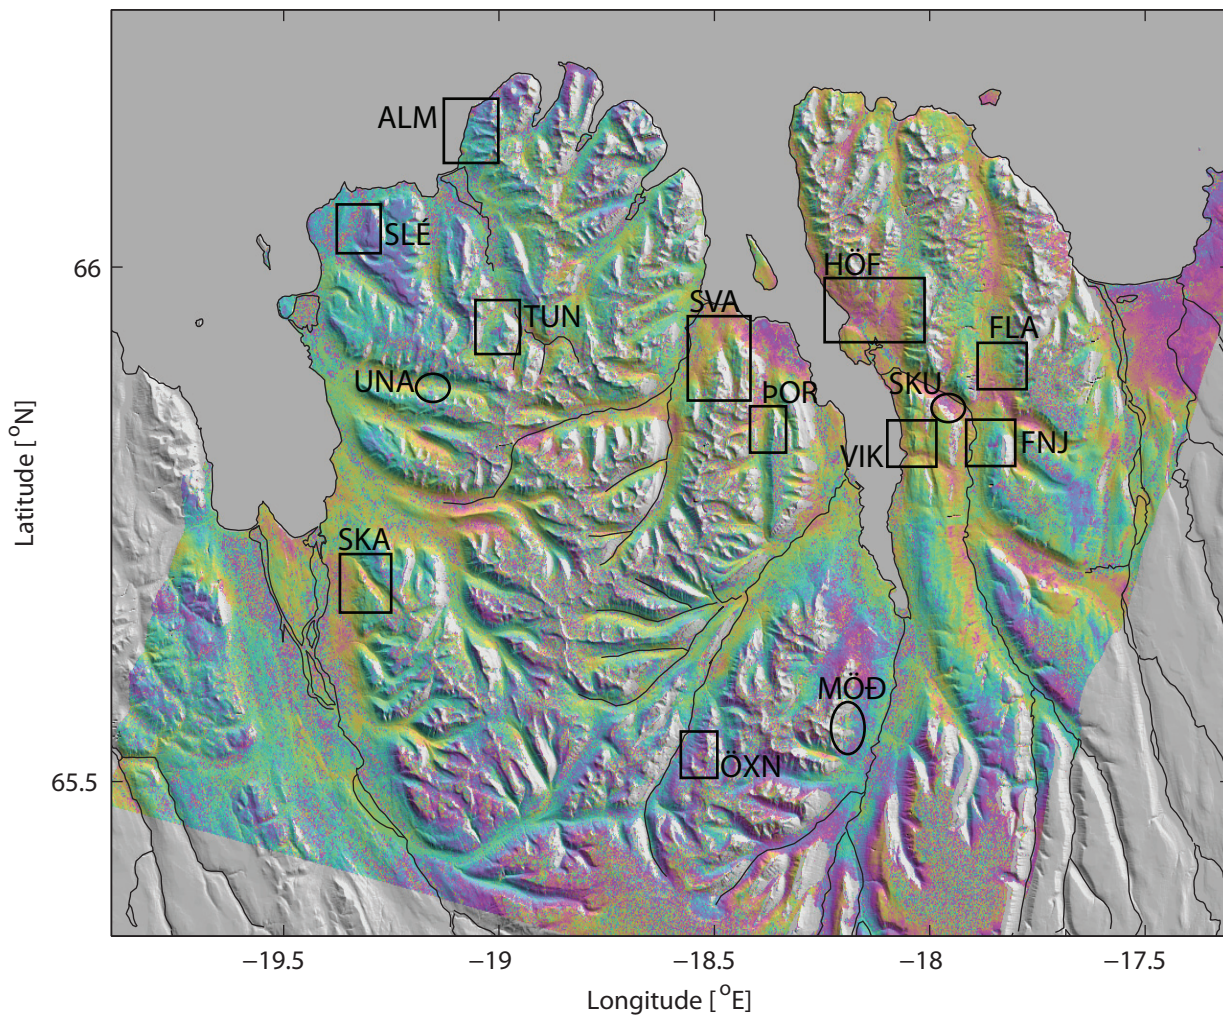
Figure 9. *Descending ERS interferogram of North Iceland (11 July - 19 September, 1995) showing locations where deformation was detected (in this and/or in other interferograms), see Chapter 4 for details. ALM - Almenningur, SLÉ - Sléttuhlíð, TUN - Tungudalur, UNÁ - Unadalur, SKA - Gljúfurárdalur in Skagafjörður, SVA - Svarfaðardalur, POR - Þorvaldsdalur, HÖF - Höfðahverfi, FLA - Flateyjjardalsheiði, SKU - Skuggabjörg, VIK - Vikurhólar, FNJ - Fnjóskadalur, MÖÐ - Möðrufellshraun, ÖXN - Öxnadalur. ©ESA.*

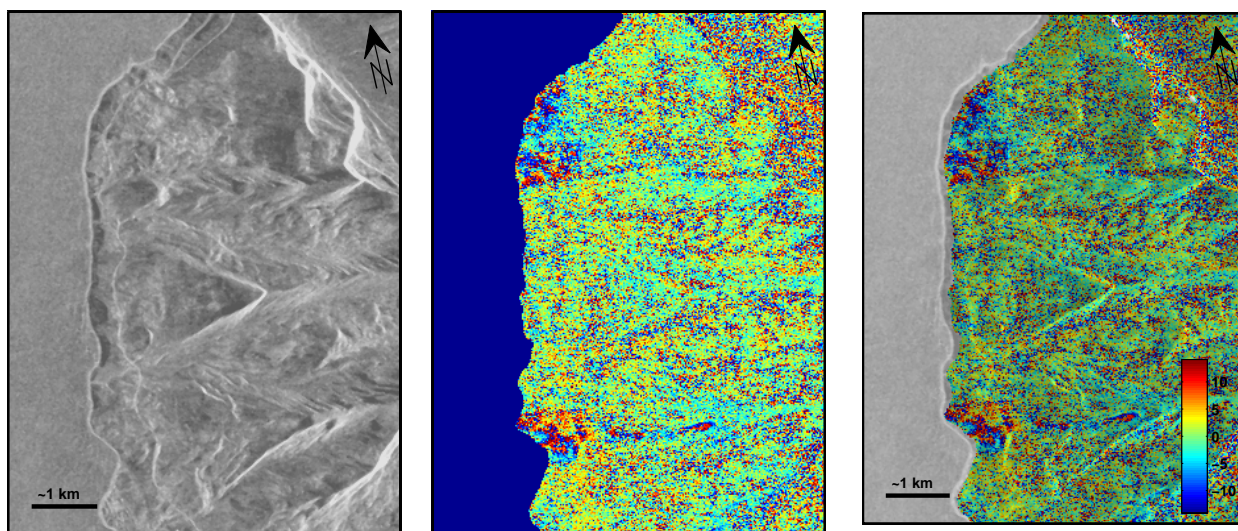
Figure 10. *Display example of an interferogram from Almenningur near Siglufjörður. The displayed image includes a SAR amplitude image (left) as a background shading for the interferometric phase observation (middle) and the result is a shaded interferogram (right).* ©ESA.

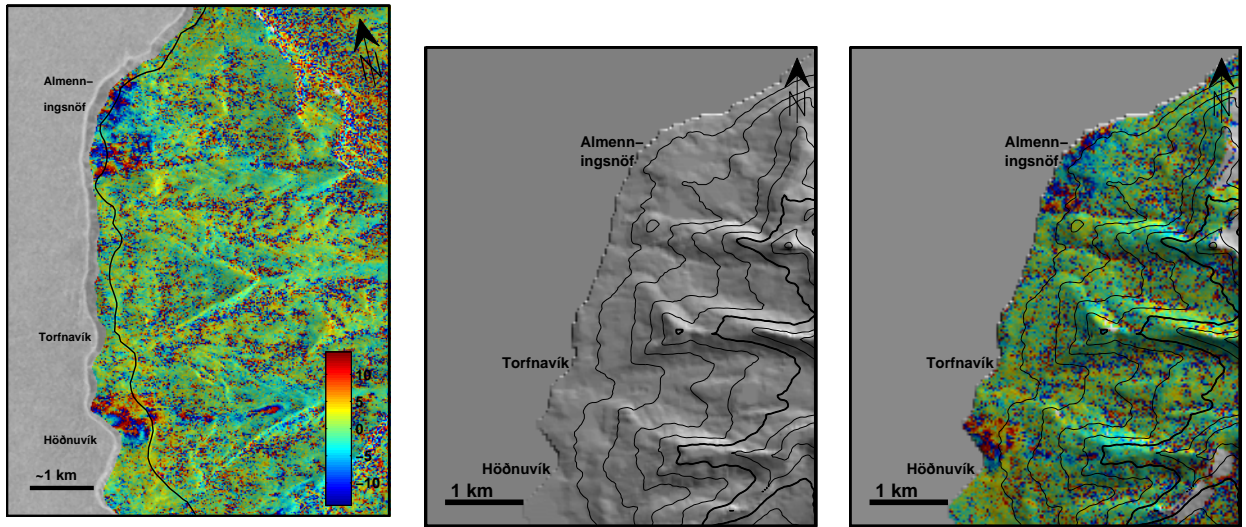
Figure 11. *Example of the postprocessing of an interferogram from Almenningur near Siglufjörður: Filtered interferogram (left), shaded relief map (middle), and a geocoded interferogram (right). ©ESA.*

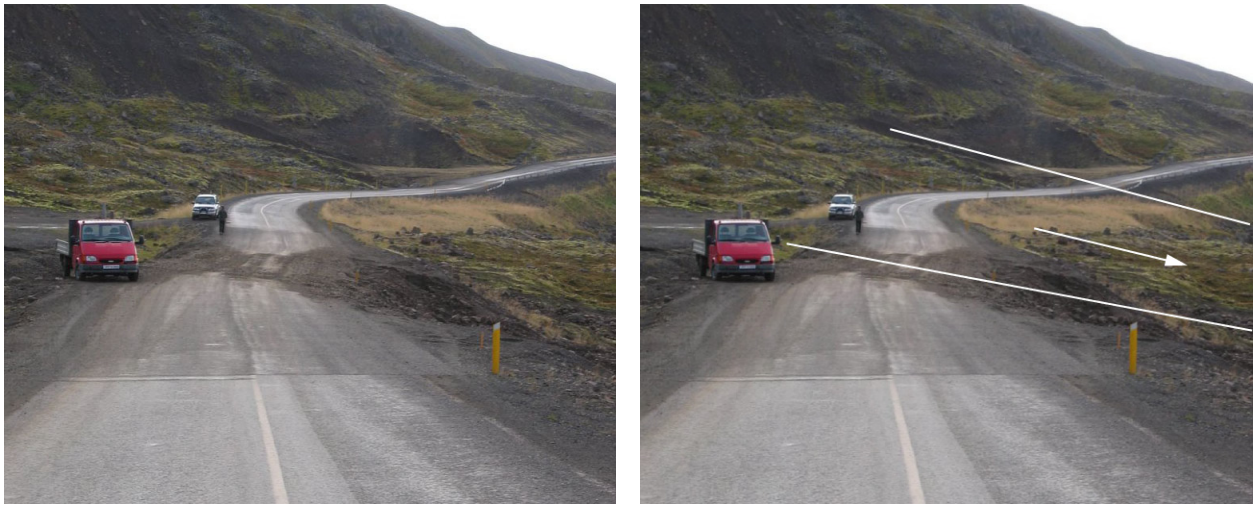
Figure 12. Looking south along the road from Siglufjörður town in Almanningur exhibiting meter-scale displacement of a portion of the road since its surface was paved.

The deposits in Almanningur have been known to be actively moving for some time as signs of movements are clear in the area. Repeated repairs of the road to Siglufjörður have been needed in the past decades, especially after periods of significant precipitation. Figure 12 shows one of the locations along the road exhibiting meter-scale landslide movement since the surface of the road was last paved. These deposits have been described in great detail by *Guðmundsson* [2000].

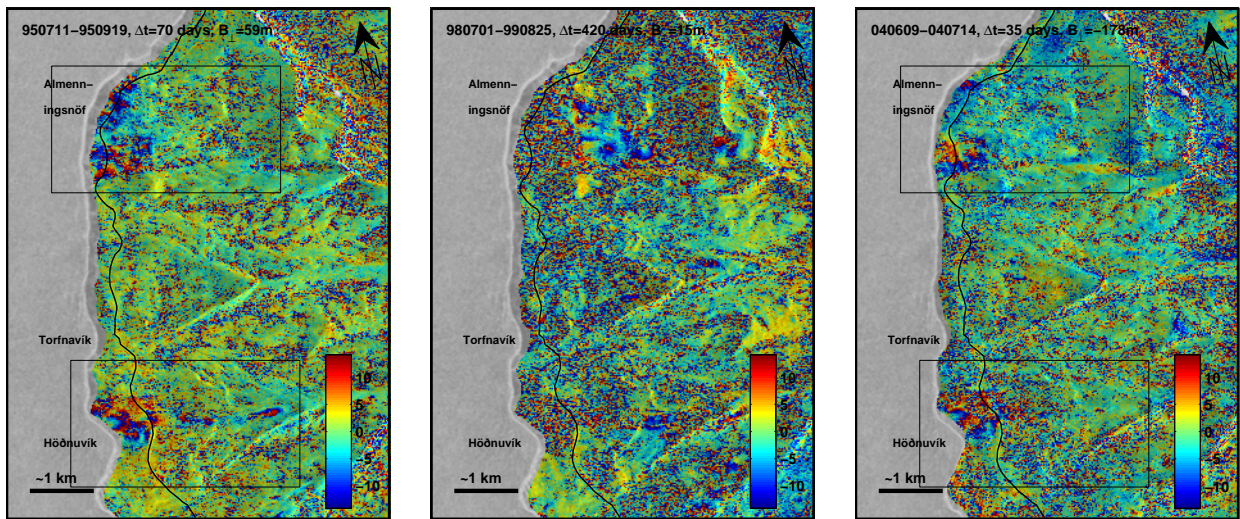
Figure 13. Three interferograms of Almenningur spanning two months in 1995 (left), one year from 1998 to 1999 (middle) and one month in 2004 (right). The Siglufjörður road is marked as a black line. ©ESA.

The Almanningur deposits are well imaged from descending orbits and clear signs of movement are detected along the road in most of the processed interferograms. Figure 13 shows three examples of interferograms of Almanningur. Two of the interferograms, one spanning 70 days in 1995 and the other 35 days in 2004, show clearly two main areas of active landslide displacement, one to the north in an area known as Almenningsnöf and the other on the north side of Höðnuvík inlet. The Almenningsnöf landslide appears to be almost 2 km wide along the coast, but narrower at higher elevations. Its maximum displacement appears to be near its southern and well defined edge (see close up in Figure 14). The pattern of displacement of the Höðnuvík landslide appears to be almost identical in these two interferograms, at least below the road (Figure 14). A notable difference, however, is that the 1995 interferogram also shows movement high up on Breiðafjall mountain. The middle interferogram in Figure 13 spans a much longer time period than the other two, or 420 days from 1 July 1998 to 25 August 1999. The lower portions of the Almenningsnöf and Höðnuvík landslides are decorrelated in this interferogram, almost certainly because the displacements are simply too large and chaotic. More subtle displacements, however, are visible higher on the Almenningsnöf landslide and possibly on the Höðnuvík landslide too, in areas where no visible movement was seen in the shorter-term interferograms. This indicates that the different portions of these two large landslides are moving at a different rate.

In addition, it is clear that the motion of these deposits is not at a steady rate, because no significant displacements are found in the 35-day interferogram (July-Aug. 2004, not shown here) that follows the one shown to the right in Figure 13.

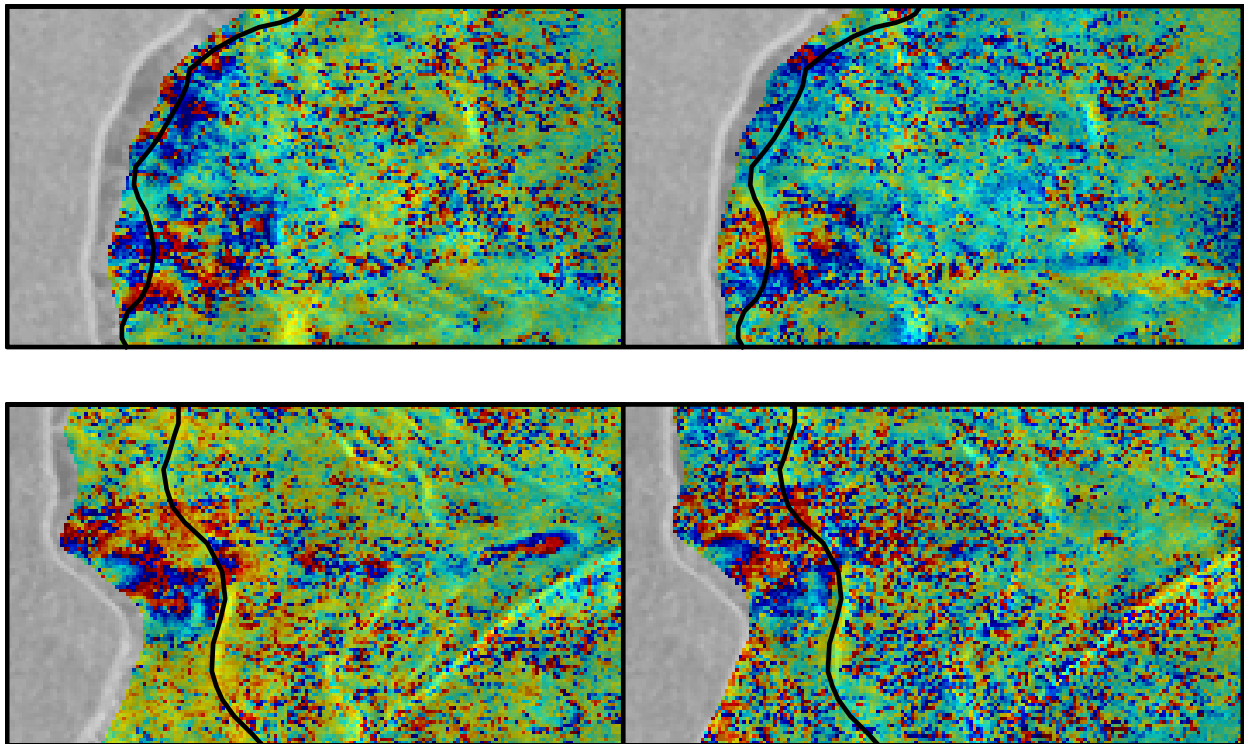
Figure 14. Close-ups of the interferograms shown in Figure 13 showing Almenningunöf (top panels) and the Höðnuvík site (lower panels). The interferograms span July-September 1995 (left) and June-July 2004 (right). ©ESA.

The extent of the two areas that are actively seen moving in the interferograms matches very well with the investigations of *Guðmundsson*, [2000, page 155], where he maps locations of "recent movement". In addition to the Almenningsnöf and Höðnuvík sites *Guðmundsson* [2000] maps signs of recent movements of a smaller area below Torfnakambur in Torfnavík (or Selvík). This site is not found to be moving in the 1-2 month interferograms but the one-year interferograms are mostly decorrelated at this location, which possibly is due to too much deformation.

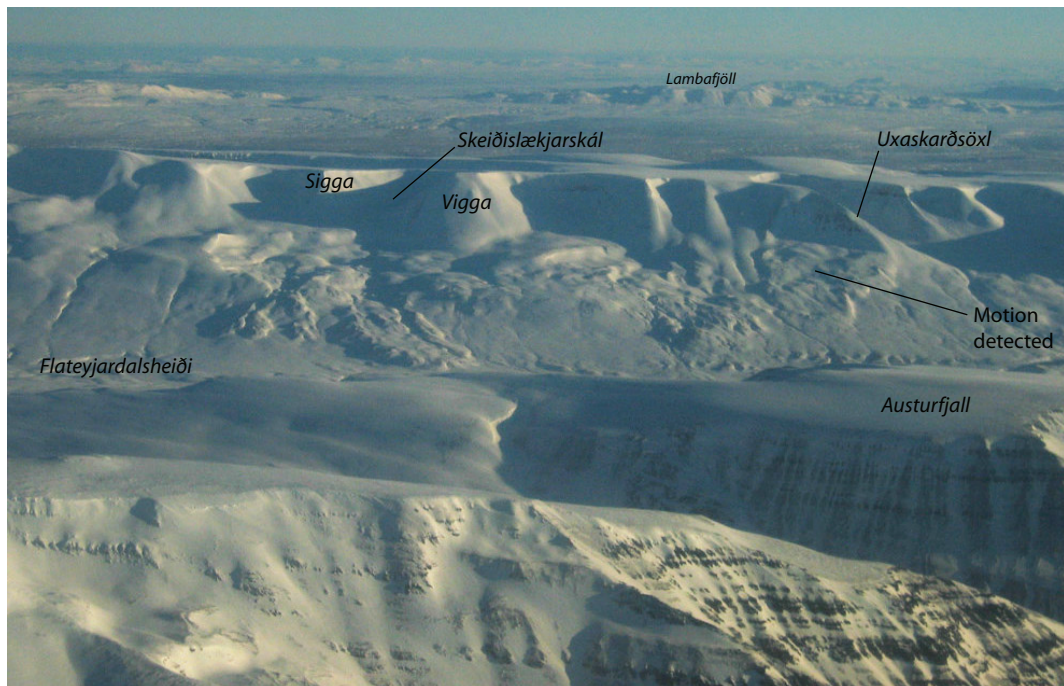
Figure 15. Photograph taken from an airplane looking east to the slopes above Flateyjardalsheiði. In the foreground is Austurfjall, north of Dalsmynni. Several deposits can clearly be seen below Sigga and Vigga and near the Uxaskarðsöxl ridge. Surface displacements were only detected on the deposits farthest to the south under Uxaskarðsöxl.

The other locations where clear loose deposits exist, i.e. under Sigga and Vigga mountains do not appear to be moving during the the time periods the different interferograms span, despite that these deposits appear fresh looking and similar to the unstable deposits below Uxaskarðsöxl (Figure 15).

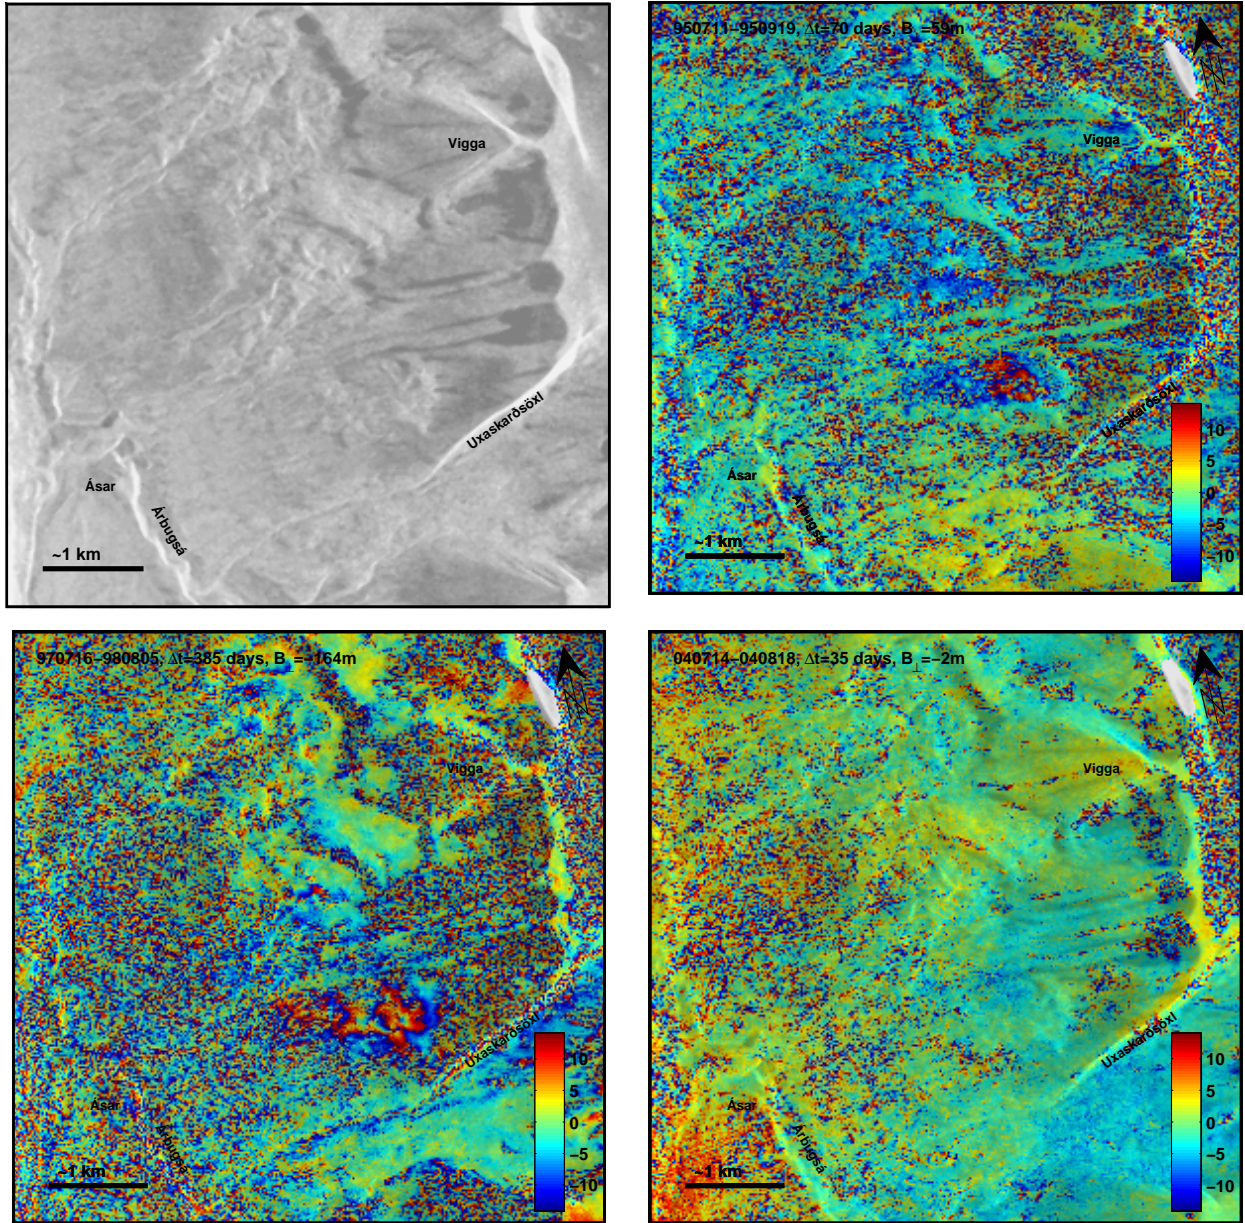
Figure 16. A radar amplitude image (top left) and three interferograms of Flateyjardalsheiði. The 70-day interferogram from 1995 (top right) shows clear signs of displacements near Uxaskarðsöxl, while the 35-day interferogram from 2004 (bottom right) exhibits no measurable deformation. The one-year interferogram from 1997-1998 (bottom left) is noisier due to the longer time-span but clearly shows deformation below Uxaskarðsöxl ©ESA.

Several interferograms show motion of the deposits near Uxaskarðsöxl while the deposits further north appear stable. A 70-day interferogram spanning July-September 1995 shows clear movement of up to 2 cm (Figure 16) and a similar signal is seen during June-July 2004 (not shown here). Interestingly, however, no displacement is found on the landslide during the following month July-August 2008 (Figure 16). One-year interferograms are rather noisy in this area and usually provide only limited information, although signs of movement near Uxaskarðaöxl is seen in many of them. The clearest example of these one-year interferograms is shown in Figure 16 and it spans the time period from July 1997 to August 1998. This interferogram clearly shows displacements on the site near Uxaskarðsöxl although it is hard to judge the amount the displacement amplitude, but it is at least 3 cm. The extent of the moving area seems somewhat larger than in the 70-day interferogram from 1995.

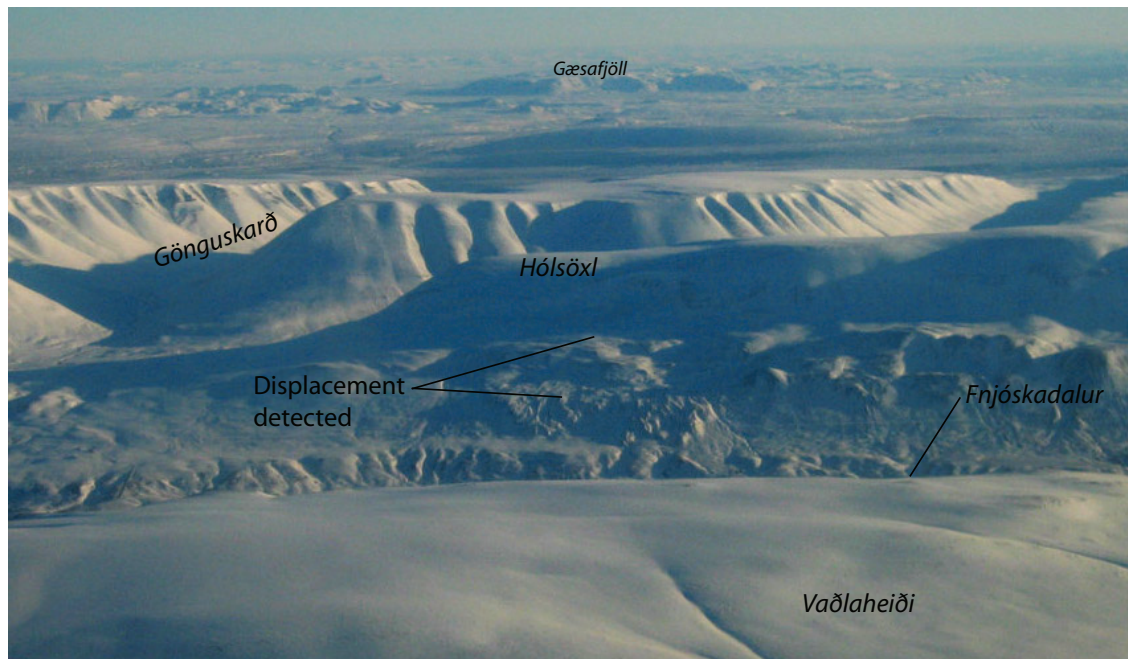
Figure 17. Looking east over Vaðlaheiði towards Hólsöxl on the east side of Fnjóskadalur valley. Loose deposits can be seen under Hólsöxl, above and north of the farm Böðvarsnes, and they appeared to be moving in some of the processed interferograms.

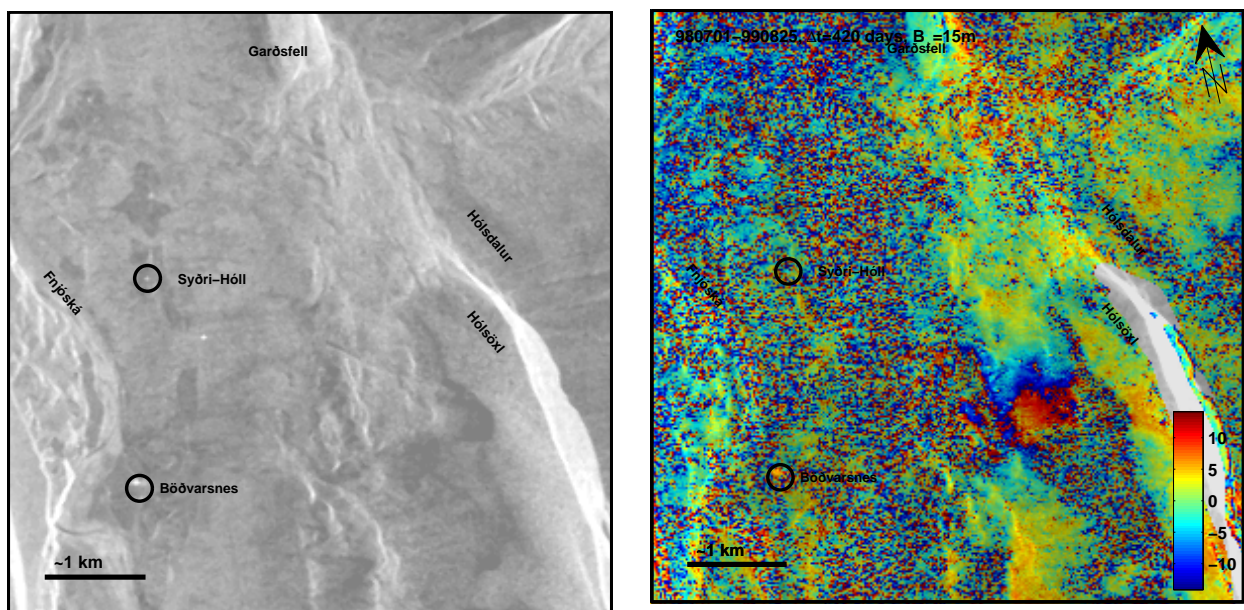
Figure 18. SAR amplitude image (left) and a one-year interferogram of Hólsöxl in Fnjóskadalur. This 1998-1999 interferogram shows displacements above the Böðvarsnes farm. ©ESA.

The Böðvarsnes landslide is described in detail by *Jónsson* [1976, page 203]. He reports that the deposits look very fresh in some places that cracks can be seen at the various locations as well, which he interprets as being clear signs of recent or ongoing movement. He also reports that the farmer in Böðvarsnes farm had often found new cracks and realized that old ones had closed, a further indication of active movement. The clearest sings of movement in the interferograms is found rather high on the landslide, where the slope is relatively gentle (Figure 18) and higher than where *Jónsson* [1976] described fresh looking cracks. However the lower parts of the landslide are decorrelated in most of the interferograms, possibly due to fast displacement rates on this part of the deposits.

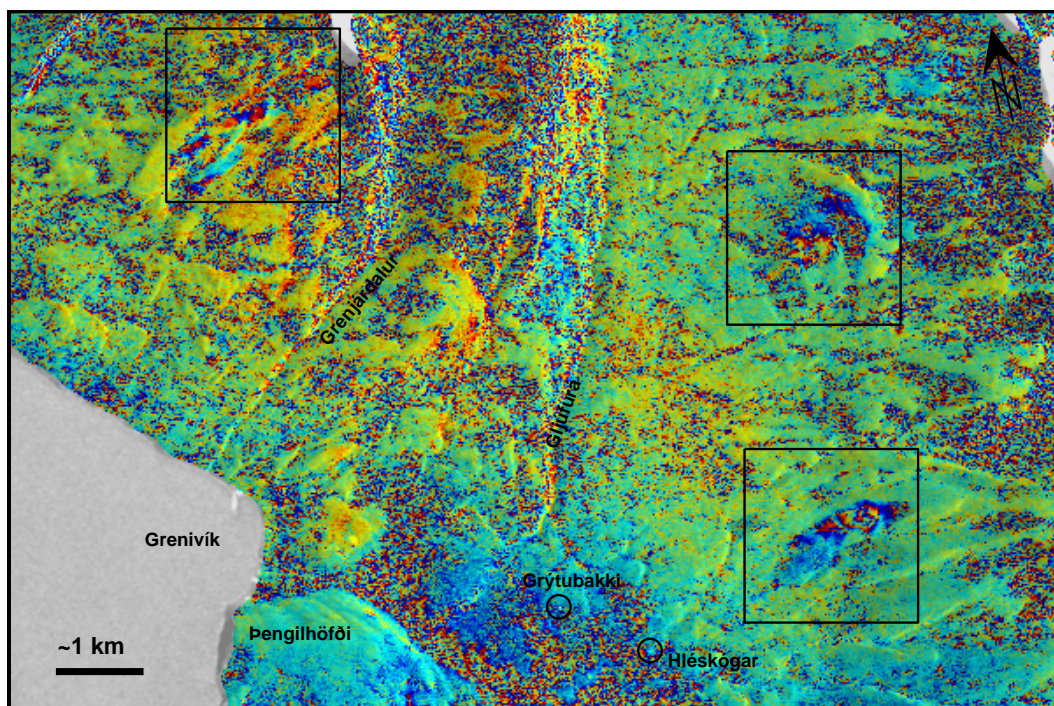
Figure 19. *Interferogram (July-Sept. 1995) from Höfðahverfi showing movement at three locations: Above Hléskógar (bottom right), on Leirdalsheiði (top right) and Kaldbakur (left).*

Another location is on Leirdalsheiði, above an area called Grásteinsmóar. This area appears fairly large, or about 1 km wide and is moving as much as 2-3 cm in the July-September 1995 interferogram (Figure 19). These deposits exhibit movements in some of the longer-term interferograms, e.g. in 1998-99, but appear to be moving in fewer interferograms than the ones under Benidiktscambur. For example, they do not show any significant surface displacements in the interferograms from summer of 2004. The altitude of the area is between 400 and 600 meters.
