A Survey of Active Slope Movements in Central-North Iceland from Satellite Radar Interferometry

Sigurjón Jónsson, ETH Zürich

Skýrsla nr.: VÍ 2009-002	Dags.: Júní 2009	Dreifing: Opin <input checked="" type="checkbox"/> Lokuð <input type="checkbox"/>
		Skilmálar:
Heiti skýrslu / Aðal- og undirtitill: A survey of active slope movements in Central-North Iceland from satellite radar interferometry		Upplag: 26
		Fjöldi síðna: 78
Höfundar: Sigurjón Jónsson, ETH Zürich		Verkefnisstjóri: Þórður Arason
Gerð skýrslu/Verkstig: Lokaskýrsla		Verknúmer: 2341-0-0002
Unnið fyrir: Ofanflóðasjóð		
Samvinnuaðilar:		
Útdráttur: Lýst er könnun á notagildi bylgjuvíxlmælinga úr ratsjargervitunglum til að mæla örliðlar hreyfingar á lausum jarðefnum í fjallshlíðum, sem geta verið aðdragandi skriðufalla. Aðferðin hentar vel til að kortleggja virkar skriður í heilum landshlutum og finna a.m.k. 100–200 m stór svæði í fjallshlíðum sem hníga fram um 1–5 cm/ári. Fjallað er um mælingar á slíkum hreyfingum í fjallshlíðum á Mið-Norðurlandi. Höfundur hefur áður gefið út niðurstöður svipaðrar rannsóknar fyrir Austurland í greinargerð Veðurstofunnar 07004.

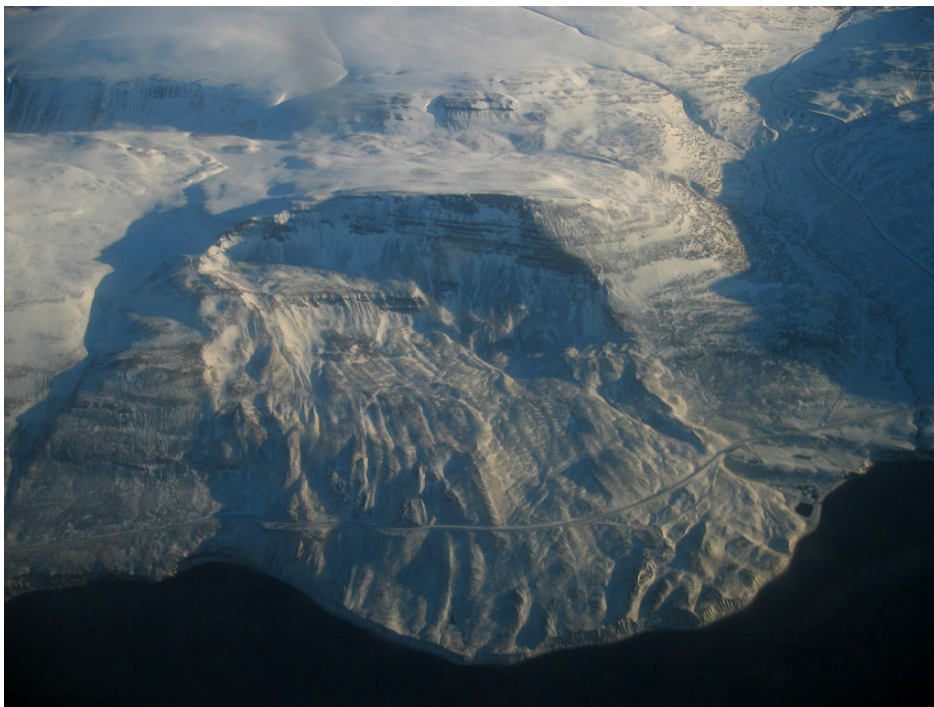
Figure 20. *Photograph looking east towards the Víkurhólar deposits. The road across the deposits can be clearly seen as well as the road up to the Víkurskarð pass on the right.*

The Víkurhólar hills are deposits on the eastern shore of Eyjafjörður, just north of the Víkurskarð pass. This site can clearly be seen from the other side of the fjord or from the Víkurskarð road, as the deposits are remarkably distinct, extending from a bowl on Ystuvíkurfjall mountain down to the sea, where they form an arcuate shoreline into the fjord (Figure 20). The geomorphology of these deposits has been detailed by Jónsson [1976] and he estimated its area to be 2.5 km^2 and its volume $50 \times 10^6 \text{ m}^3$. High cliffs on the Ystuvíkurfjall mountain mark the bowl and Jónsson [1976] describes clear cracks on the top of the mountain, near the edge of the cliffs. One of these cracks is 450-500 m long and only 15-60 m from the edge. Jónsson [1976] believes the cause of the instability of this landslide is related to a fault that runs through Ystuvíkurfjall mountain and can be seen on the south side of the Kræðufjall mountain to the north of the Víkurhólar landslide. The fact that the deposits reach into the fjord has caused some concern that they could potentially generate a tsunami, threatening Akureyri and other towns in Eyjafjörður [Davíðsdóttir, 2008].

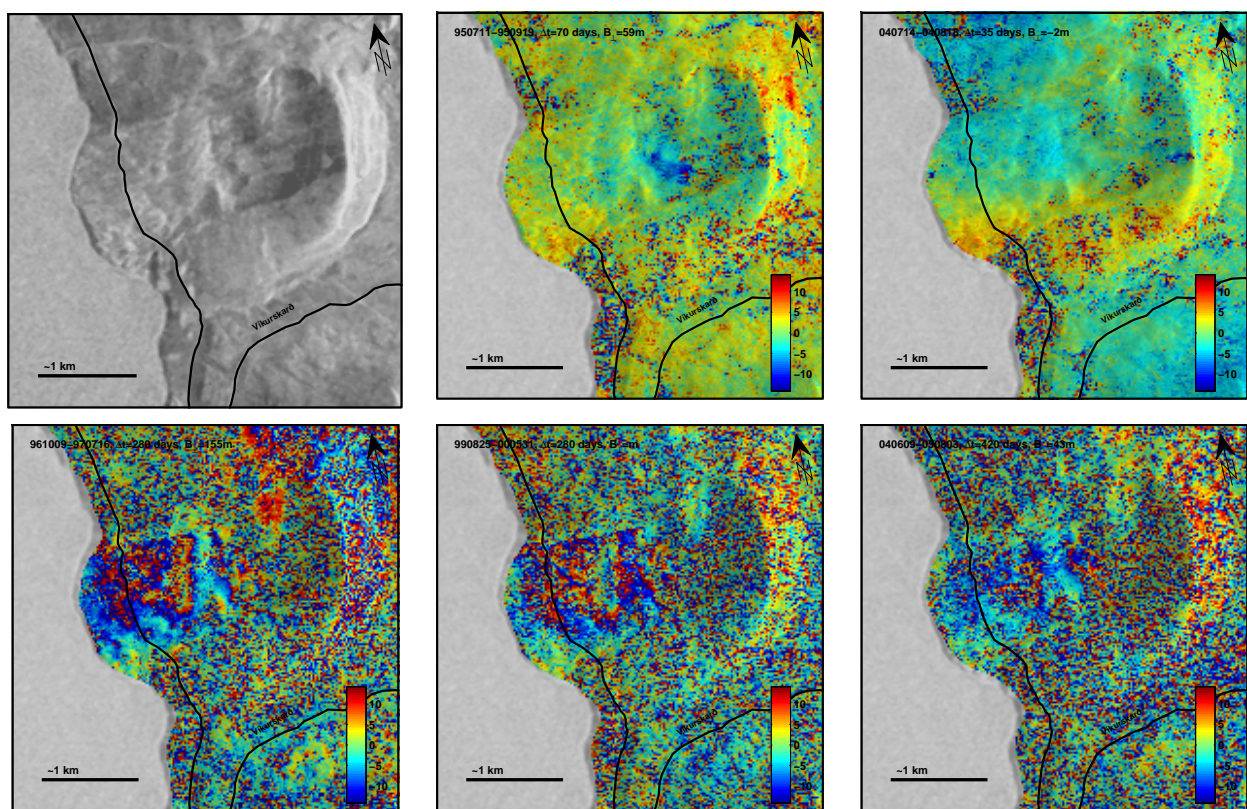
Figure 21. SAR amplitude image (top left) and five interferograms of Víkurhólar in Eyjafjörður, two spanning only 70 and 35 days (top middle and right) and three spanning about a year in 1998-99, 1999-2000, and 2004-05 (bottom). ©ESA.

and shows that the northern half of the landslide is moving faster than the southern half, with the southernmost part of the deposits not moving at all. The northern edge of the moving area is very well defined and can be seen as a straight line in many of the interferograms (e.g. Figure 21, bottom-middle panel). The southern boundary of the moving area, on the other hand, appears irregular and is not as clearly detectable as in the north. The maximum displacement rate is usually found above the road crossing the landslide and it seems to fluctuate somewhat from one year to another. The maximum rate is 1-2 cm/year in 1995-96, around 2 cm/year in 1996-97, less than 1 cm/year in 1997-98, but around 3 cm/year in 1998-2000 (Figure 21). The rate revealed by the Envisat interferograms shows again slower rate for 2004-05, or about 1 cm/year. These results are summarized in Table 2.

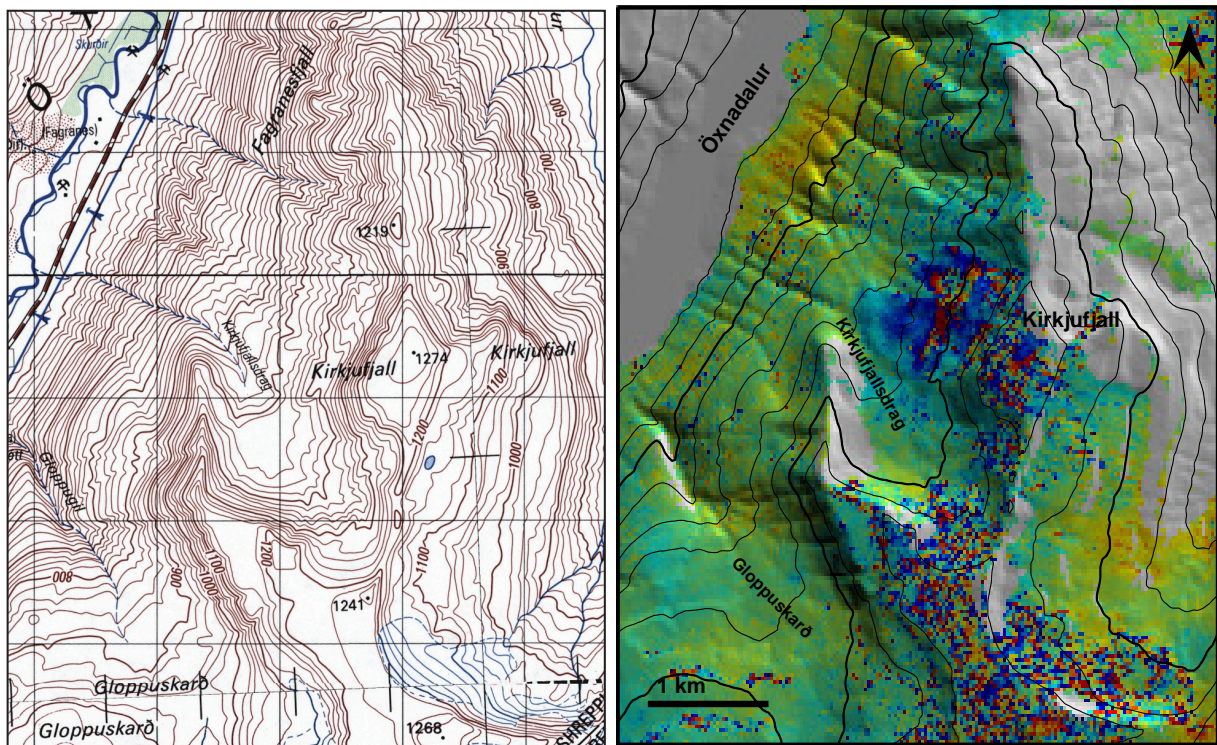
Figure 22. Map and a geocoded interferogram (July-August, 2004) of Kirkjufjall in Öxnadalur showing deformation near Kirkjufjallsdrög with 2-3 cm maximum LOS displacement. Both 100 m and 500 m (thick) elevation contour lines are shown. ©NLSI and ESA.

One site of mass movement was detected in Öxnadalur valley under the mountain of Kirkjufjall. This site is south of the farms Hraun and Engimýri, above an abandoned farm called Fagranes. High on the Kirkjufjall mountain some displacements can be seen in the shorter-term descending interferograms spanning 1-2 months. The area that is moving is under the high summit of Kirkjufjall (1274 m.a.s.l) at elevations between 800 m and 1100 m, just north of a small tributary valley called Kirkjufjallsdrag (Figure 22). The pattern of displacement shows two tongues of movement; the southern tongue is larger and moving about 1 cm in this image, the northern tongue is smaller but appears to be moving faster, with a maximum displacement of at least 2-3 cm. The interferogram is decorrelated on the top of Kirkjufjall and at elevation above 1100 m to the south of the summit. Otherwise the west-facing slopes of Kirkjufjall are nicely coherent, but do not exhibit any other detectable movement.

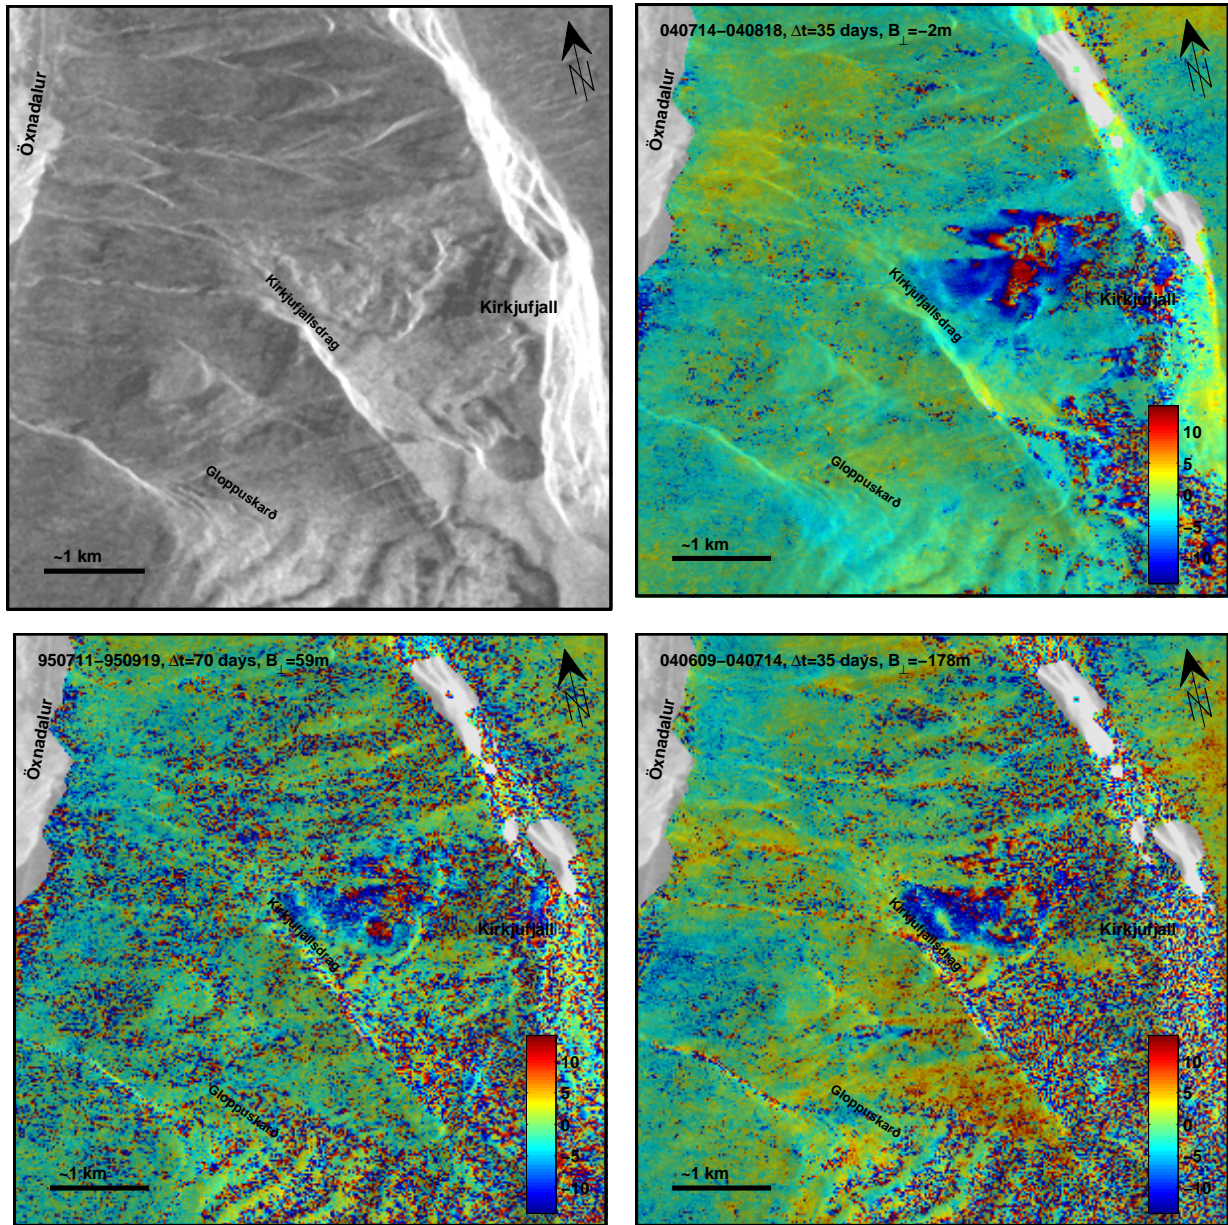
Figure 23. Amplitude image and interferograms of Öxnadalur. A 35-day interferogram (July-August, 2004) shows deformation in Kirkjufellsdrög in the radar-geometry (same as in Figure 24). Two other interferograms spanning 70 days in 1995 (bottom left) and June-July 2004 (bottom right) also show displacements at this site. ©ESA.

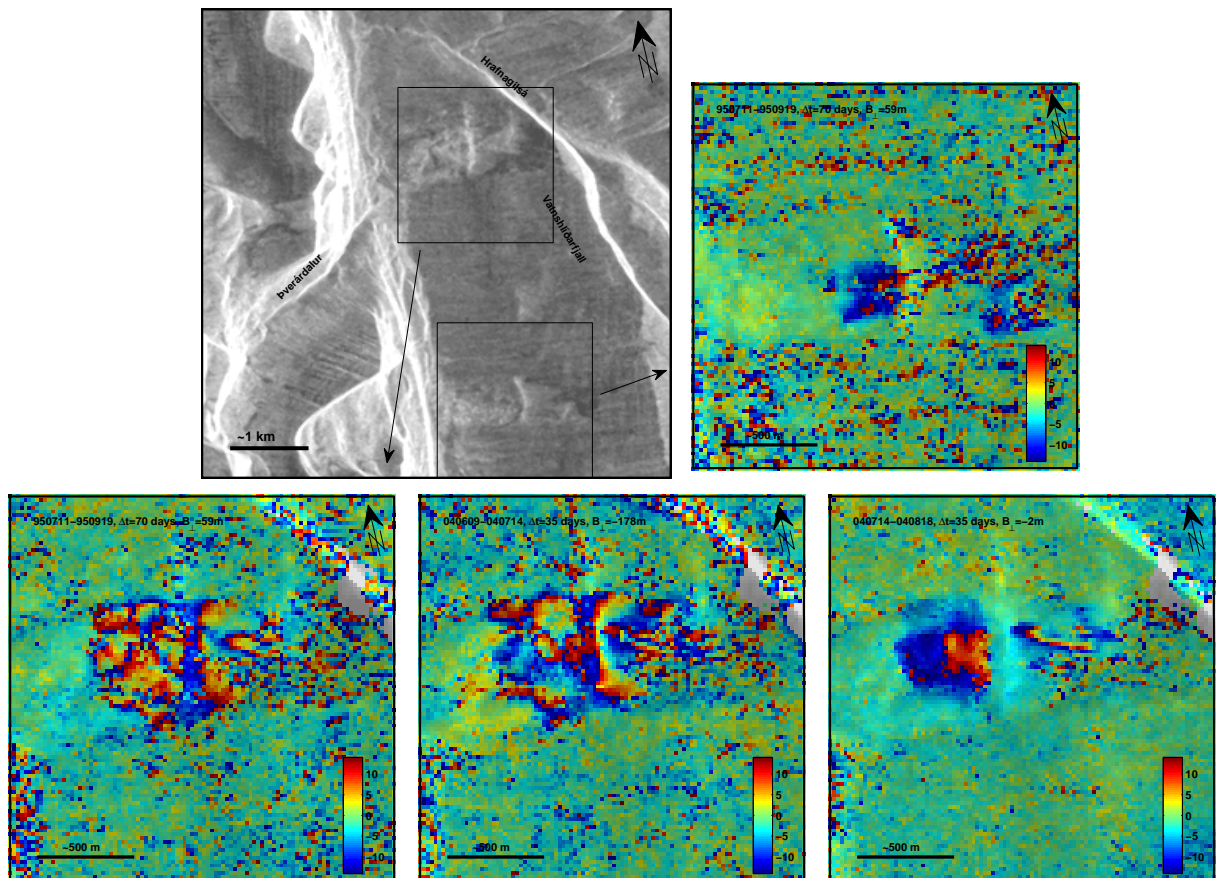
Figure 25. Amplitude image and interferograms of Porvaldsdalur. The July-August (2004) interferogram is here shown in radar coordinates (it is in map coordinates in Figure 24) and it shows clear deformation on Hrafnagilshraun (bottom right). Two other interferograms spanning 70 days in 1995 (bottom left) and June-July 2004 (bottom middle) show stronger displacements at the same site as well as hint of displacement further south near Hesthraun (top right). ©ESA.

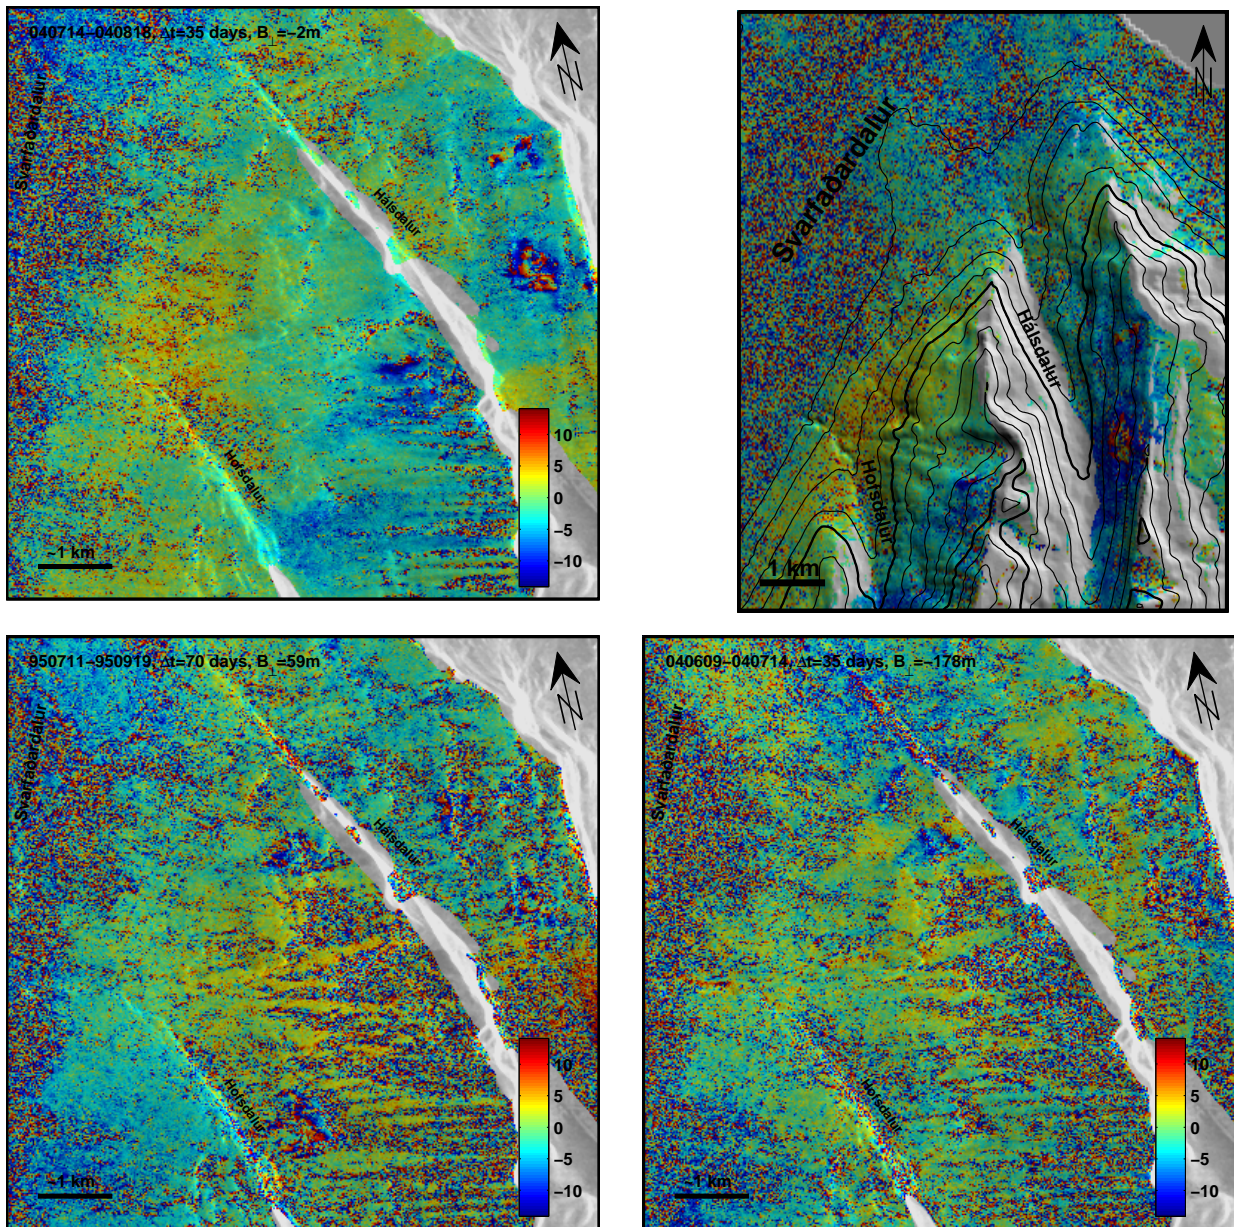
Figure 26. Interferograms of Svarfaðardalur. A 35-day interferogram (July-August, 2004), both in geographic and in radar coordinates (top). Two other interferograms spanning 70 days in 1995 (bottom left) and June-July 2004 show the same area in radar coordinates (bottom). ©ESA.

The shorter-term (35 or 70 day) interferograms show a reasonable degree of coherence at these sites when conditions are snow free, but most inter-annual interferograms are too noisy for extracting useful information about the movement at these sites. The July-August (2004) Envisat interferogram proves here to be the least noisy example, as in many of the other cases in this report, showing a clear displacement signal at one site (possibly two) in Hálsdalur (Figure 26, top left). The same interferogram is also shown in map coordinates to localize where these signals are seen and there one can see that the most prominent landslide motion takes place between 600 and 800 m.a.s.l. The very different appearance between the geocoded interferogram and the one in radar coordinates is in this case a result of the dramatic topography in and around Svarfaðardalur. Two other interferograms hint at displacements in Hólsdalur, although these data sets are more noisy than the one from July-August 2004 (Figure 26). *Jónsson* [1976] describes large deposits near the northern end of Hálsdalur that are called Ripplar. However, the detected displacements in the interferograms do not correspond to the Ripplar site, as movement is found higher and further south.

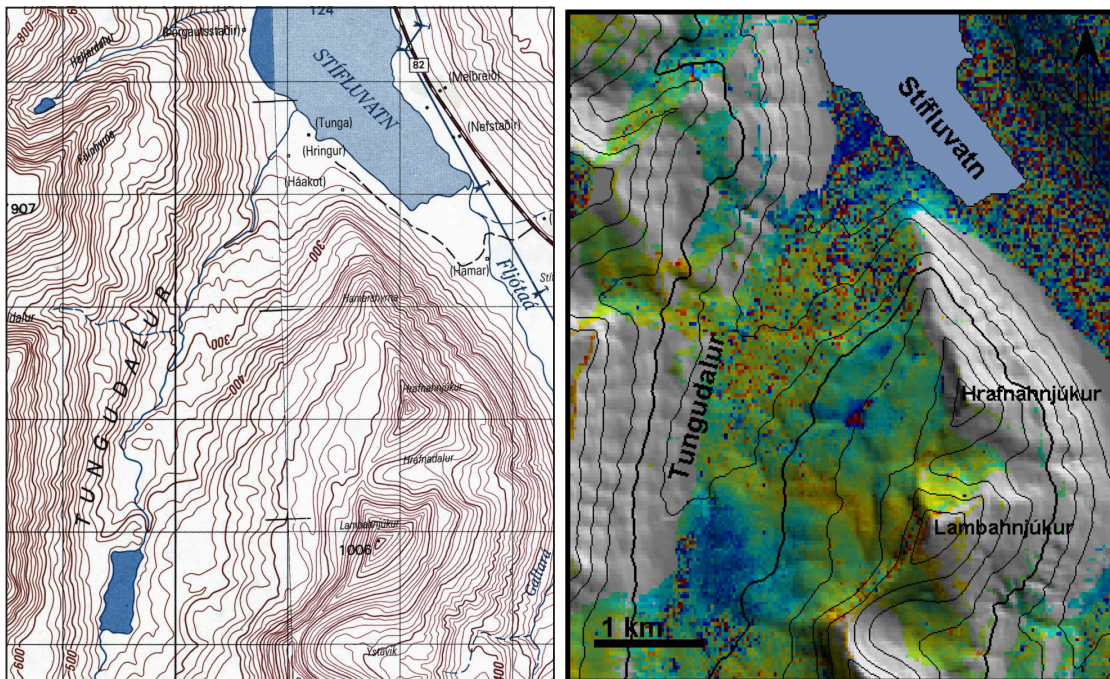
Figure 27. Map and a geocoded interferogram (July-August, 2004) of Tungudalur near Stífluvatn showing deformation below Hrafnahnjúkur at 600 m.a.s.l. The interferogram has 100 m contour lines with the 500 m line displayed thick. ©NLSI and ESA.

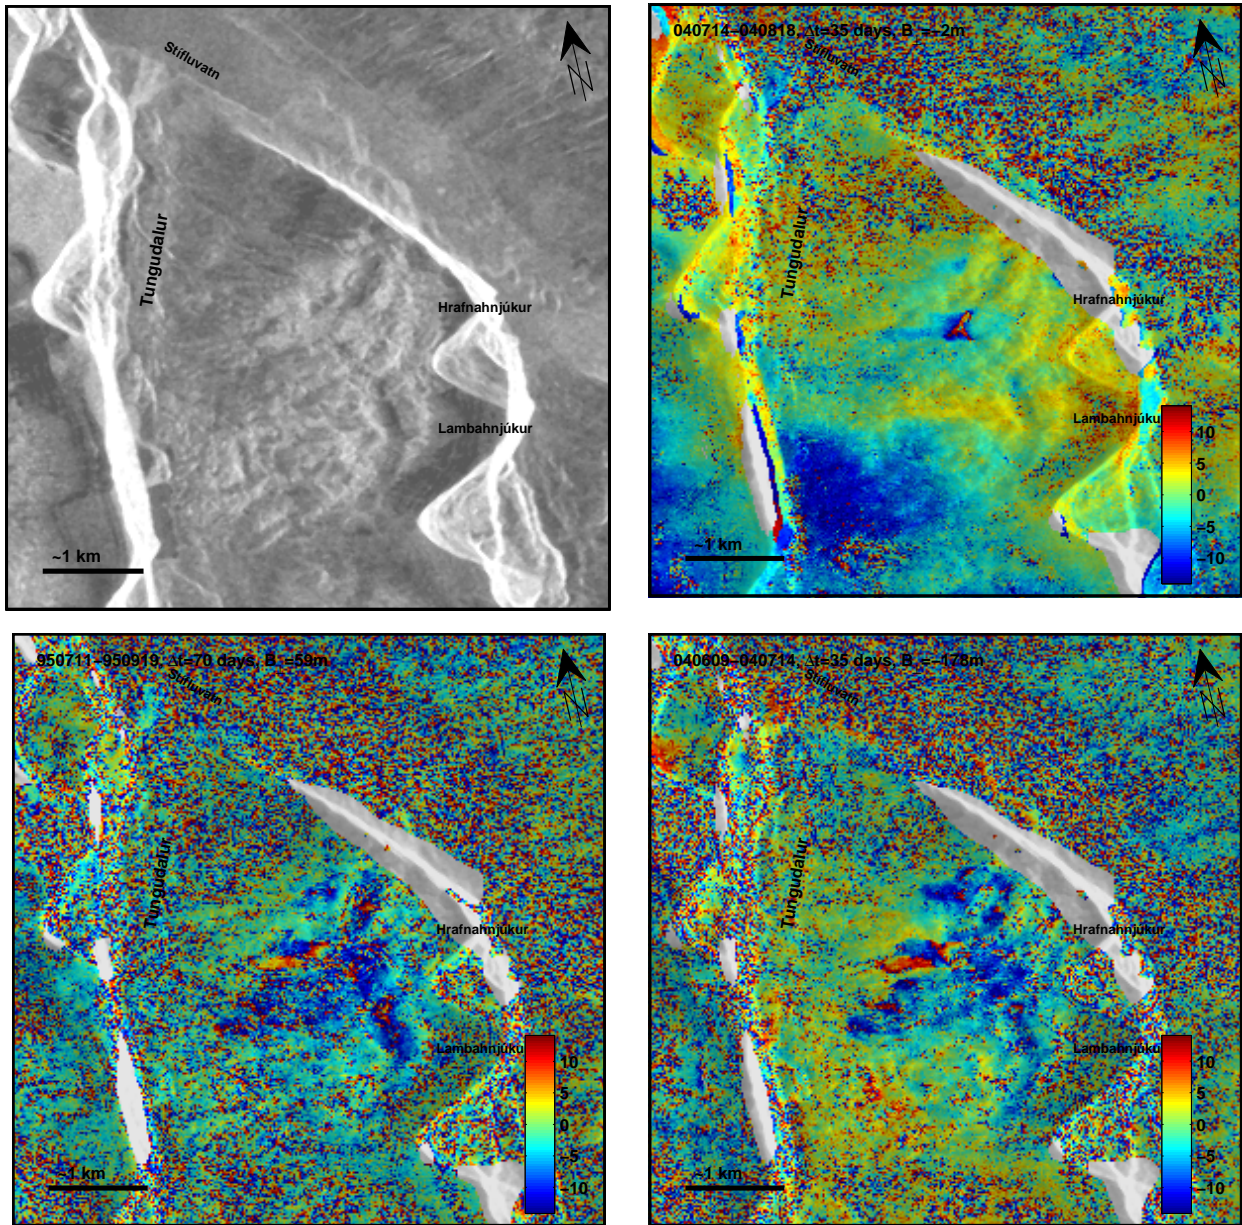
Figure 28. SAR amplitude image and interferograms of Tungudalur. The 35-day interferogram (July-August, 2004) is the same as in Figure 27, except it is here in radar coordinates. Two other interferograms spanning 70 days in 1995 (bottom left) and June-July 2004 (bottom right) show stronger displacements at the same site. ©ESA.

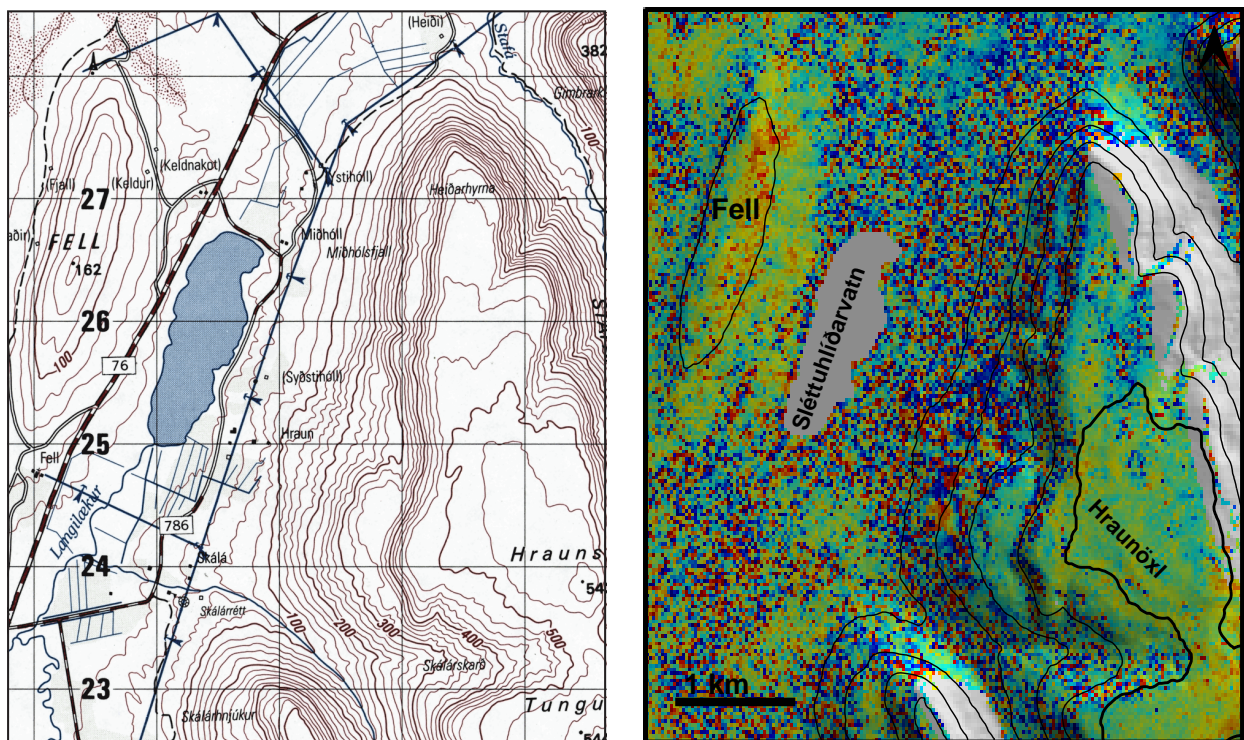
Figure 29. Map and a geocoded one-year interferogram (2004-2005) of Sléttuhlíð. ©NLSI and ESA.

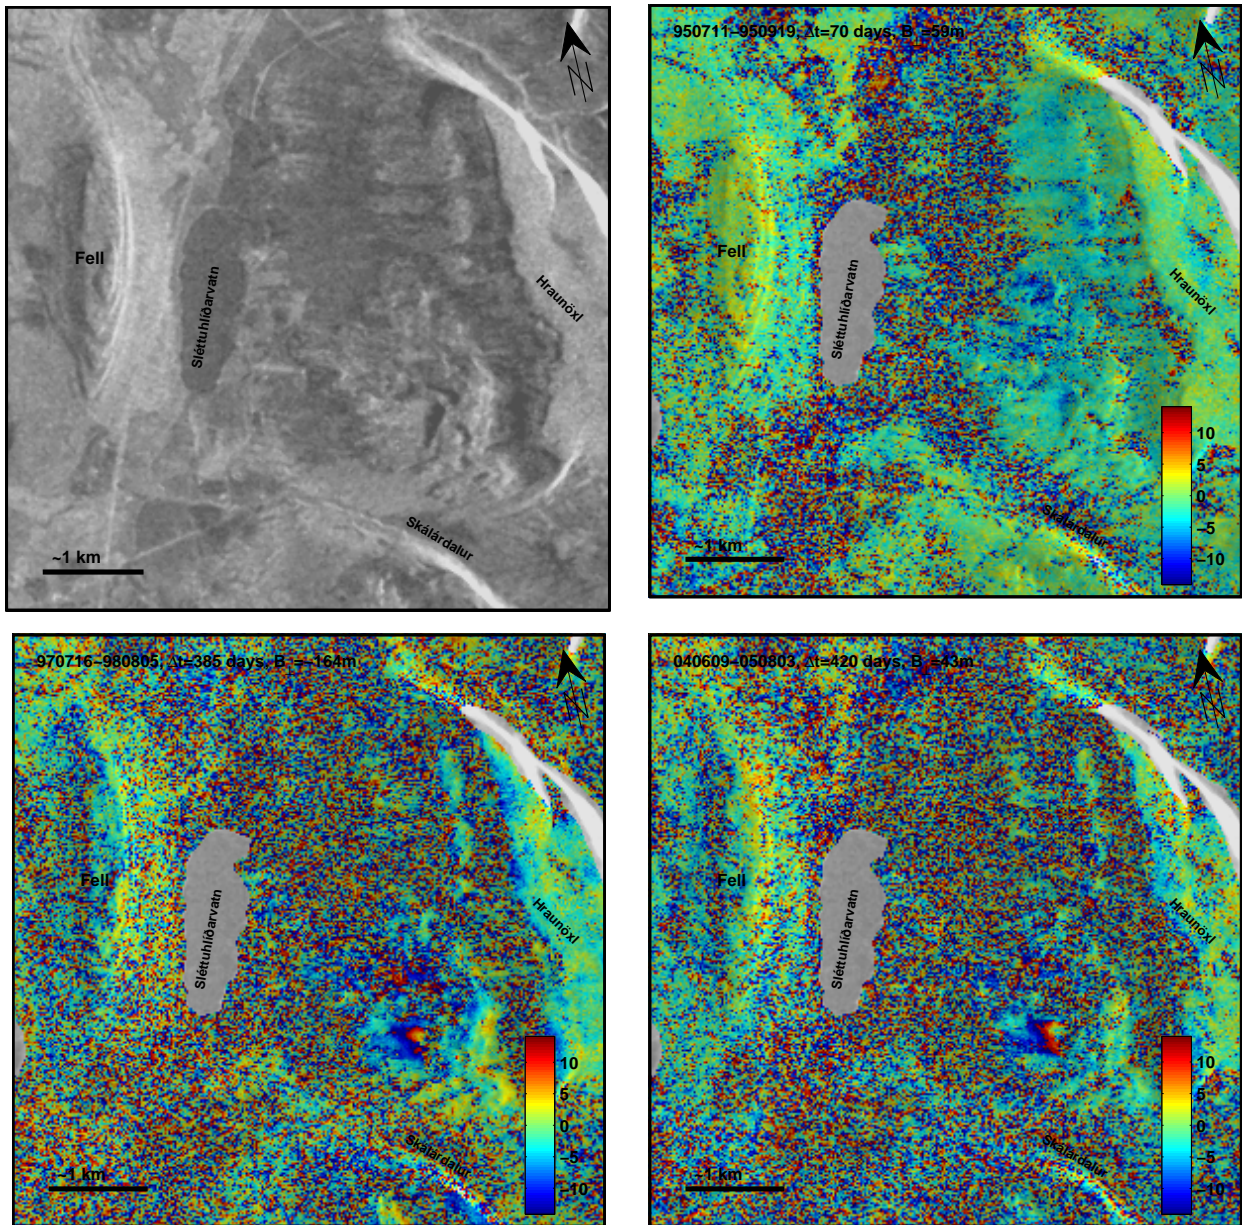
Figure 30. SAR amplitude image and interferograms of Sléttuhlíð in radar coordinates. The 70-day interferogram (July-Sept. 1995, top right) exhibits little or no deformation, while the one year interferograms (bottom) from 1997-1998 and 2004-05 show up to 3 cm of displacements on part of the deposits. ©ESA.

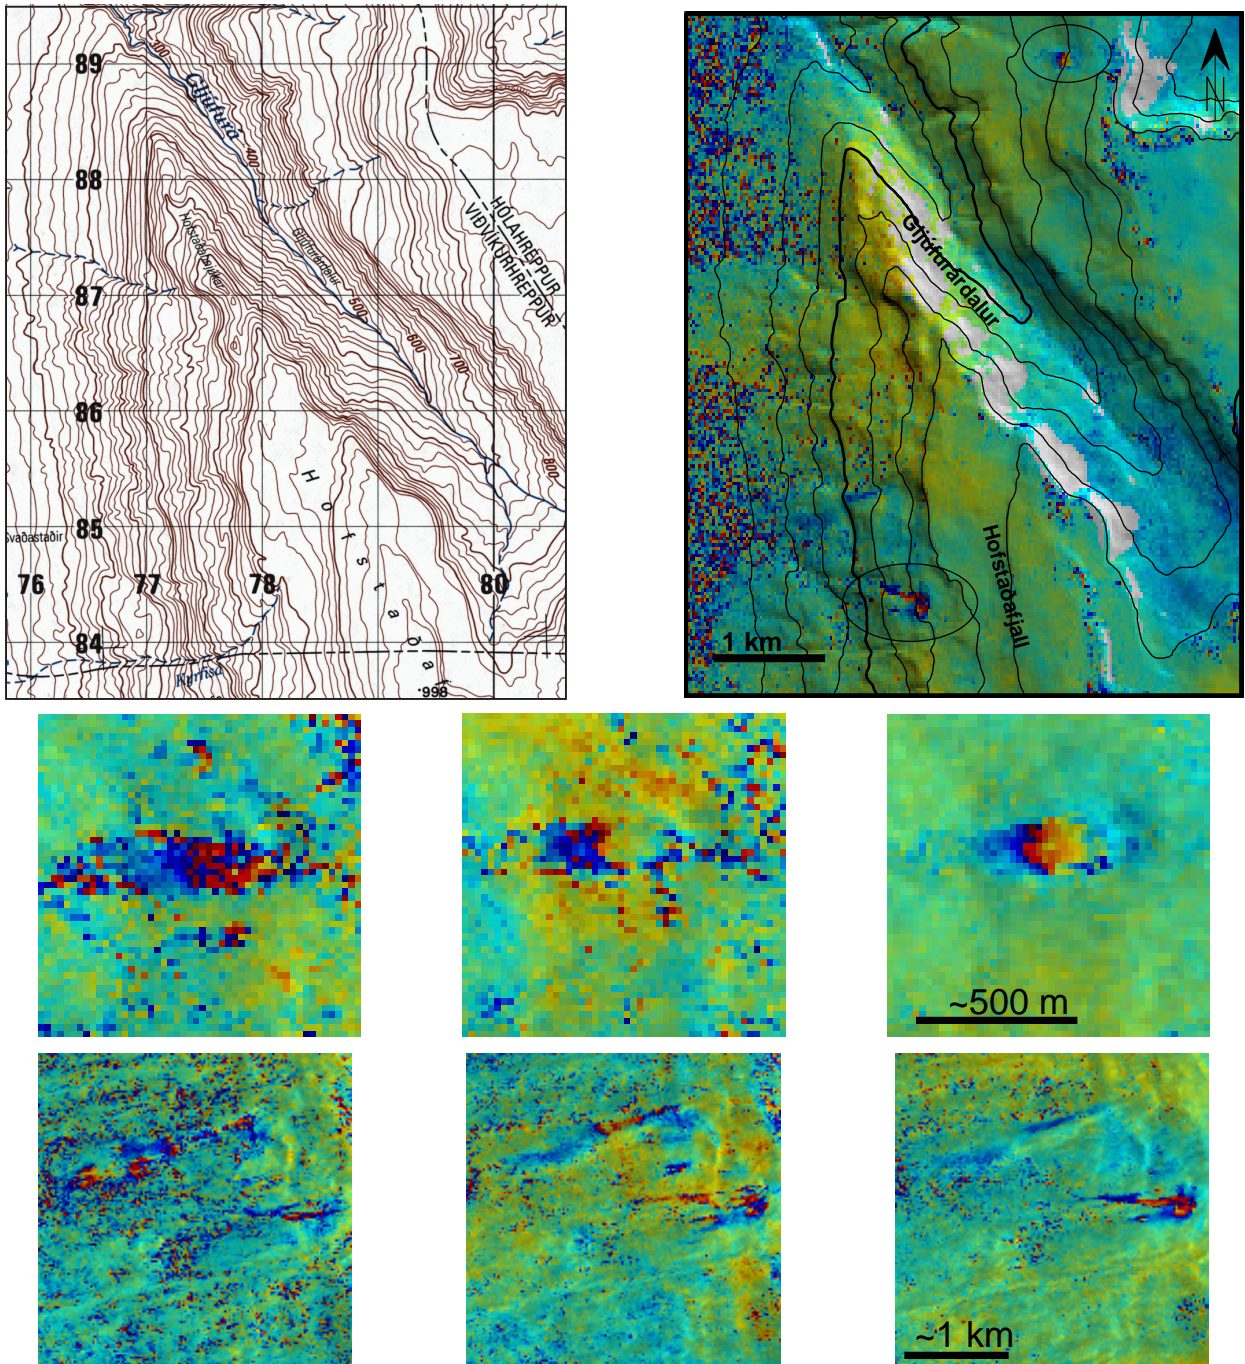
Figure 31. Map and interferograms from Skagafjörður. The map shows a small area around Gljúfurárdalur, at the eastern side of Skagafjörður, just south of Hjaltadalur. The geocoded interferogram (top right) shows two small locations of unrest marked by ellipses. These two sites are to the north and south of Gljúfurárdalur and are shown in close-ups in radar coordinates (middle row and bottom row, respectively) in three different interferogram (July-Sept. 1995, June-July 2004, and July-August 2004). ©NLSI and ESA.

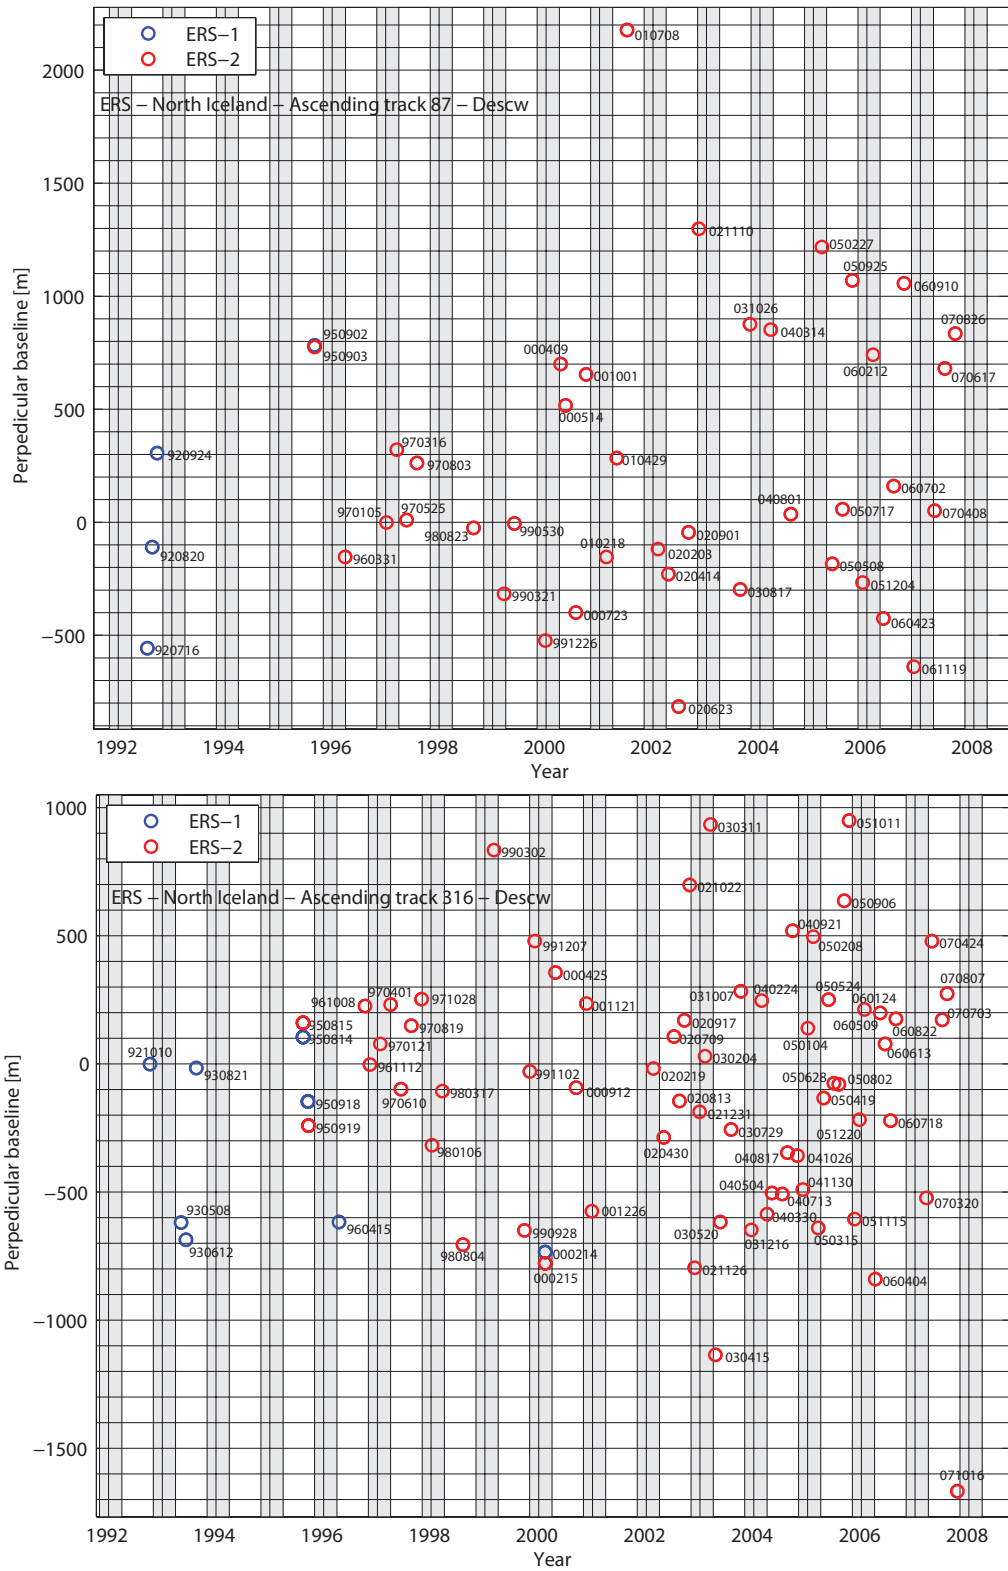
Figure 32. Spatio-Temporal baseline information for ERS-1/2 radar data of Central-North Iceland acquired from ascending tracks 87 and 316. The information was extracted from ESA's Descw database.

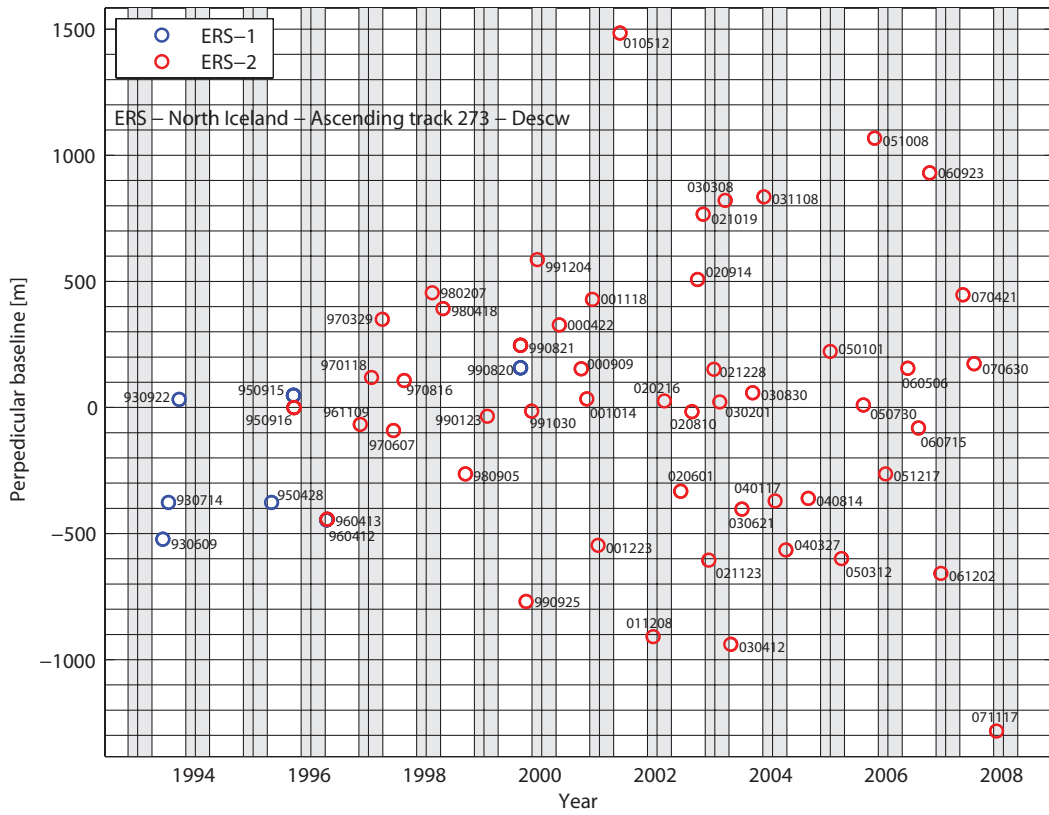
Figure 33. Same as Figure 32, except for ascending tracks 44 and 273.

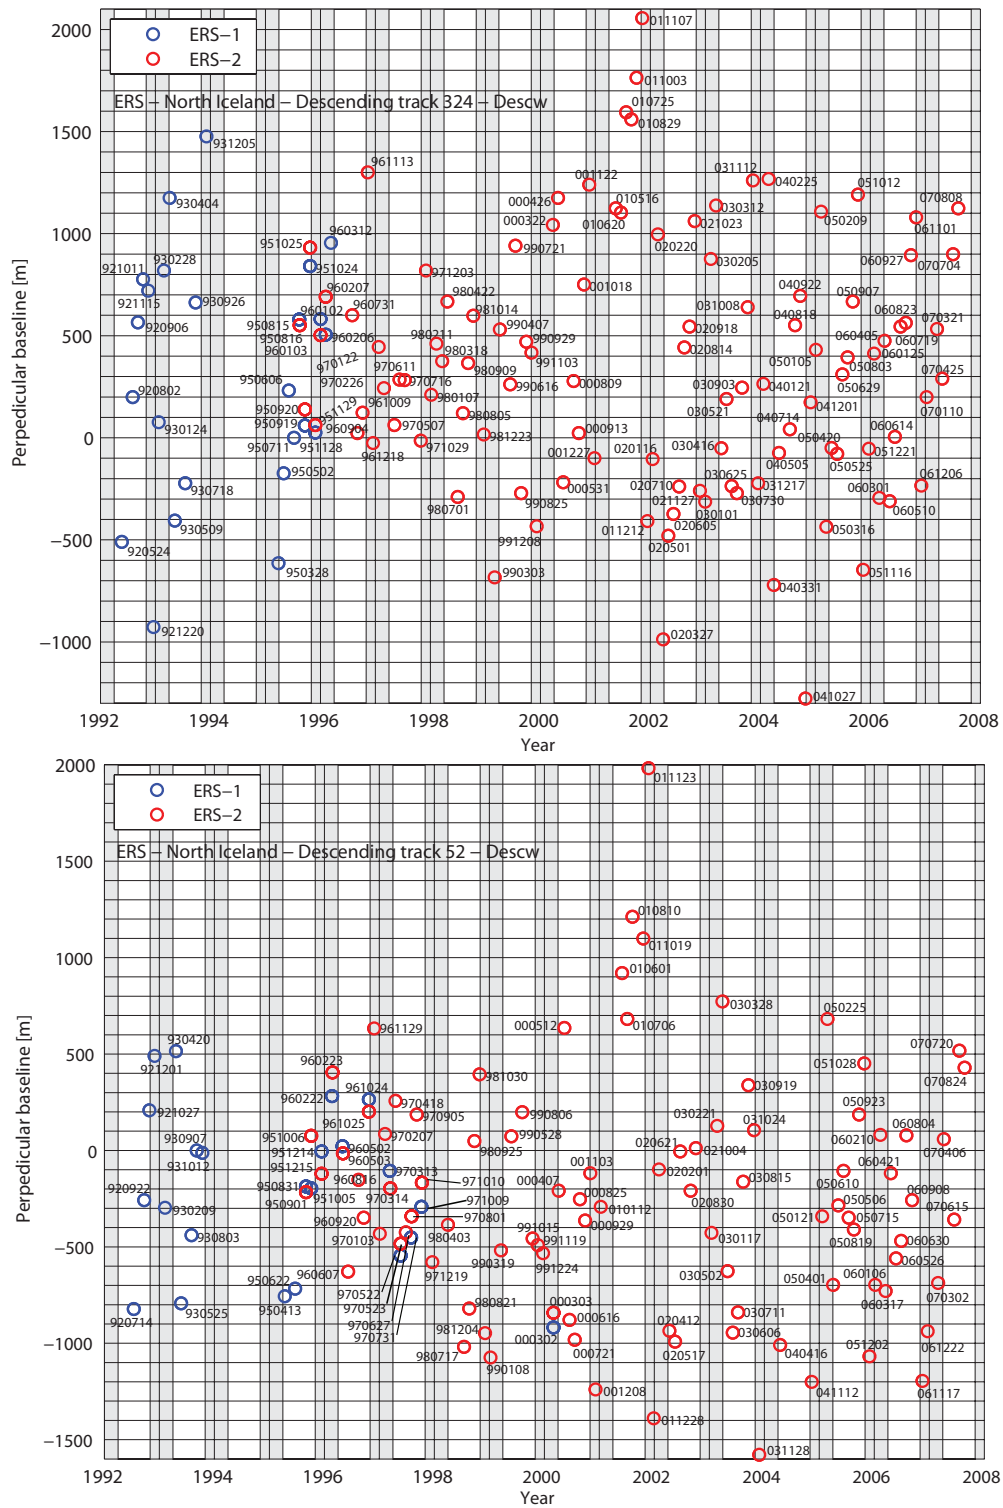
Figure 35. Same as Figure 32, except for descending tracks 324 and 52.

The amount of acquired descending data is larger, especially for tracks 324 and 52 (Figures 34-35). The spatio-temporal baseline distribution indicates that many potentially usable interferograms can be formed using data from any of the four descending tracks. Due to the better spatial coverage of track 324, compared to track 52, data from this track were ordered for this project. The ordered data were acquired mainly during summers of 1995-2000 (Figure 6b), but a few additional scenes were ordered 2002-2003, which turned out to be unusable due to the ERS-2 steering problem. The data were selected based on acquisition date (summer) and the possibility to combine multi-month and multi-year scenes with a relatively small perpendicular baseline (<200 m) due to the steep topography in North Iceland. In addition, two one-day tandem pairs (one ascending and one descending) were ordered to generate a high-resolution DEM of the area. However, in the end a 25 m DEM of North Iceland was used in the data processing. From the descending images I generated 12 interferograms with variable perpendicular baselines from 10 m to 400 m and with temporal baselines from one day to two years (Figure 6b).

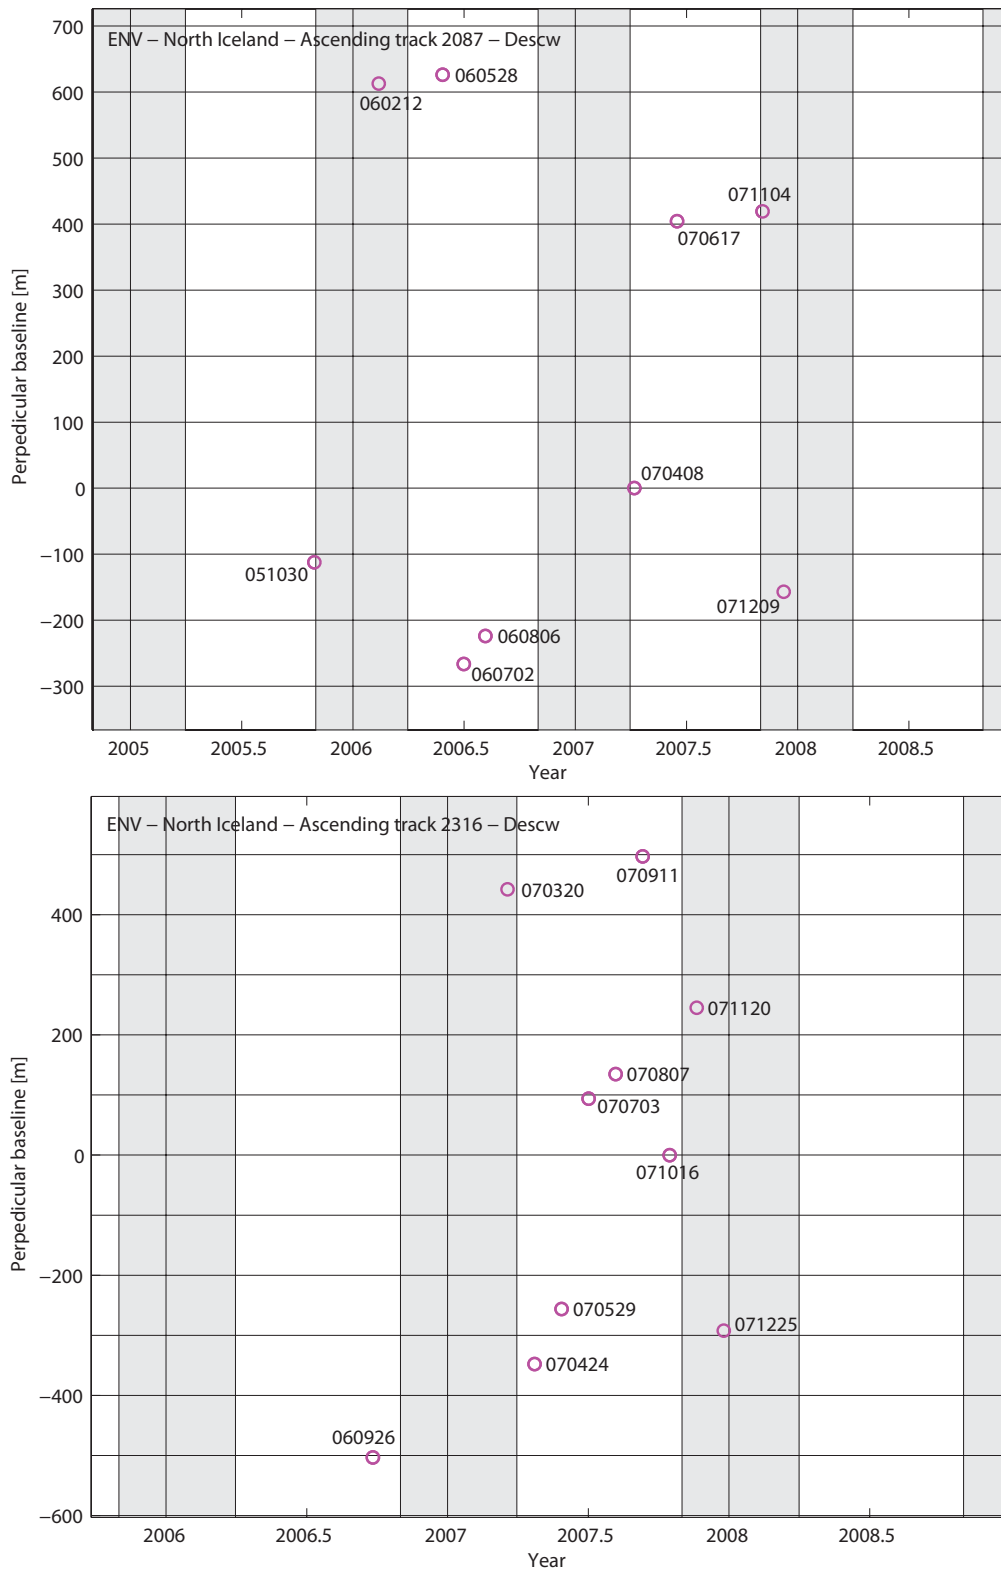
Figure 36. Spatio-Temporal baseline information for Envisat radar data of Central-North Iceland acquired from ascending tracks 2087 and 2316, mode IS-2. The information was extracted from ESA's Descw database.
