A Survey of Active Slope Movements in Central-North Iceland from Satellite Radar Interferometry

Sigurjón Jónsson, ETH Zürich

Skýrsla nr.: VÍ 2009-002	Dags.: Júní 2009	Dreifing: Opin <input checked="" type="checkbox"/> Lokuð <input type="checkbox"/>
		Skilmálar:
Heiti skýrslu / Aðal- og undirtitill: A survey of active slope movements in Central-North Iceland from satellite radar interferometry		Upplag: 26
		Fjöldi síðna: 78
Höfundar: Sigurjón Jónsson, ETH Zürich		Verkefnisstjóri: Þórður Arason
Gerð skýrslu/Verkstig: Lokaskýrsla		Verknúmer: 2341-0-0002
Unnið fyrir: Ofanflóðasjóð		
Samvinnuaðilar:		
Útdráttur: Lýst er könnun á notagildi bylgjuvíxlmælinga úr ratsjargervitunglum til að mæla örliðlar hreyfingar á lausum jarðefnum í fjallshlíðum, sem geta verið aðdragandi skriðufalla. Aðferðin hentar vel til að kortleggja virkar skriður í heilum landshlutum og finna a.m.k. 100–200 m stór svæði í fjallshlíðum sem hníga fram um 1–5 cm/ári. Fjallað er um mælingar á slíkum hreyfingum í fjallshlíðum á Mið-Norðurlandi. Höfundur hefur áður gefið út niðurstöður svipaðrar rannsóknar fyrir Austurland í greinargerð Veðurstofunnar 07004.

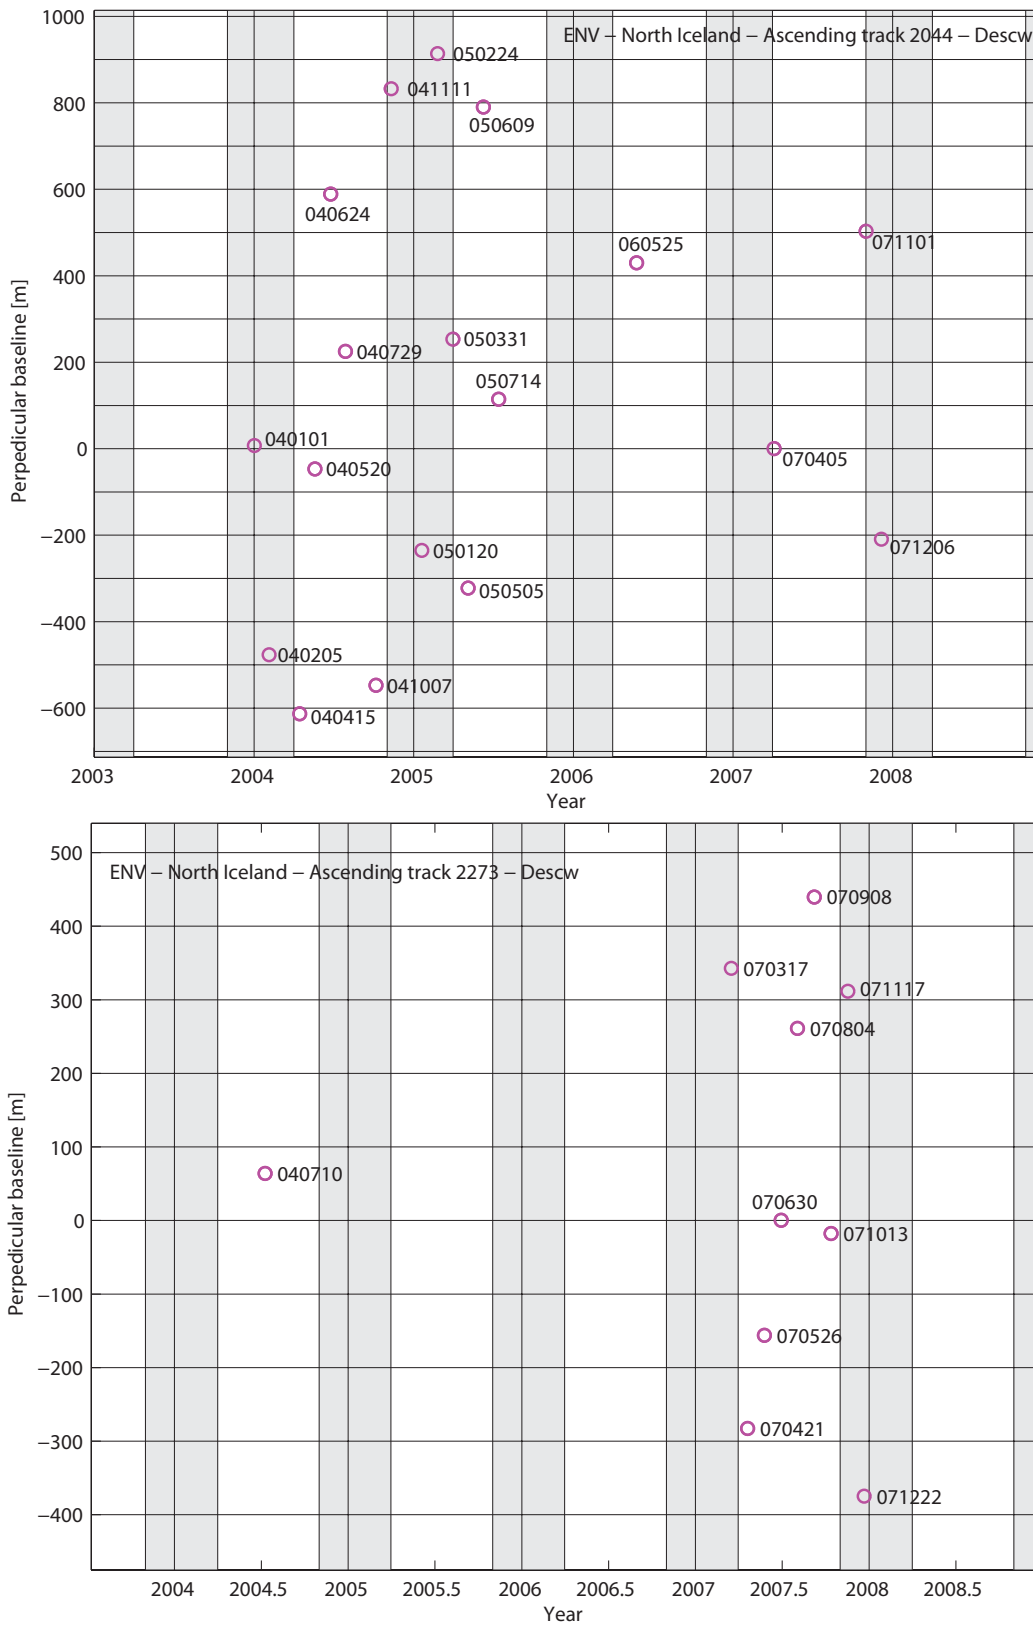
Figure 37. Same as Figure 36, except for ascending tracks 2044 and 2273.

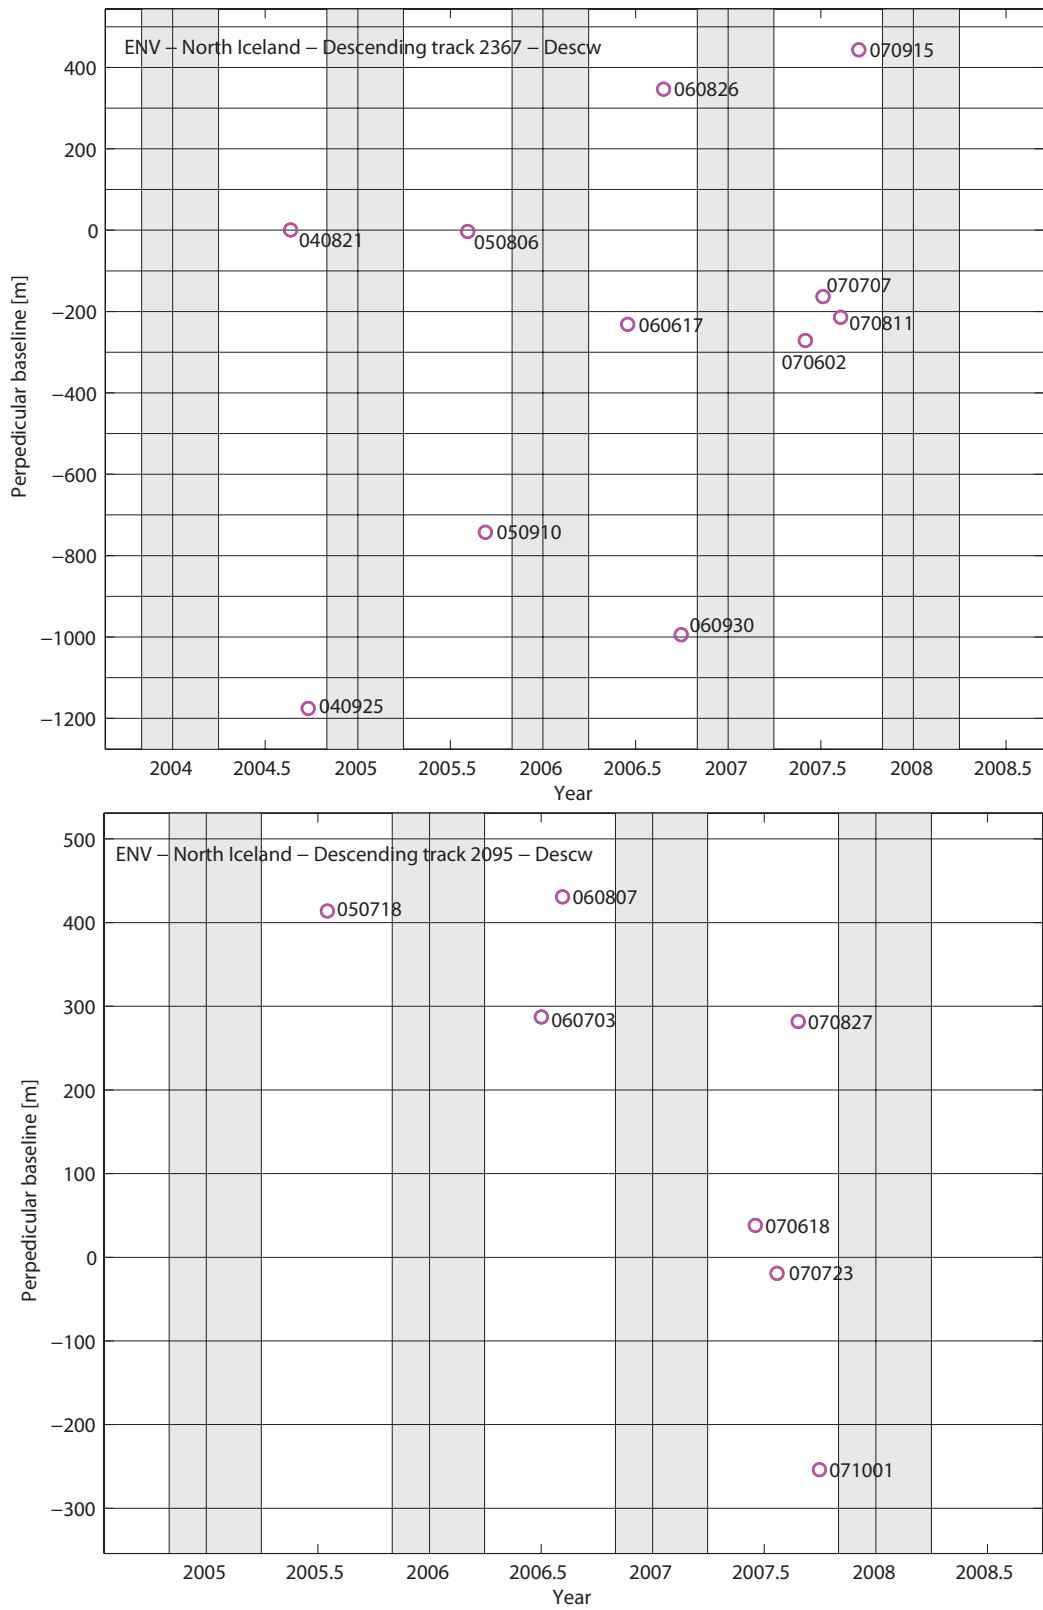
Figure 38. Same as Figure 36, except for descending tracks 2367 and 2095.

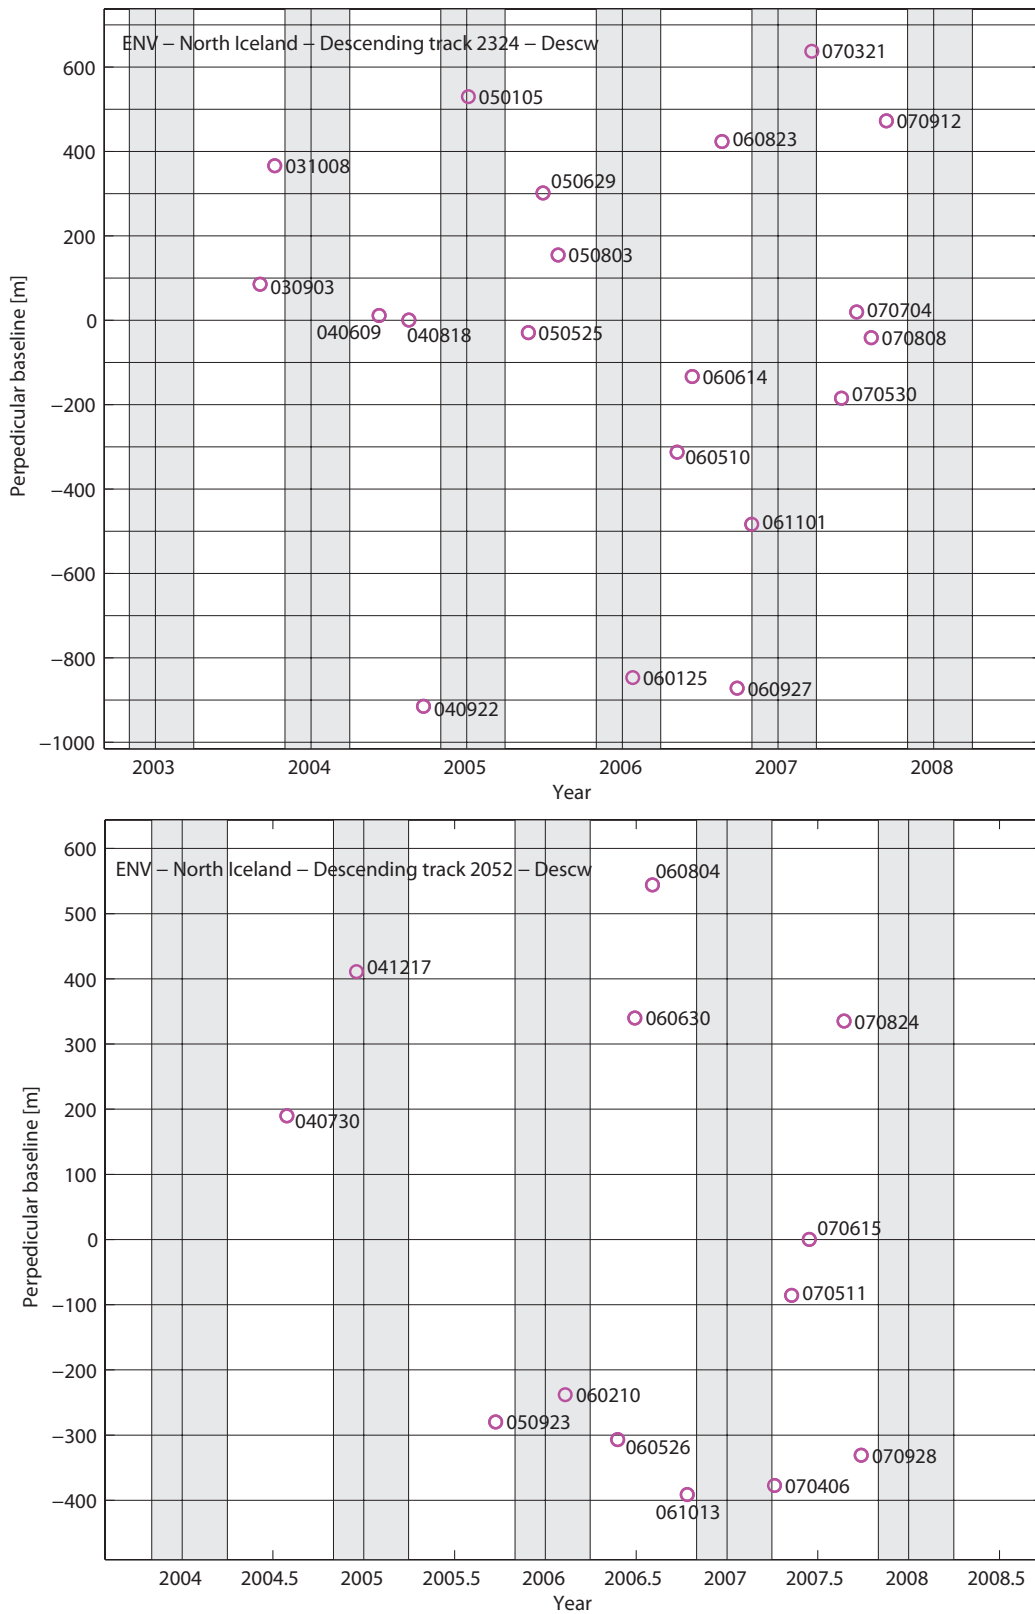
Figure 39. Same as Figure 36, except for descending tracks 2324 and 2052.
