Hazard zoning for Siglufjörður

Technical report

VÍ-ÚR11
Reykjavík
December 2001

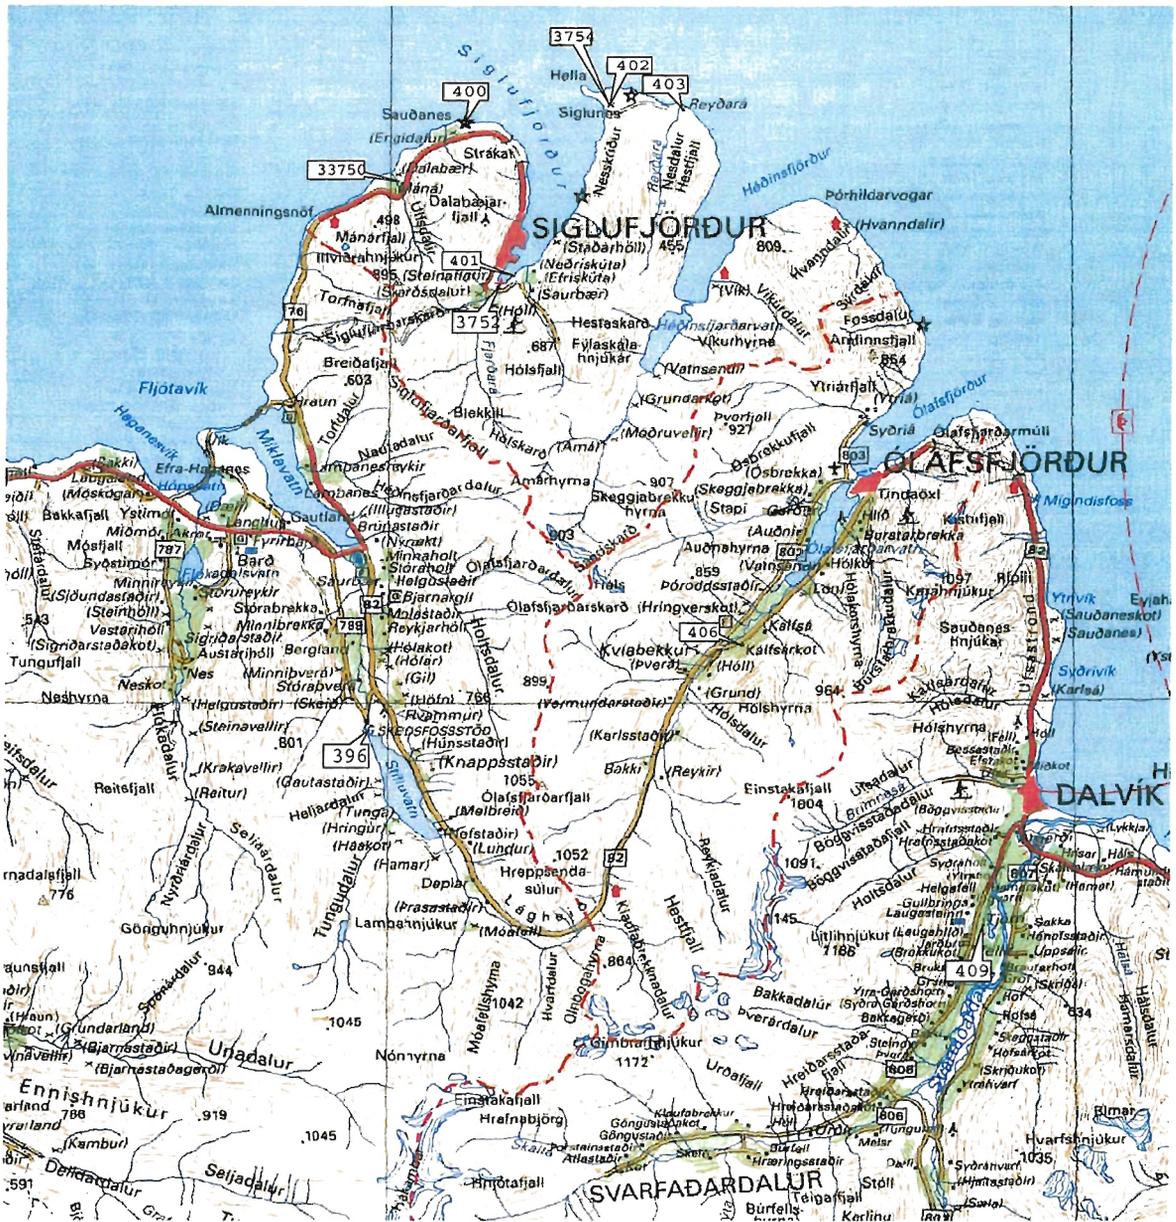
Figure 1. An overview of the area around Siglufjörður with the locations of meteorological stations indicated. © The National Land Survey of Iceland.

observations at these two stations. Since 1995 automatic weather stations have been operated at Siglunes, Siglufjörður and by Siglufjarðarvegur (the road between Siglufjörður and Skagafjörður). Since 1990 synoptic observations have been carried out at Sauðanesviti, which is the only station in the area where present weather is observed. In addition several stations close to Siglufjörður record precipitation and snow depth. These are Skeiðsfoss in Fljót, Kálfsárkot in Ólafsfjörður and Tjörn in Svarfaðardalur. The manual observations of precipitation in Siglufjörður were replaced by an automatic precipitation recorder in 1995. The location of these stations is shown in Figure 1.

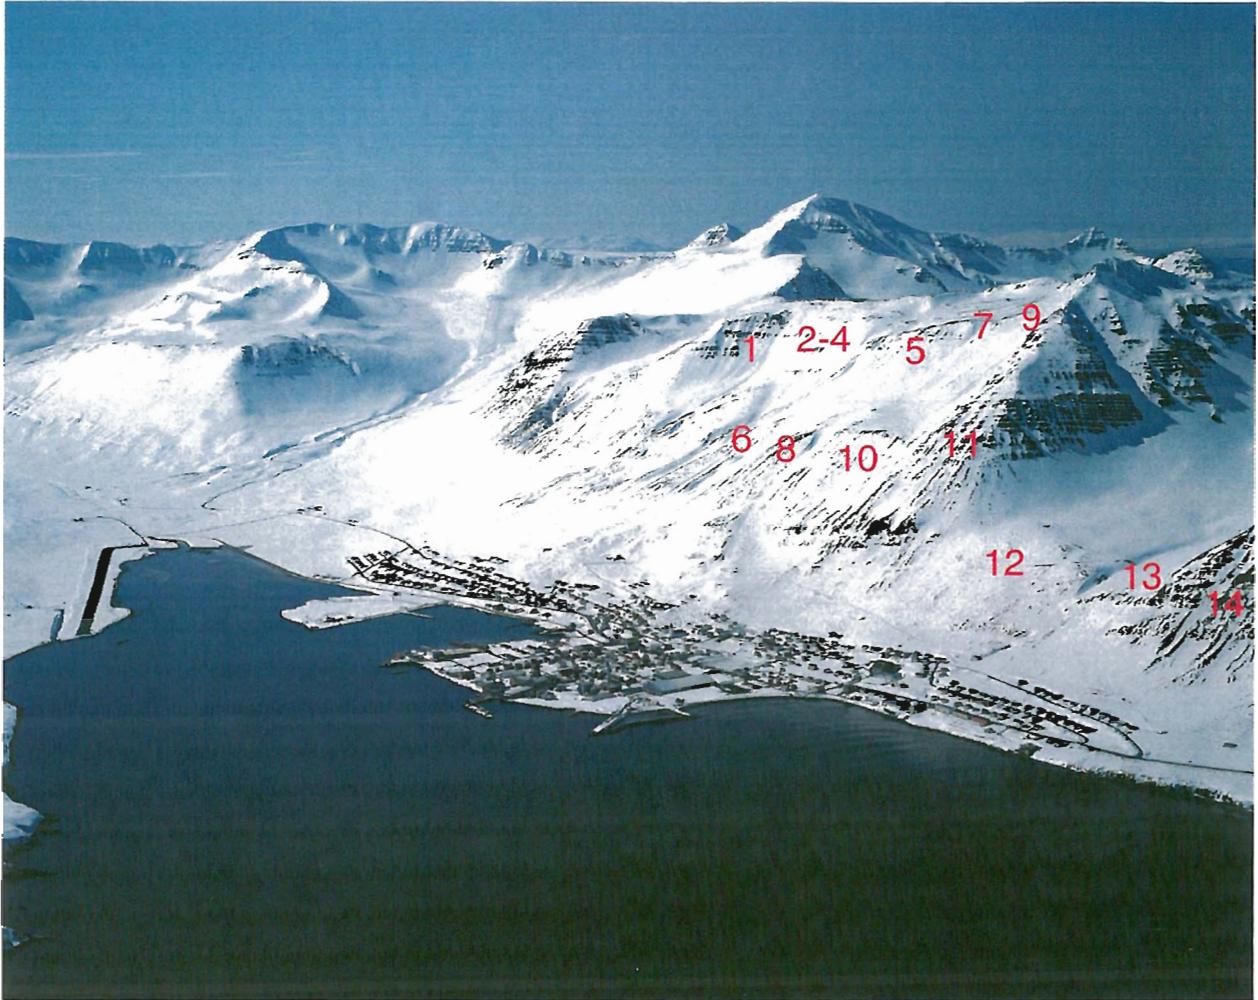
Figure 3. *View from north east of the avalanche paths above Siglufjörður. The red numbers indicate the approximate location of starting areas that were delineated during field investigation (see Map 4) (Photo: Mats Wibe Lund).*

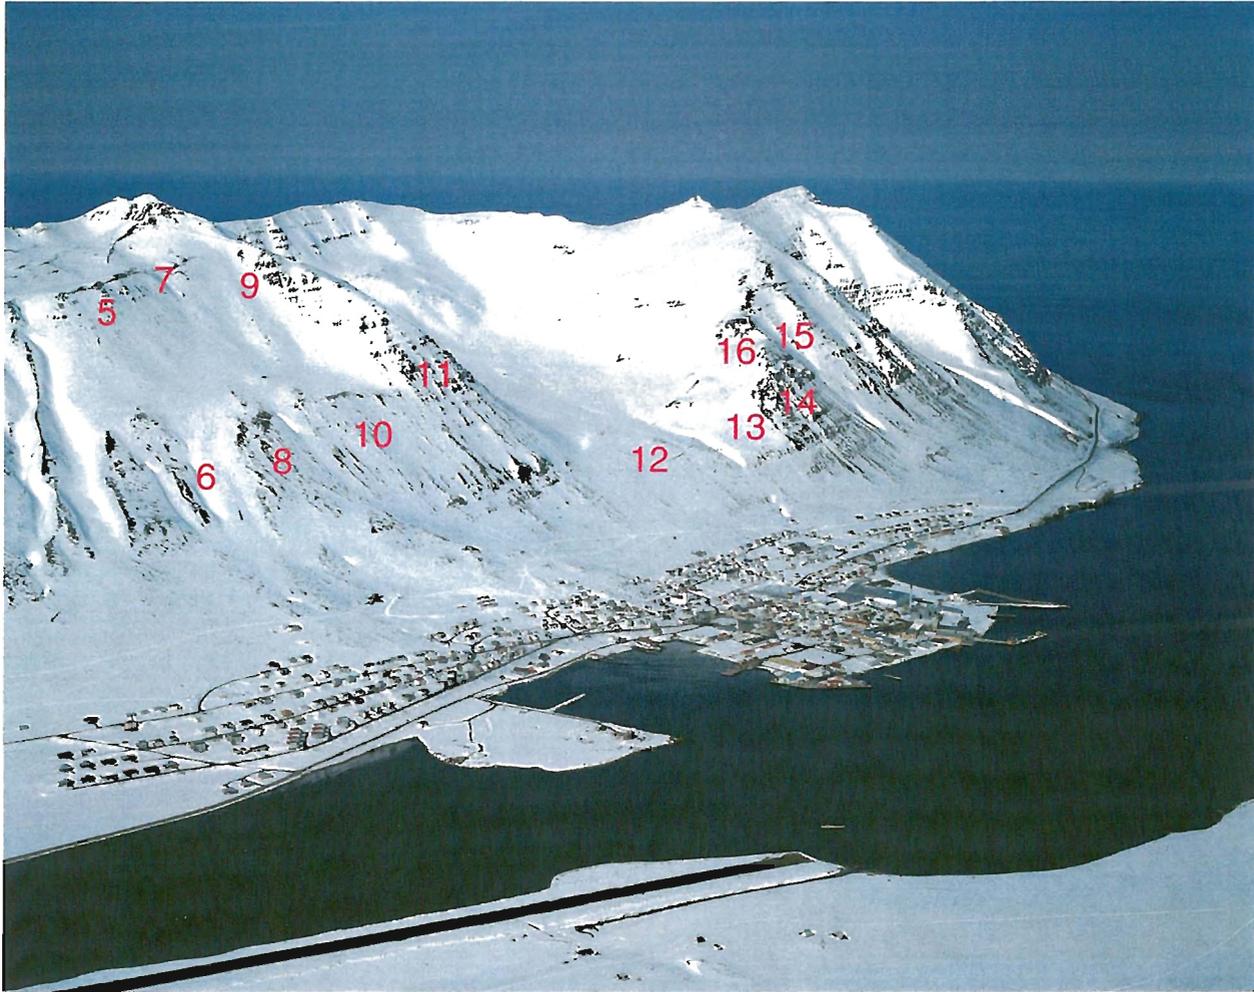
Figure 4. View from south east of the avalanche paths above Siglufjörður. The red numbers indicate the approximate location of starting areas that were delineated during field investigation (see Map 4) (Photo: Mats Wibe Lund).
