Þorsteinn Arnalds  
Siegfried Sauermoser  
Tómas Jóhannesson  
Esther Jensen

## Hazard zoning for Eskifjörður

This report describes the results of a project carried out by the Icelandic Meteorological Office (IMO) with the aim to evaluate avalanche, debris flow and rockfall hazard in Eskifjörður. The result is a hazard zoning proposal for Eskifjörður based on the current Icelandic hazard zoning regulation.

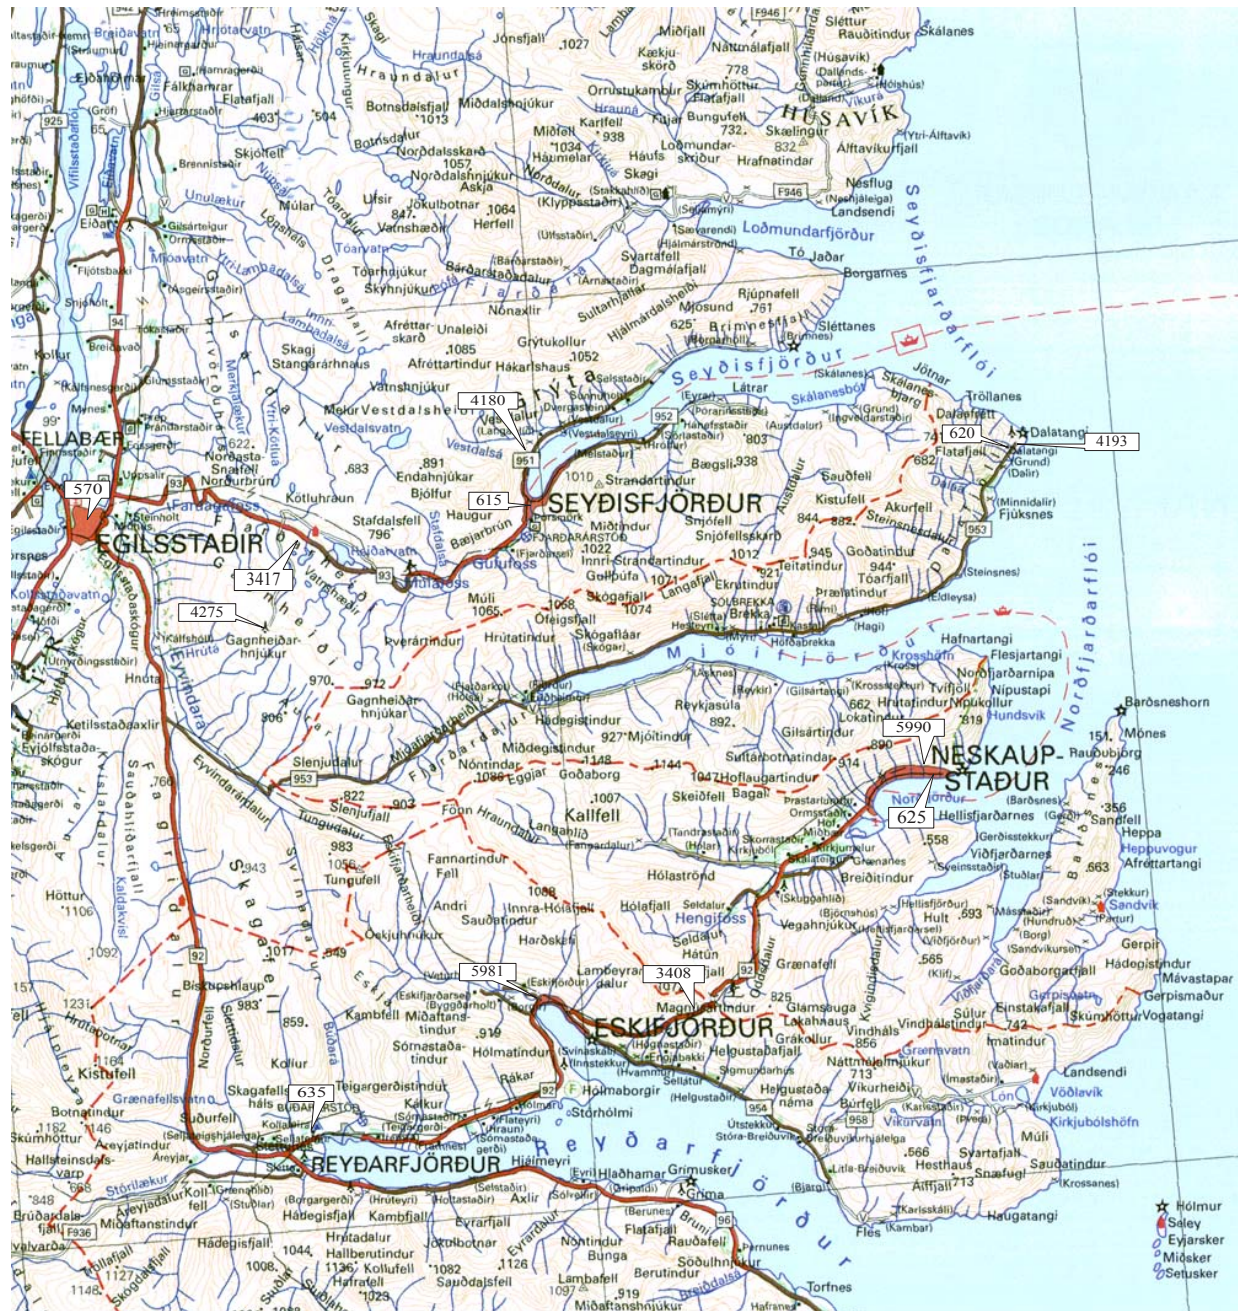
**Figure 1.** An overview of the area around Eskifjörður with the locations of meteorological stations indicated. © The National Land Survey of Iceland.

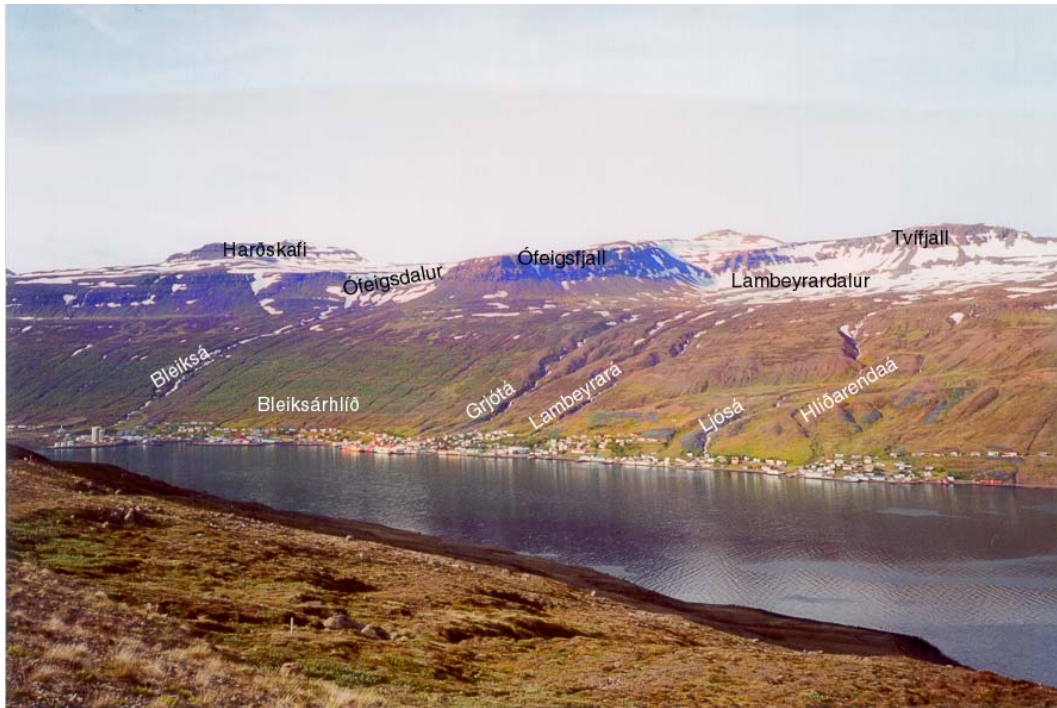
**Figure 2.** *Eskifjörður and the names of main landmarks. (Photo: Esther H. Jensen).*
