1 Introduction

This report is an assessment of avalanche hazard for the village Patreksfjörður which is within the community of Vesturbyggð. It was carried out by the Icelandic Meteorological Office (IMO). The assessment is done according to a regulation on hazard zoning due to avalanches and landslides, classifications and utilization of hazard zones, and preparation of provisional hazard zoning issued by the Ministry for the Environment in July 2000.

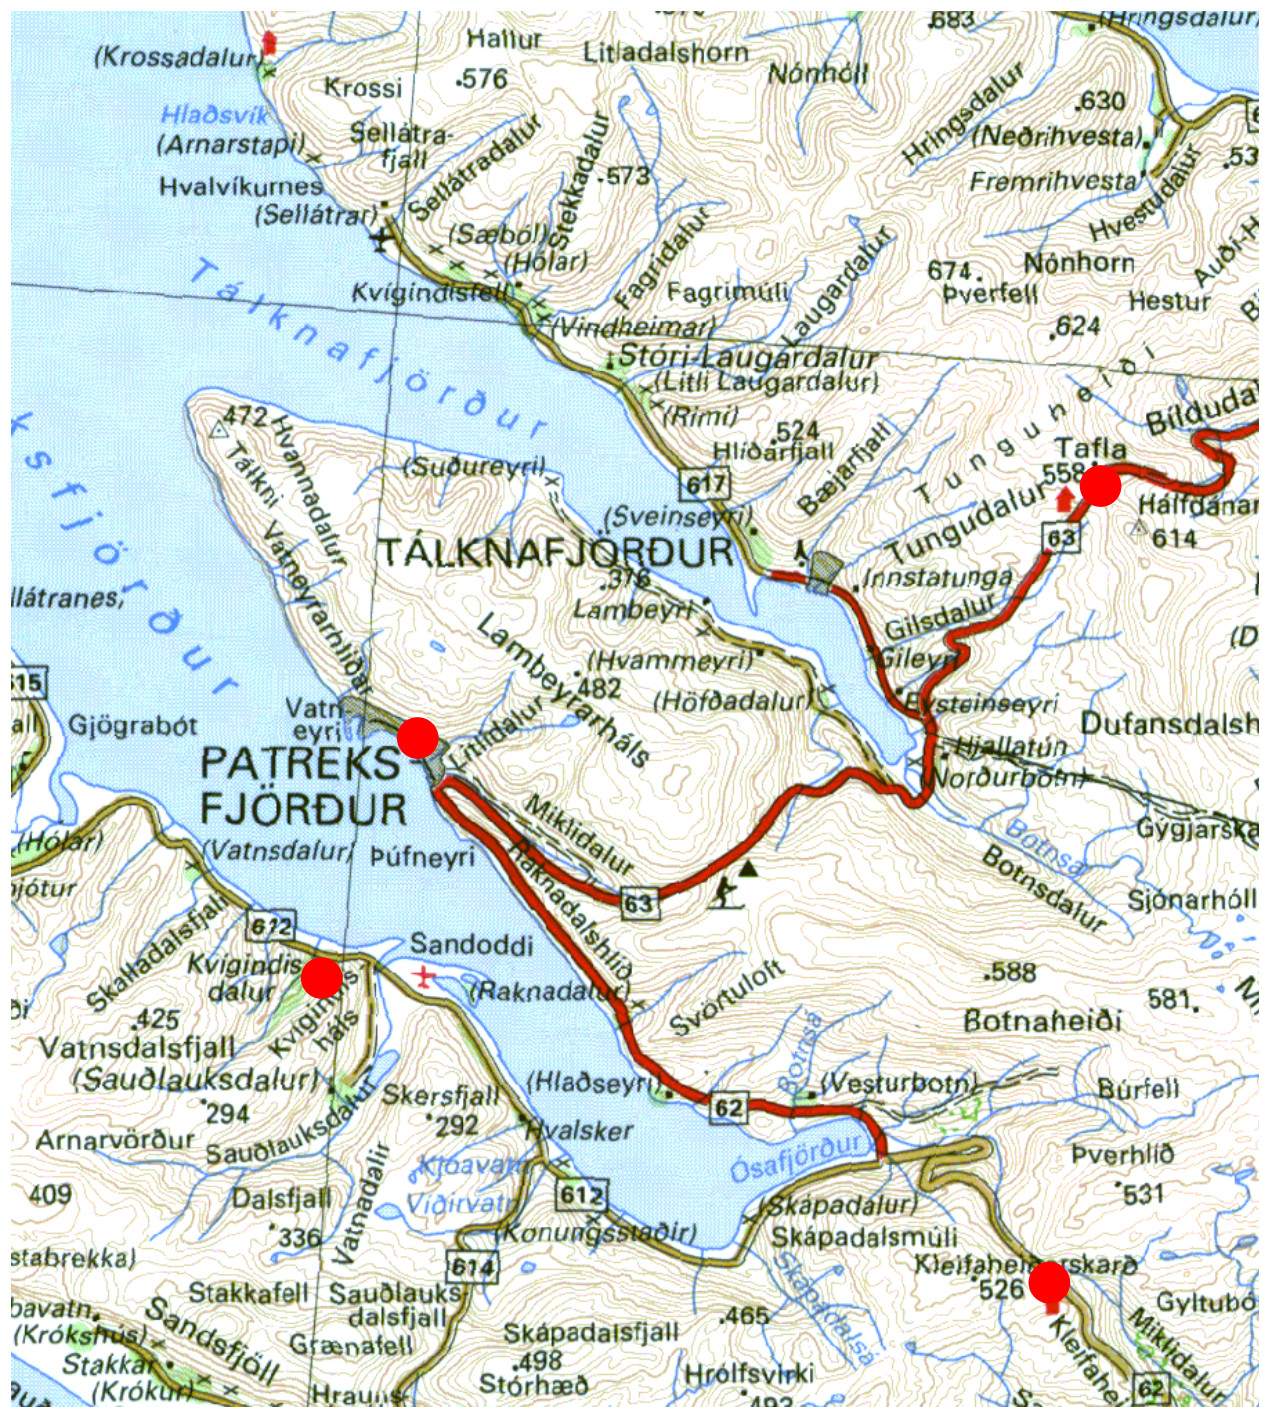
Figure 1. Overview of the area around Patreksfjörður. Meteorological stations are marked with red circles. © The National Land Survey of Iceland.

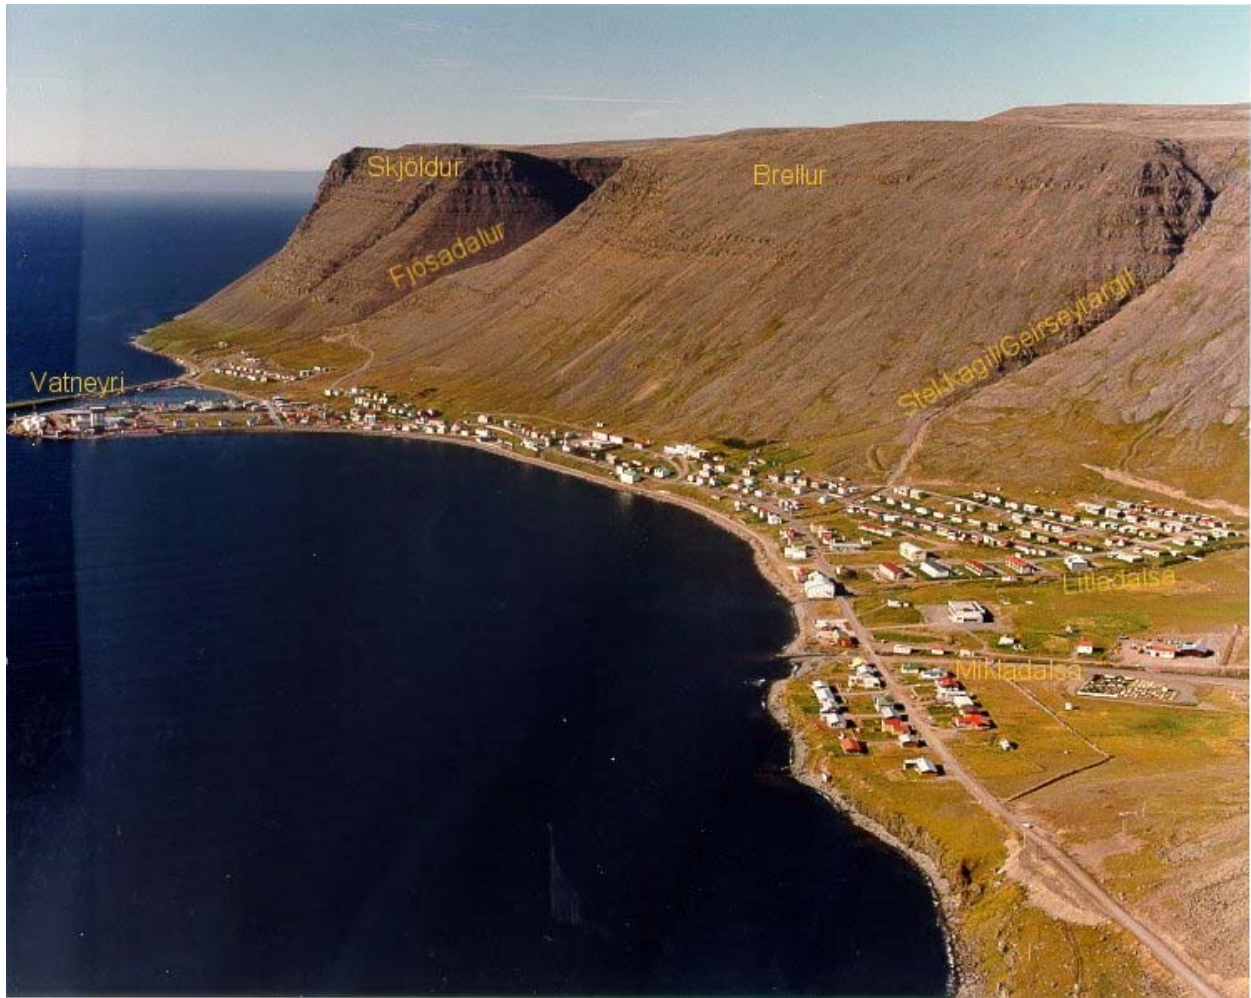
Figure 2. *Patreksfjörður and the name of the main landmarks. (Photo: © Mats Wibe Lund).*

Patreksfjörður is a fjord on the southern part of the NW-peninsula of Iceland and this large peninsula is called Vestfirir. The village of Patreksfjörður is located on the northern shore of the fjord (see Map 1 and Figures 1 and 2) which opens to NW. This shore is mainly continuous mountainside leaving little or no lowland along the coast. The largest valleys that cut the mountainside in the vicinity of the settlement are Litli- and Miklidalur. Litlidalur has an E-W trend and Miklidalur NW-SE trend parallel to the fjord and opens into Litlidalur. The northernmost part of the mountain between Miklidalur and the fjord is Geirseyrarmáli. The area at the coast where the valleys open to the fjord is called Geirseyri. About 1 km outwards (NW) of Geirseyri there is a small peninsula, Vatneyri. Just outwards of Vatneyri there is a little valley, Fjúsadalur. The mountain between Fjúsadalur and Litlidalur is named Brellur.

The main part of the settlement is located below the mountain Brellur, from the outer part of Vatneyri to the river Litladals. Further, a quarter of domestic houses named Björg is located SW of Mikladals and NW of the mountain Geirseyrarmáli.

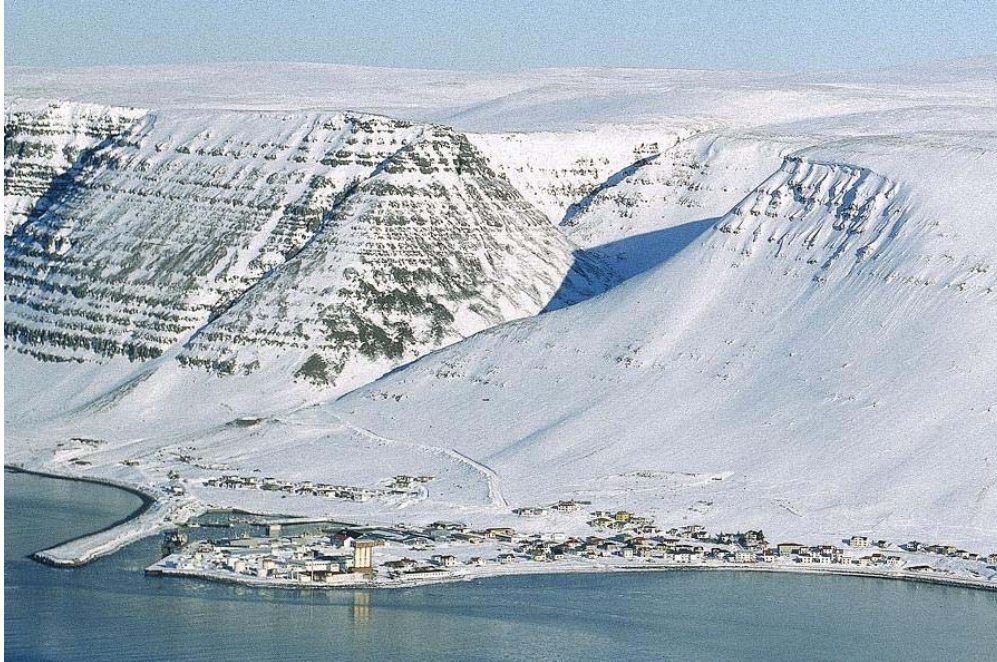
Figure 3. *Vatneyri* (Photo: © Mats Wibe Lund).

The area above Vatneyri can be divided into two subareas. The outer one is below the rim of Fjúsadalur and the inner one is the area of Urðir and the bowl above it.

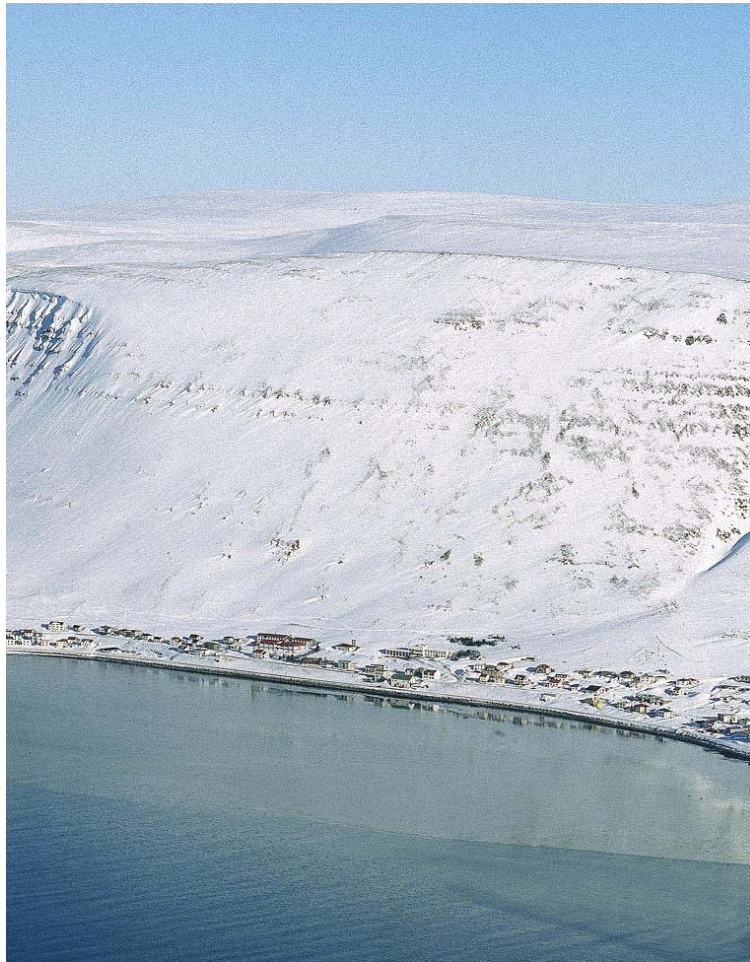
Figure 4. *Klif* (Photo: © Mats Wibe Lund).

The area between Urðir and Geirseyrargil is called Klif in this report. It is divided into two main parts. In the outer part one large starting area is delineated (Area no. 3 on Map 3) while two smaller areas are in the inner part (Areas no. 4 and 5 on Map 3).

The overall shape of the mountainside is convex but the potential starting areas are below the edge of the mountain Brellur where there are slight depressions in the mountainside.
