Longyearbyen Svalbard – Mitigation Measures for Sukkertoppen and Vannledningsdalen

Árni Jónsson^{1*}, Kalle Kronholm², Lars Eid Nielsen², Eiður P. Birgisson³

ABSTRACT

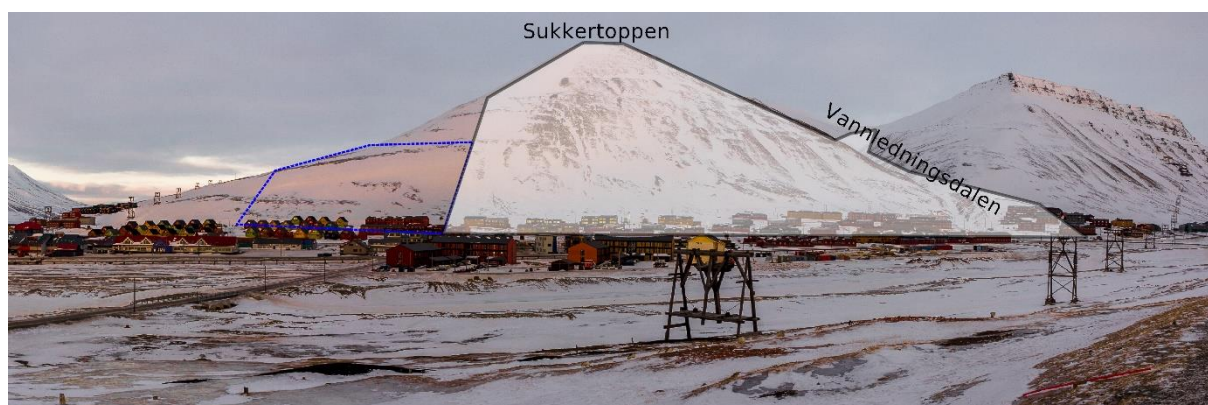
Figure 1. Overview over the habitation below Sukkertoppen mountain and on the delta below Vannledningsdalen. Black polygon boundary depicts the area that poses threat to the people and buildings in the runout zone. Blue dotted polygon to the left of Sukkertoppen depicts the area protected in 2018.

This project describes an ongoing mitigation work for the area below Sukkertoppen mountain Longyearbyen, see Figure 1. The client is The Norwegian Water Resources and Energy Directorate (NVE) on behalf of Longyearbyen lokalstyre (LL) and the main work is carried out by HMIT consulting Iceland, Skred AS Norway and the geotechnical consultant Rambøll Norge AS. Information in this article is based on a report from the first phase of the hazard assessment and the preliminary phase of the mitigation work (Jónsson et al., 2018a).

The second phase of the mitigation work was initiated in 2018 when NVE engaged consultants to work out a plan for mitigation measures for the area from town centre to Vannledningsdalen, see Figure 1. A preliminary report with various mitigation combinations and hazard zoning was delivered in December 2018 (Jonsson et al., 2018a).

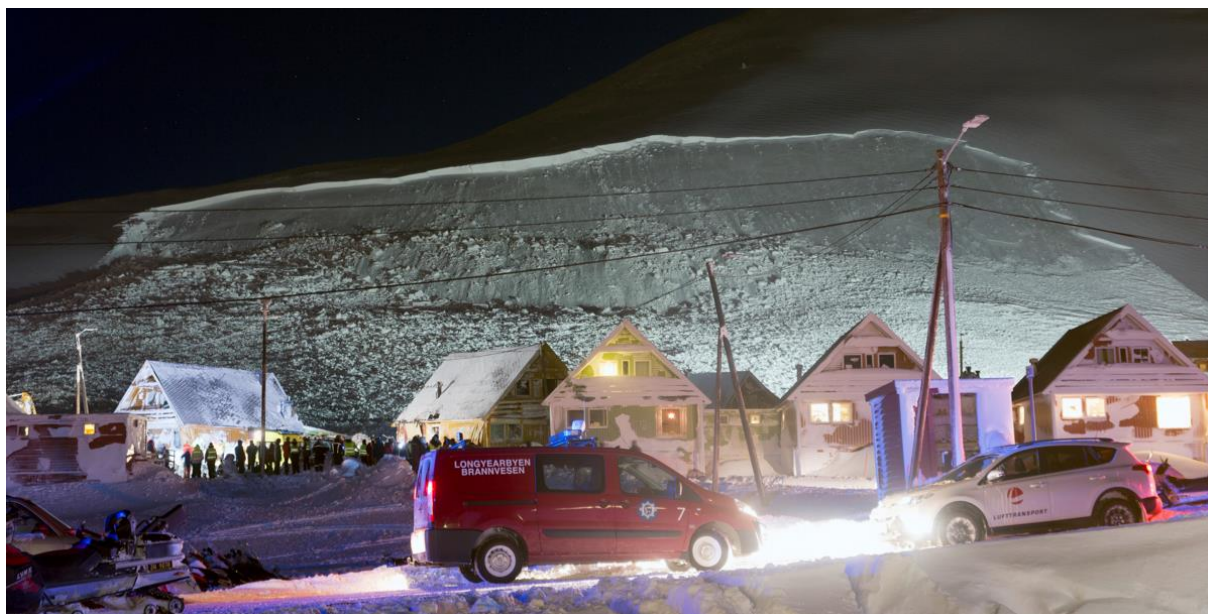
Figure 3. The avalanche site during rescue operation in December 2015. This photo is one of the best information on snow conditions in Lia. The fracture line to the left is approx. 3 m and approx. 1 m to the right with estimated average height of 2 m and volume of approx. 15000 m³. Photo: Svalbardposten.no.

end of the 21st century. However, this scant observed annual precipitation does not say much about possible 24h precipitation in winter. The December 2015 event (Figure 3) is probably one of those cases where intense precipitation in combination with strong winds brings in a lot of snow due to a long fetch behind the slope and forms unstable snow cover. The snow height was roughly estimated to be in the range of 5-6 m on northern part of Lia (Norges Geotekniske Institutt NGI, 2018) but the height of accumulated snow on the northern shoulder of Sukkertoppen mountain is unknown. The release height of the avalanche in Feb. 2017 was measured to be approx. one meter at the fracture at top but neither the snow height nor the snow distribution elsewhere in the mountainside are known. However, there are several photos available from “normal” winters that show the distribution in the mountain side and that indicates large quantities at the shoulder and little snow in the middle of the mountain side.
