International Symposium on Mitigation Measures against Snow Avalanches and other Rapid Gravity Mass Flows – Siglufjörður 3–5 April 2019

Field excursion – hand-out

Hazard zoning and protection measures for Siglufjörður

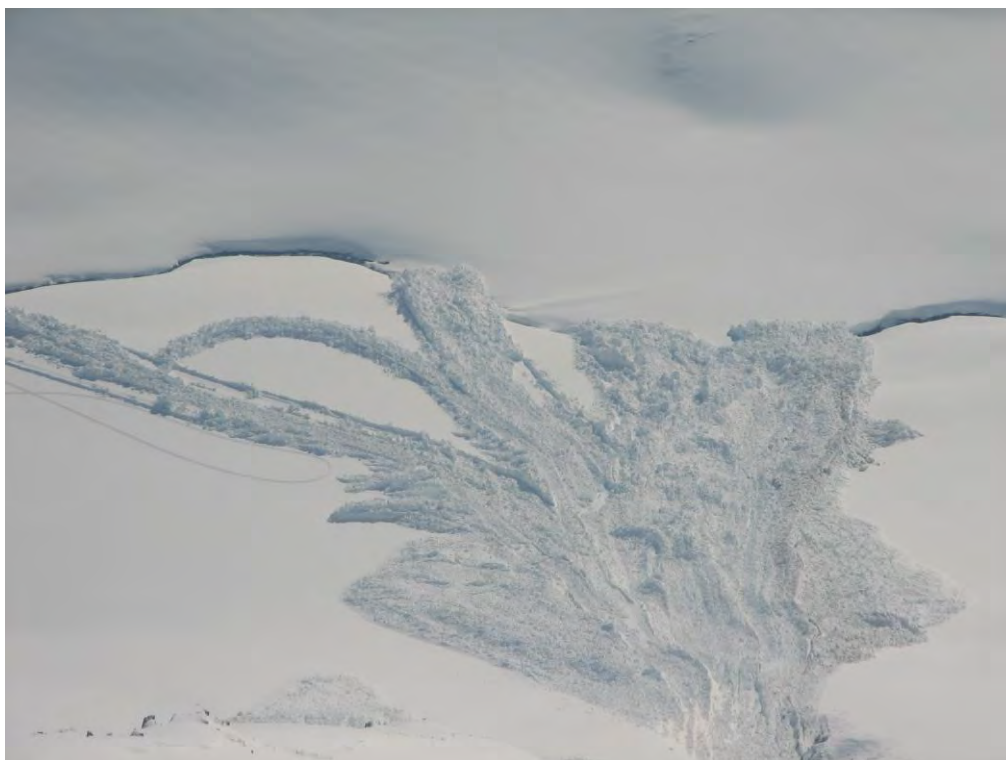
Figure1: The tongue of a wet-snow avalanche in Skeggjabrekkudalur in Ólafsfjörður on 30 April 2013. The tongue on the valley bottom was ca. 350 m wide and ca. 450 m long in the flow direction, and ca. 6.5 ha in area. The undulating wet-snow “fingers” in the avalanche tongue were several metres high with towers of piled-up snow up to 8–10 metres high. Photograph: © Ingimar Eydal.

Skeggjabrekkudalur, 28.3.1953, 5.12.1992: The valley Skeggjabrekkudalur on the west side of Ólafsfjörður is severely threatened by snow avalanches. The pipes of the municipal heating facility for the town of Ólafsfjörður have repeatedly been damaged by snow avalanches from the north side of the valley, in some cases transporting pieces of hot-water pipes hundreds of metres up the opposing valley side. A photograph of a wet-snow avalanche in Skeggjabrekkudalur is shown on the previous page.

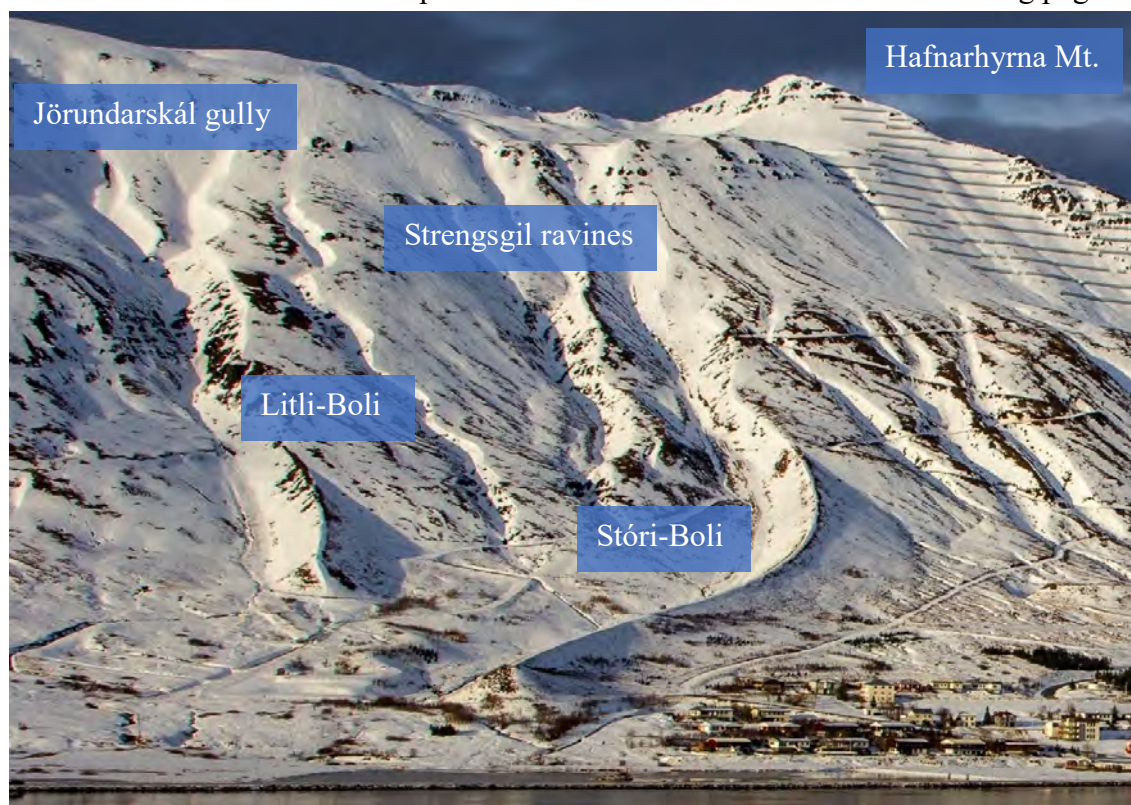
Figure 2: The deflecting dams Litli-Boli (left) and Stóri-Boli (right) mitigate the avalanche danger from the Jörundarskál gully and the Strengsgil ravines. Photo: © Árni Jónsson, 2018.

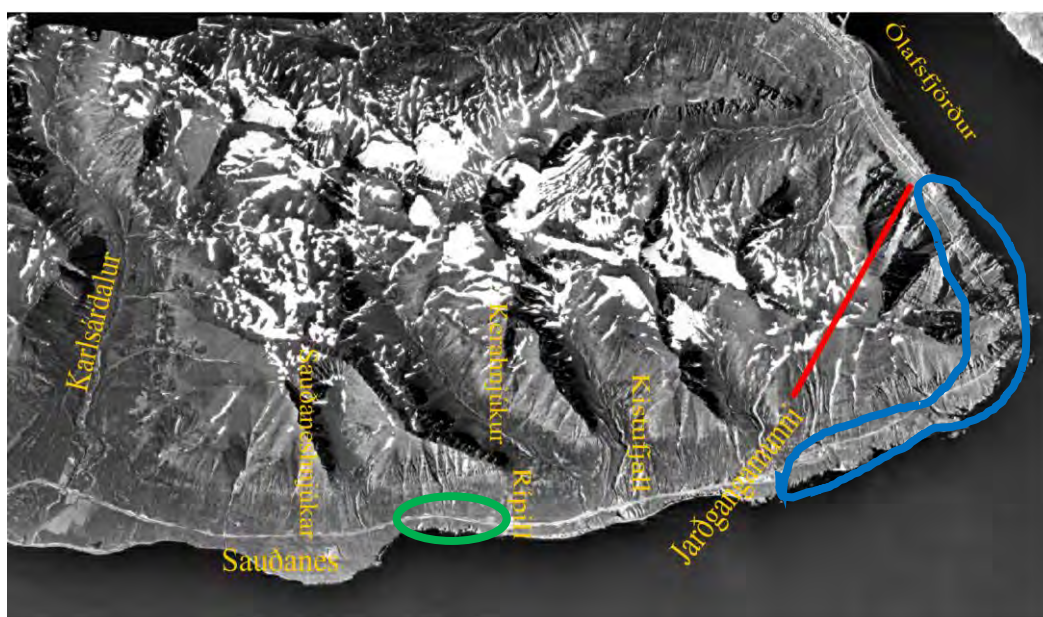
Figure 3. The mountain range between Sauðanes/Dalvík and Ólafsfjörður. The red line depicts the tunnel opened in 1991. The blue shape depicts the location of the old road used before the tunnel was opened. The green ellipse depicts the location of steel sheet piles. Aerial photo: LMI.

The road 82 from Dalvík to Ólafsfjörður (Figure 3) passes through several active avalanche paths, some of them running almost every year. The Icelandic Road and Coastal Administration (IRCA) started registration of avalanche activity in 1976 and until 2001, 2123 avalanches were registered. After the opening of the tunnel in 1991, a dramatic decrease is in the number of avalanches reaching the road can be clearly seen, Figure 4.

The tunnel eliminated some of the most severe avalanche paths but the green ellipse in Figure 3 shows an area where avalanches run almost every year in three main paths.

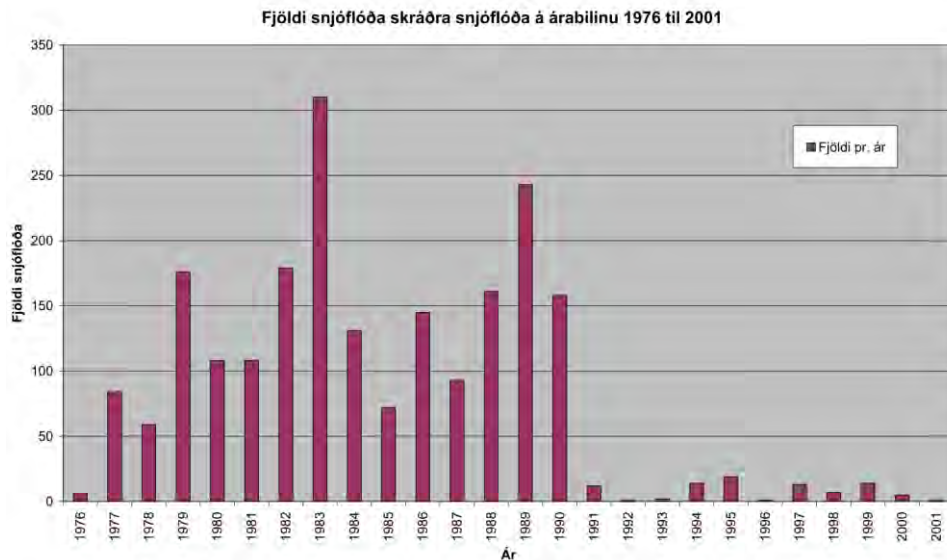
Figure 4. Number of registered avalanches from 1976 to 2001. A dramatic change in number of avalanches is seen when the Ólafsfjarðarmúli tunnel opened in 1991.

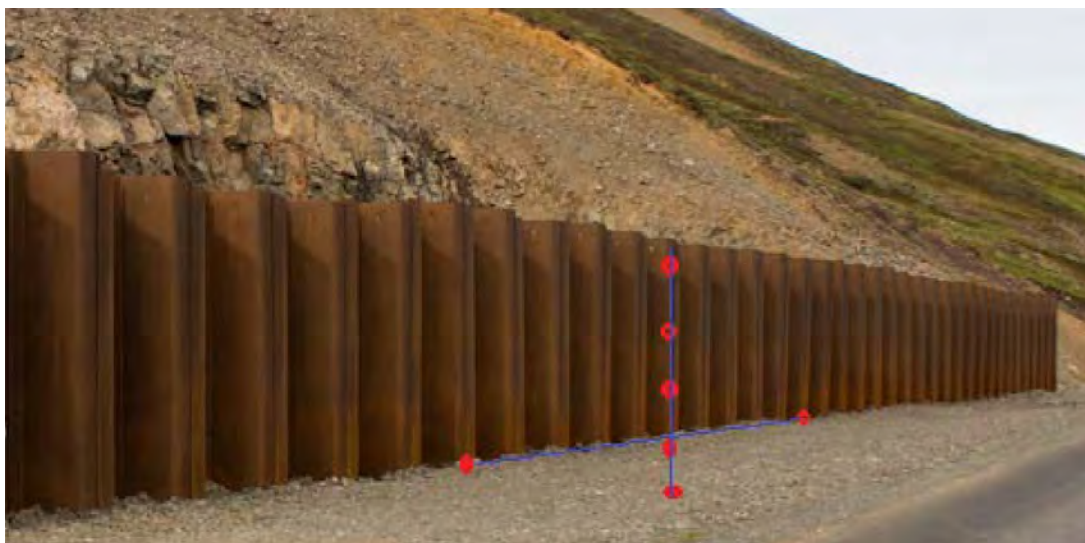
Figure 5. Red dots indicate the location of the strain gauges. The four dots seen on the ground indicate strain gauges below the ground. Photo: © Árni Jónsson

Little is known about the forces that avalanches or rock falls exert on cantilever steel sheet piles and how the latter react to these loads. For this reason, the Icelandic Road and Coastal Administration (IRCA) and the Norwegian Geotechnical Institute (NGI) decided to instrument one such wall in north Iceland in 2014 (Figure 5).

There have been many obstacles on the way in this research project such as power supply problems, false signals (triggering of the gauges) due to thermal expansion and data transmission errors but some results will be described during the excursion.

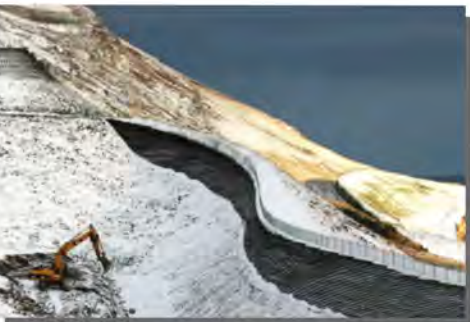
Brattir stallar þvergarða í byggingu.
Steep catching dams under construction. (MYND Þ.J.)

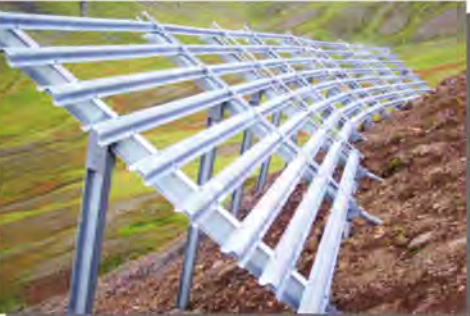
Uptakastoðvirkin minnka líkur á að snjóflóð fari af stað.
Steel bridges reduce the risk that avalanches are released. (MYND Þ.J.)

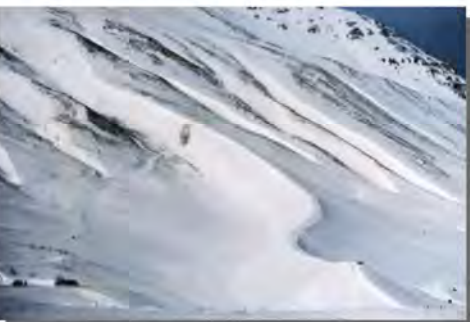
Leiðgarðurinn Stóri-Boli er vel felldur að landslaginu.
Stóri-Boli deflecting dam is designed to merge with the surrounding landscape. (MYND S.K.)

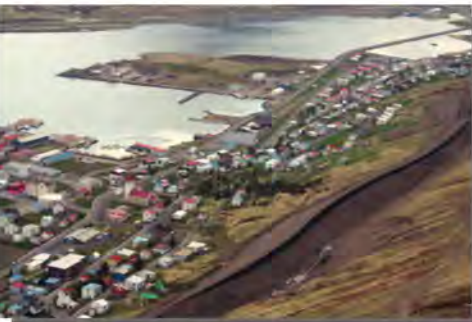
Þvergarðunum er ætlað að stöðva snjóflóð ofan byggðar.
Catching dams are intended to stop avalanches above the village. (MYND S.S.)

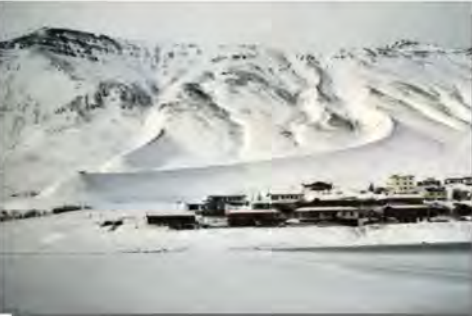
Leiðgarðarnir beina snjóflóðum frá byggð.
Deflecting dams direct avalanches away from the village. (MYND S.K.)
