Þorsteinn Arnalds  
Siegfried Sauermoser  
Tómas Jóhannesson  
Esther Jensen

## Hazard zoning for Seyðisfjörður

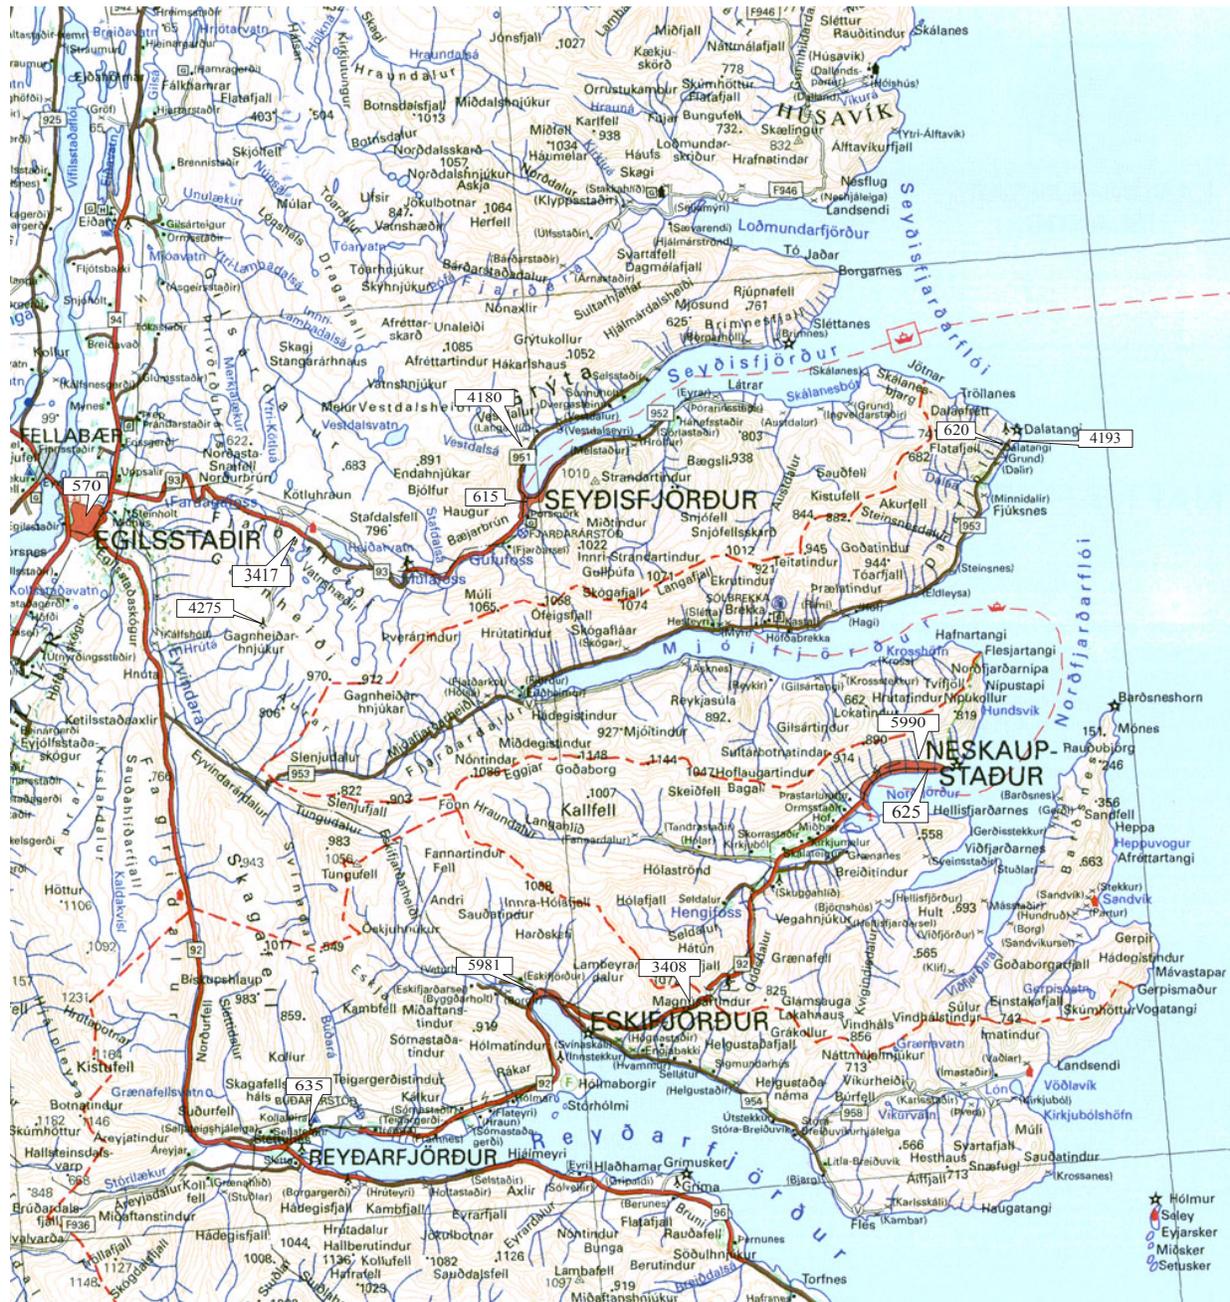
**Figure 1.** An overview of the area around Seyðisfjörður with the locations of meteorological stations indicated. © The National Land Survey of Iceland.

Several meteorological parameters were recorded in Seyðisfjörður in 1906–1953. Observations started again in 1957 and since then a climatic observation station has been operated in Seyðisfjörður. In the years 1994 and 1995 automatic weather stations were set up in Seyðisfjörður, Neskaupstaður, Dalatangi, Gagnheiði, Fjarðarheiði and Oddsskarð. Synoptic observations have been carried out at Dalatangi since 1938. The observations from these stations are used to analyse the climatic conditions in Seyðisfjörður. The locations of the stations is shown in Figure 1.

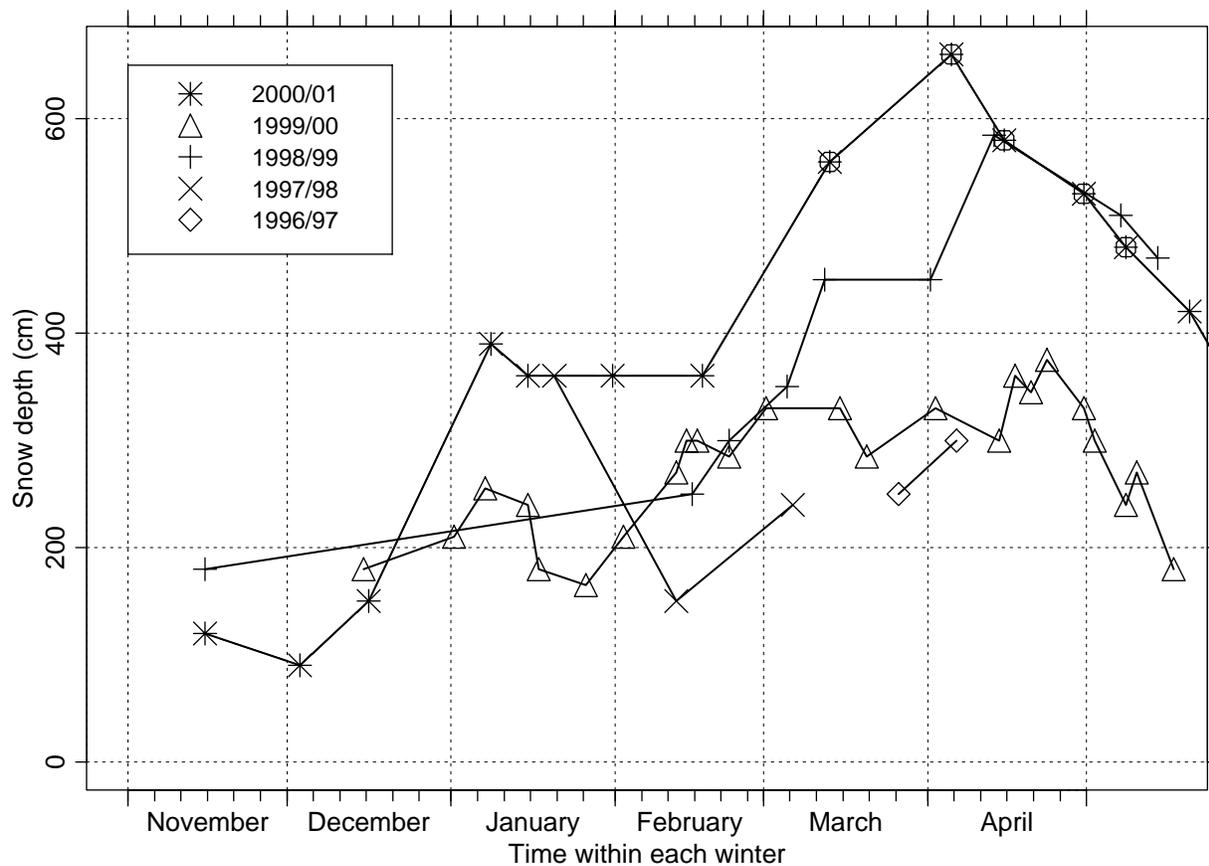
**Figure 2.** Snow depth at the stake seka01 at 602 m a.s.l. in Kálfabotn in Bjólfur. Data points, where the snow depth at buried stakes has been inferred, based on the measured variation of the snow depth at other nearby stakes, are denoted with a circle.

the range 2–3 m for the lower or more exposed parts of the slope up to more than 6 m on the stakes with the greatest snow depths in the bowl Kálfabotn in Bjólfur. The greatest snow depths were measured in the winters 1998/1999 and 2000/2001. Most of the stakes are located in a relatively unconfined terrain and greater snow depths may be expected to have occurred in the gullies that are located in several of the starting zones. No stakes are located in the main starting zones above the shelf above Brún in Bjólfur due to difficult conditions to maintain fixed stakes in this part of the mountain because of rockfall and avalanches. Photographs and scattered observations from a distance by snow observers during field trips to the shelf at Brún indicate that great snow depths are reached in this part of the mountain, perhaps similar to the measured snow depths in Kálfabotn. Figure 2 shows the measured snow depth at stake seka01 at 602 m a.s.l. in Kálfabotn for the winters since the start of the measurements in the 1996/1997.

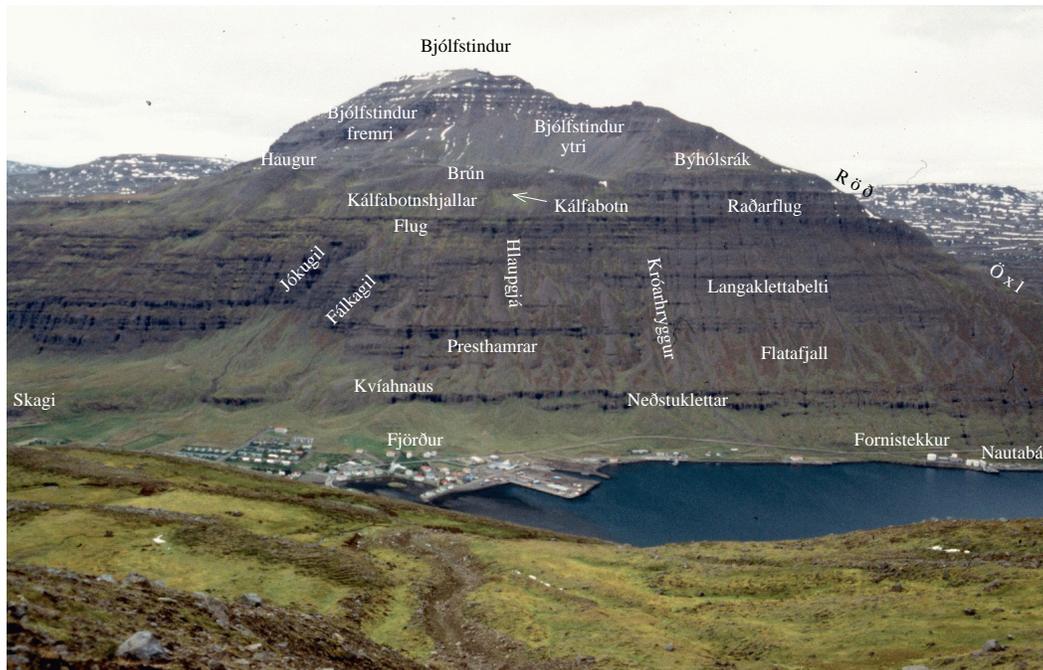
**Figure 3.** *Bjölfur and the names of main landmarks. (Photo: Thorsteinn Sæmundsson).*

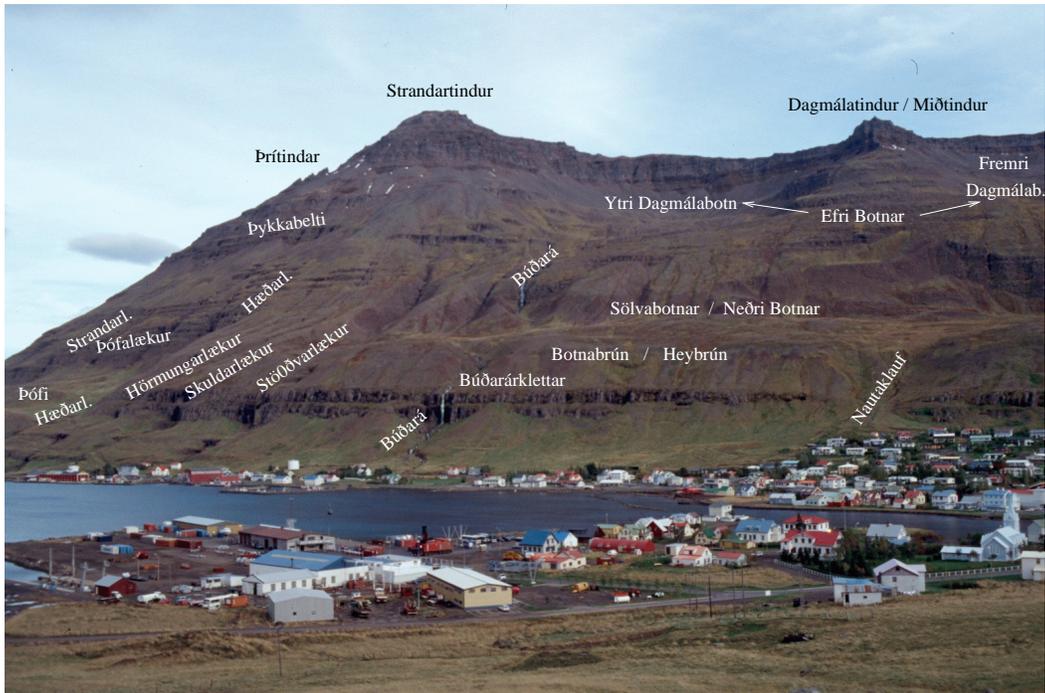
**Figure 4.** *Strandartindur and the names of main landmarks. (Photo: Thorsteinn Sæmundsson).*

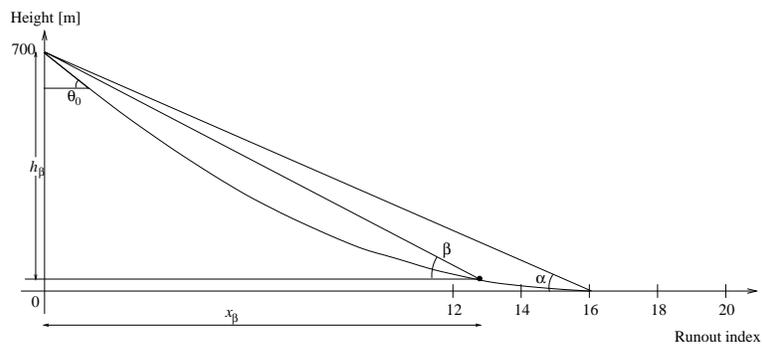
**Figure 5.** *The standard path. The  $\alpha$ -angle is the expected runout angle of an avalanche according to the  $\alpha/\beta$ -model.*

**Runout index:** The runout measured in hectometers of an avalanche that has been *transferred* (Sven Sigurðsson *et al.*, 1997) to the *standard path* making use of some transfer method. The runout index in this report is obtained by using the PCM-model with parameters lying on a predefined parameter axis. An avalanche that has a runout index of  $r_0$  is referred to as an avalanche with  $r = r_0$ . The method was developed by Kristján Jónasson *et al.* (1999).

**$F_{r_0}(F_{13})$ :** The expected frequency of avalanches with a runout index greater or equal than  $r_0$ . The value  $F_{13}$  is most often used, i.e. the frequency at the runout index  $r_0 = 13$ .

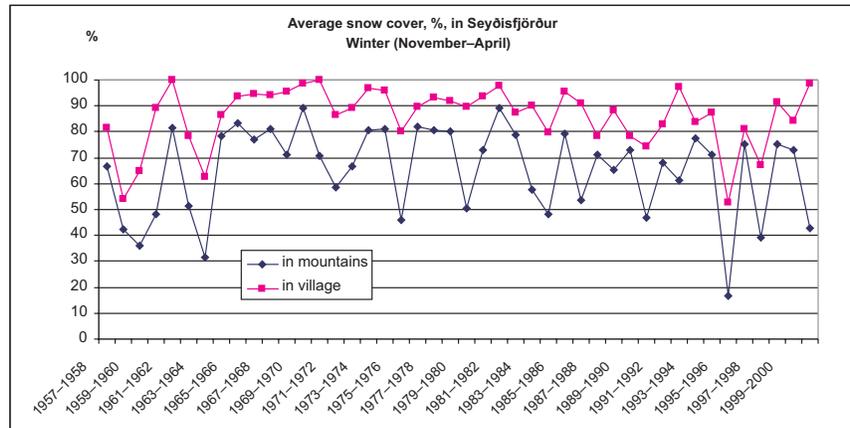
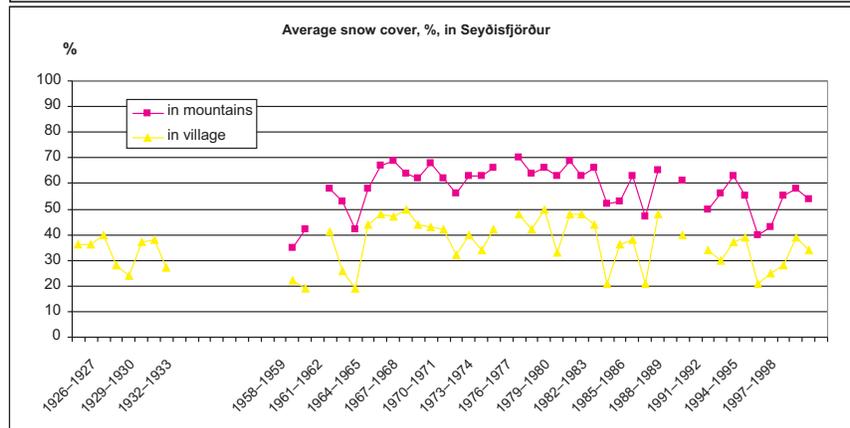
## C.1 Snow cover in Seyðisfjörður
